# CITY OF NEW PORT RICHEY PUBLIC WORKS AHU-2 HVAC ANALYSIS

NEW PORT RICHEY, FL

**VoltAir Consulting Engineers (VACE)** was requested to evaluate an existing HVAC DX Split system known as an air handling unit (AHU-2) located in Mechanical Room 127 at the City of New Port Richey (NPR) Public Works Building. This analysis involves a deficiency report based on the information gathered at the site visit conducted on Monday, June 26<sup>th</sup>, 2023.

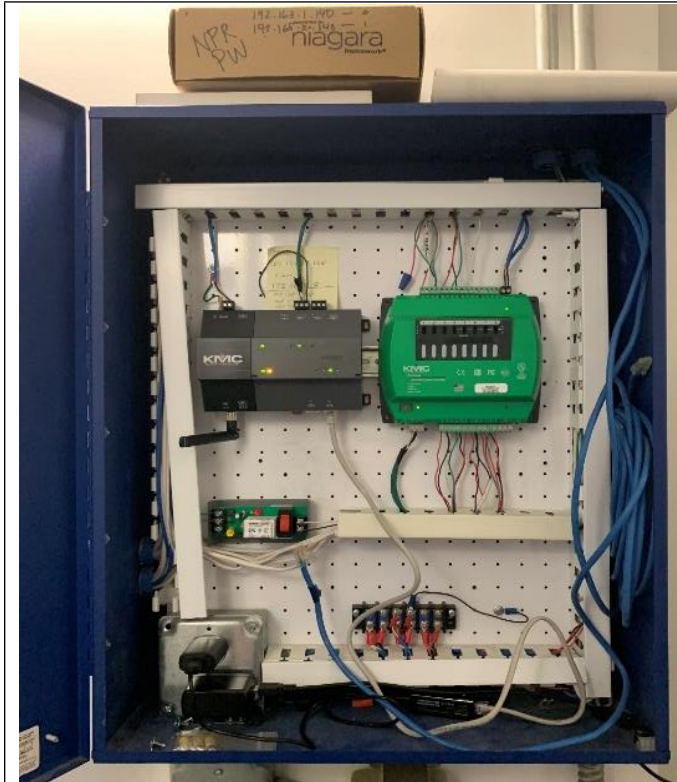
AHU-2 has a series of controls from KMC (Shown in Figure 1) with the inclusion of ABB VFD'S (Shown in Figure 2). The control panel and the VFD'S are located inside of Mechanical Room 127 (Shown in Figure 1). The controls were installed in 2009 and appear to be in good condition and functional. VACE would recommend that the control system be replaced and tied to the existing KMC Direct Digital Control (DDC) control system.

Figure 1 – Controls Panel (KMC Niagara and BACnet)

Recommend Control System for replacement. Replacement to include the same manufacturer as currently found in other. In an effort to match the other existing controls commonly used in the City of NPR Public Works Building, KMC controls are advised to be installed.

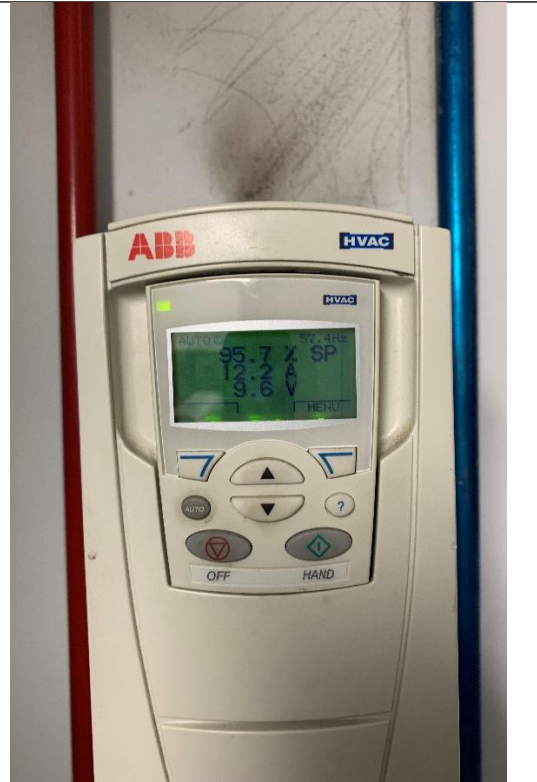
Figure 2 – ABB AHU-2 VFD

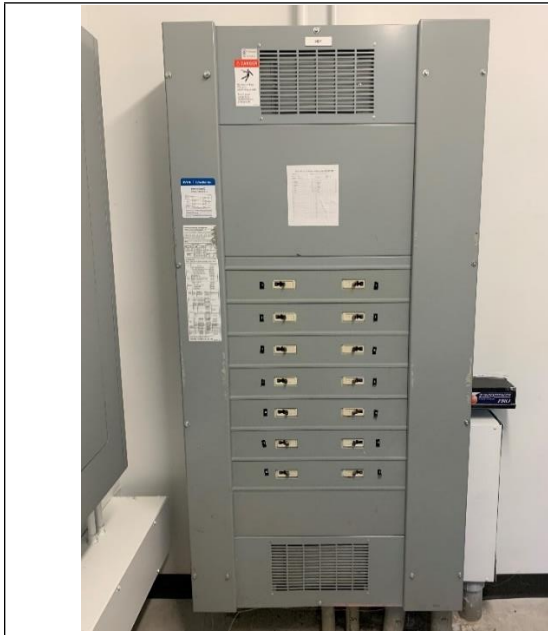
The CU-2 (Breaker #12) and AHU-2 (Breaker #14) are receiving power from an Eaton PRL4B 208-volt 3 phase electrical panel (Shown in Figures 1-3). The manufacturing date shows as installed in 2008 when the building was originally constructed (Shown in Figure 4). It's located in Electrical Room 114 and it appears to be in good condition. At the time of the visit, there were no known signs of burning smell, flickering, nor frequent breaker trips.

Figure 1 – PRL4B Panel

It is recommended the breakers are replaced as required for the new equipment.

Recommend electrical new breakers for CU-2 (Breaker #12) and AHU-2 (Breaker #14) for replacement as needed.

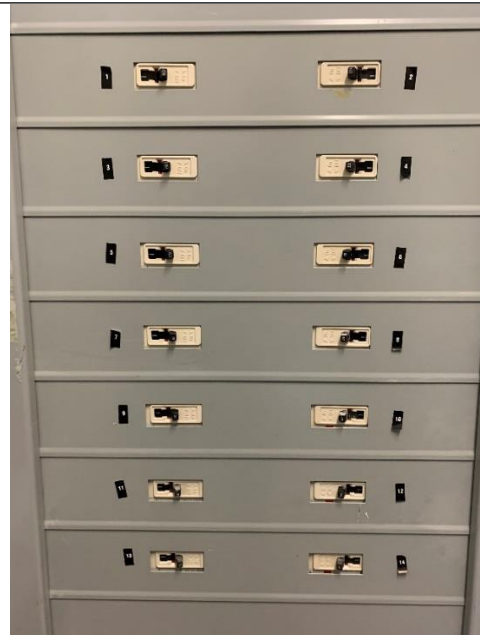
Figure 2 – Breakers

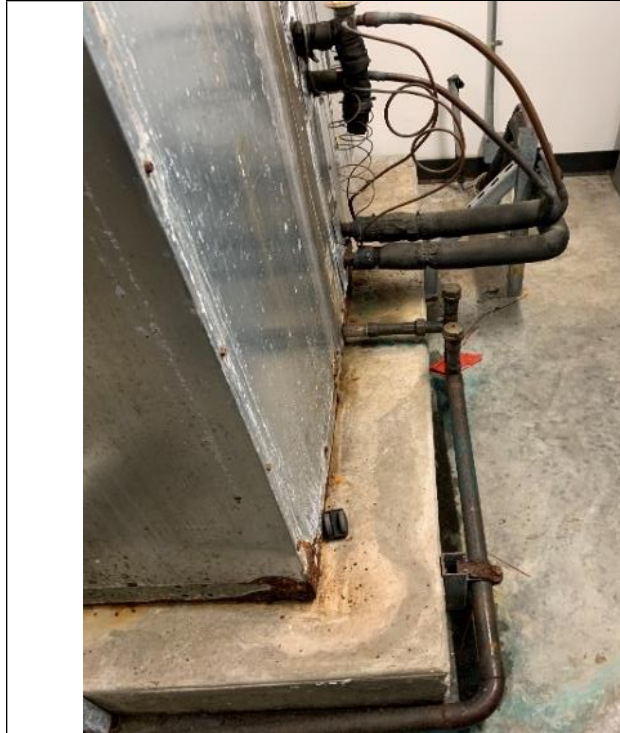
- **Liquid line insulation deteriorating (Shown in Figures 1-2)**
- **Current unit refrigerant uses type 22 (Shown in Figure 3) which is being phased out**
- **Exterior sheet metal bubbling rust (Shown in Figure 5)**
- **Rust at structural base of AHU-2 (Shown in Figure 6)**
- **Limited allowable clearance to service/replace coil**
- **Limited allowable clearance to service/replace filters (Shown in Figure 8)**
- **Open louver to the exterior next to OA louver (Shown in Figure 9)**
- **OA damper seized in place and cannot be actuated (Shown in Figure 10)**

Figure 1 – AHU-2 Liquid and Suction Lines, and Condensate Outlet

Based on observations VACE recommends AHU-2 and ductwork within the mechanical room be replaced. In addition, VACE recommends that the louver opened to the exterior be entirely sealed and the room be conditioned.

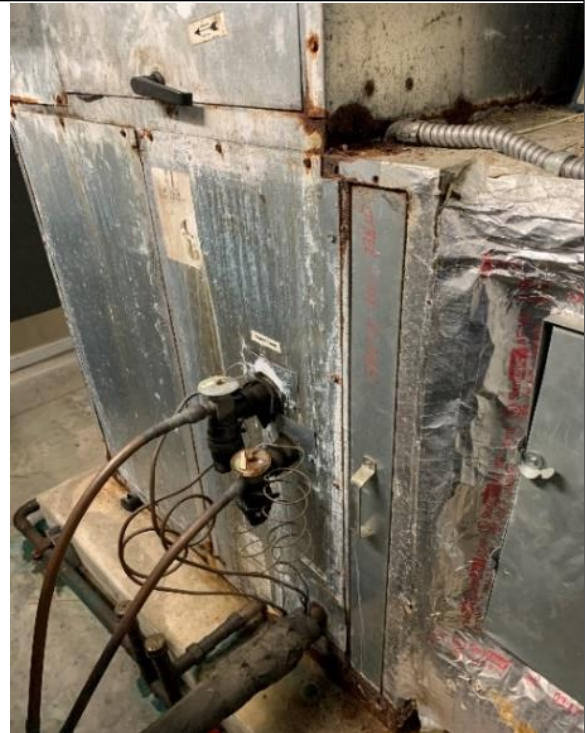
Figure 2 – AHU-2 Liquid and Suction Lines, and Coil Access

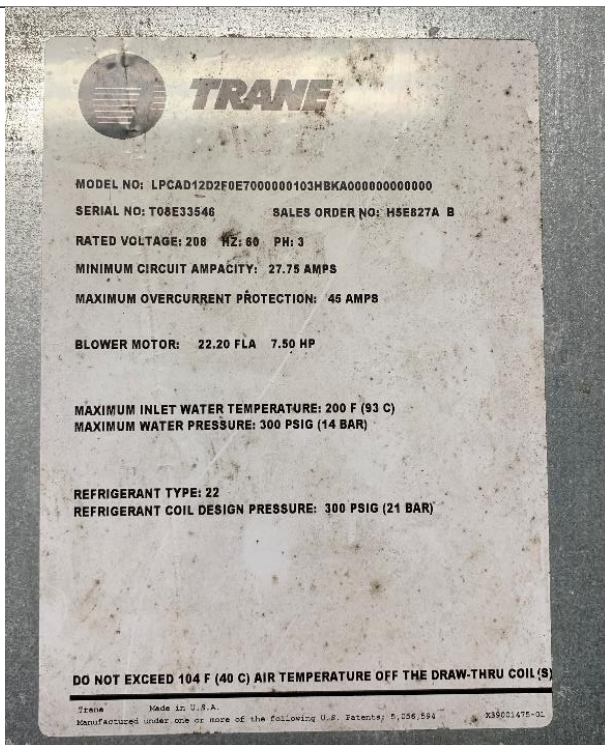
The DX split system has two (2) liquid and two (2) suction lines coming from CU-2, with refrigerant type 22, going under grade up to Mechanical Room 127 to connect with AHU-2 (Shown in Figures 1-2). Refrigerant type 22 is being phased out and is no longer available or expensive to purchase. Notably, there is a louver (Shown in Figure 9) that is open to the exterior next to the OA louver. This allows unconditioned outside air to freely enter the mechanical room and is a significant source of corrosion on the AHU and ductwork.

Figure 3 – Trane Equipment Label

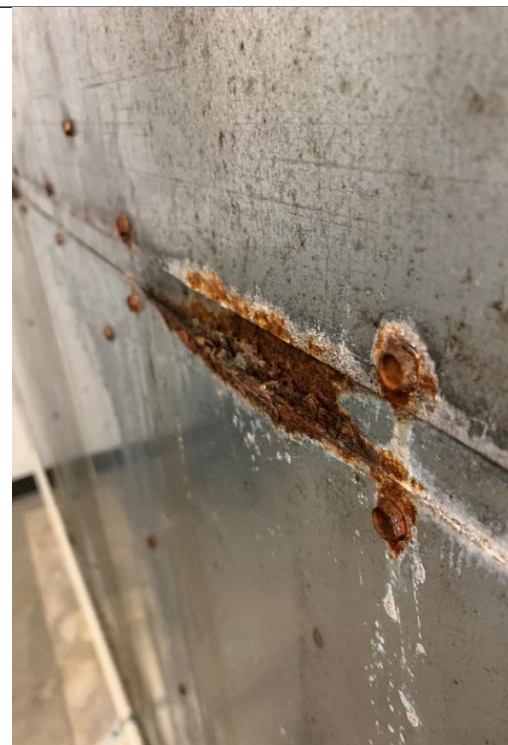
Figure 4 – AHU-2 Bubbling Rust

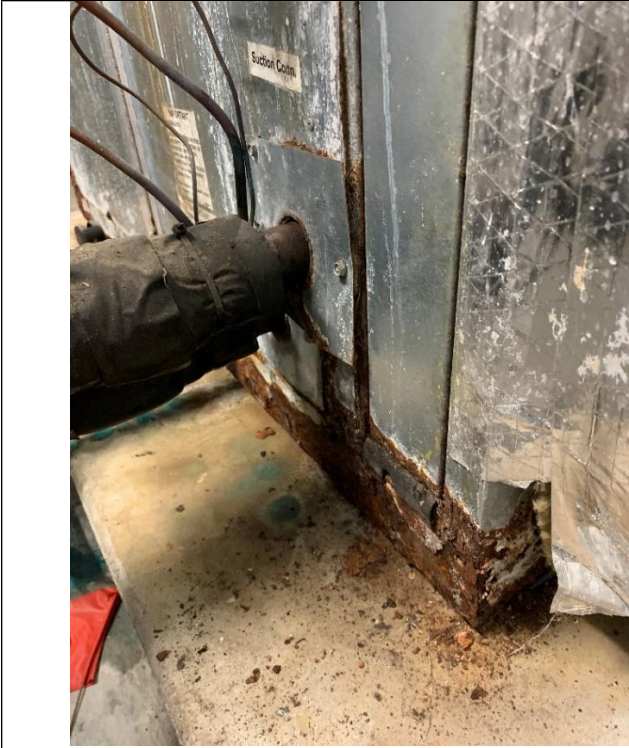
Figure 5 – AHU-2 Structural Base

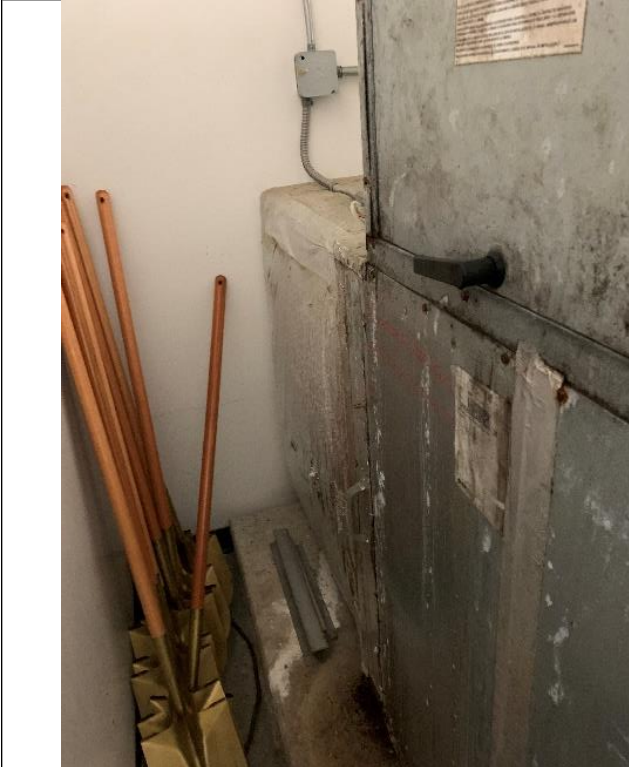
Figure 7– Filter Access

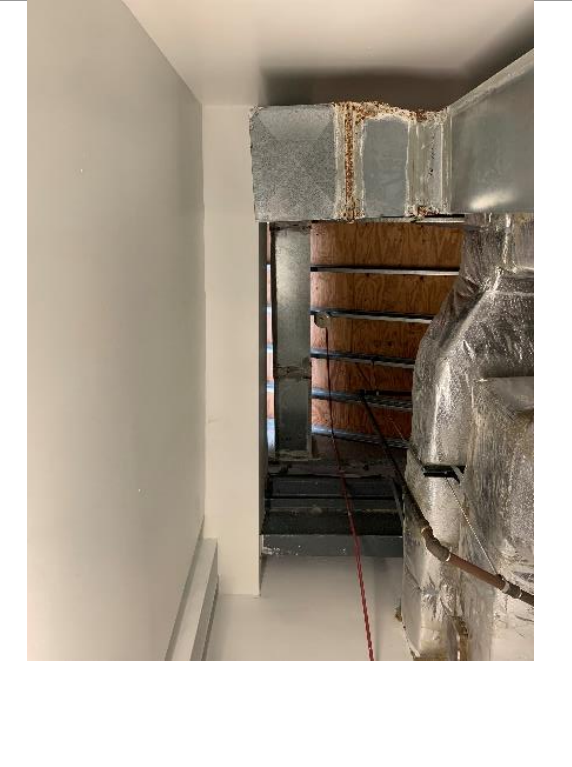
Figure 8 – OA Duct

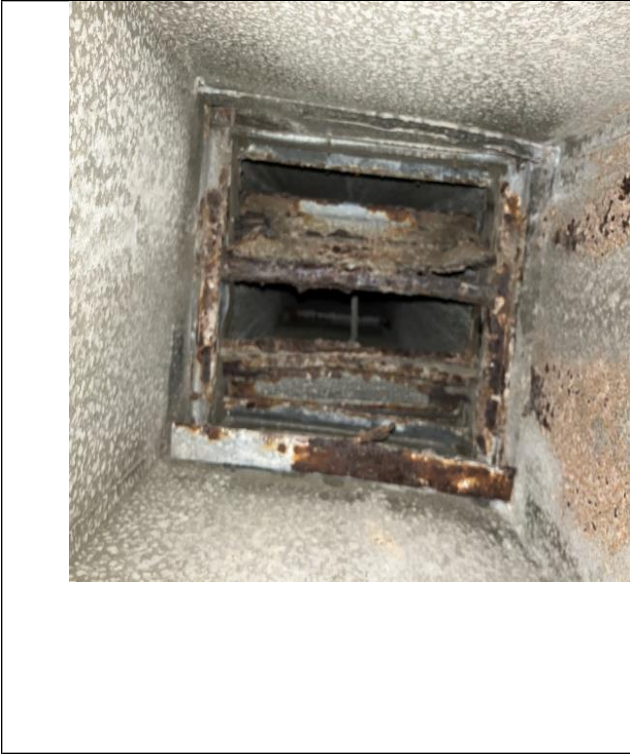
Figure 9 – Damper Inside OA Duct

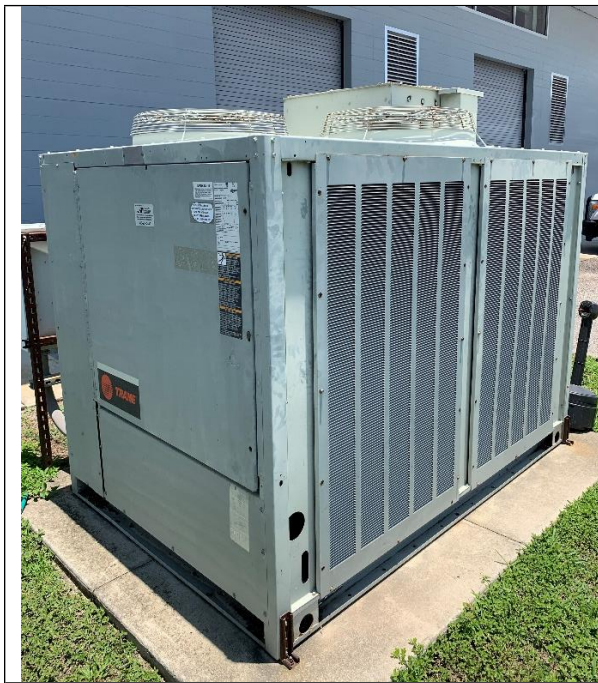
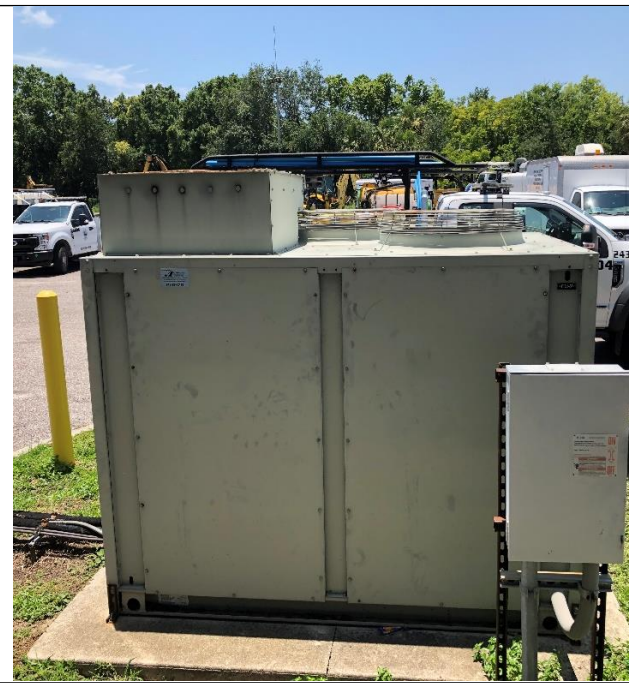
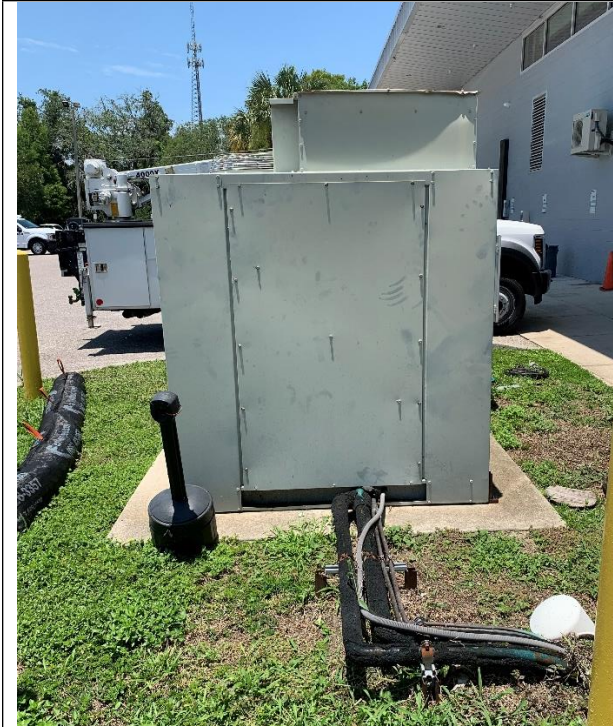
Figure 1 – CU-2

CU-2 (Shown in Figures 1-3) located outside of Storage Room 125 was installed during original construction in 2008. During the site inspection, VACE observed that CU-2 was in poor condition and is getting close to the end of its useful life as specified in the ASHRAE Handbook. Maintenance personnel informed history of replacement in the last 5 years including compressors, relays and condenser fan motors. AHU-2 is a direct expansion (DX) split system requiring a refrigerant system coming from CU-2.

Based on our observations VACE recommends that CU-2 be replaced.

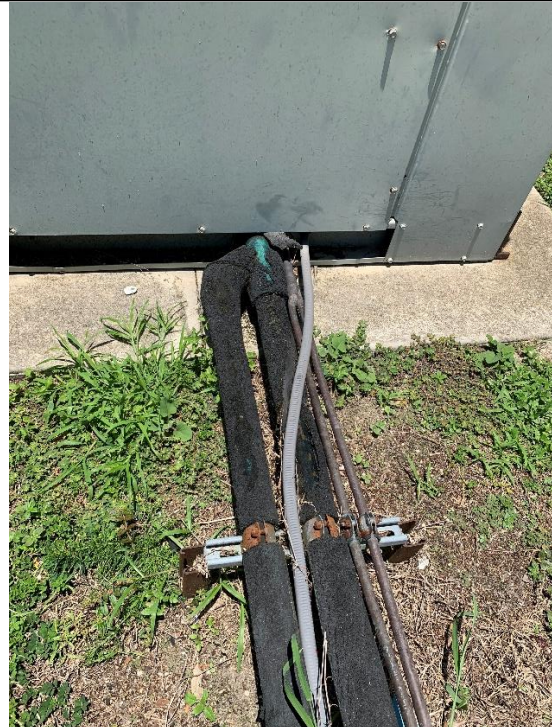
- **Liquid line insulation deteriorating (Shown in Figures 3-6 and QR Code)**
- **During the site visit, the unit shut down completely (about 1:45pm, 90°F outside) and start back on about 6 minutes after (Shown in QR Code)**
- **Continuous rattling sound when operating (Shown in QR Code)**

Figure 4 – Liquid Line out from CU-2

Recommend CU-2 for replacement. Replacement to include new liquid and suction lines from CU-2 to AHU-2.

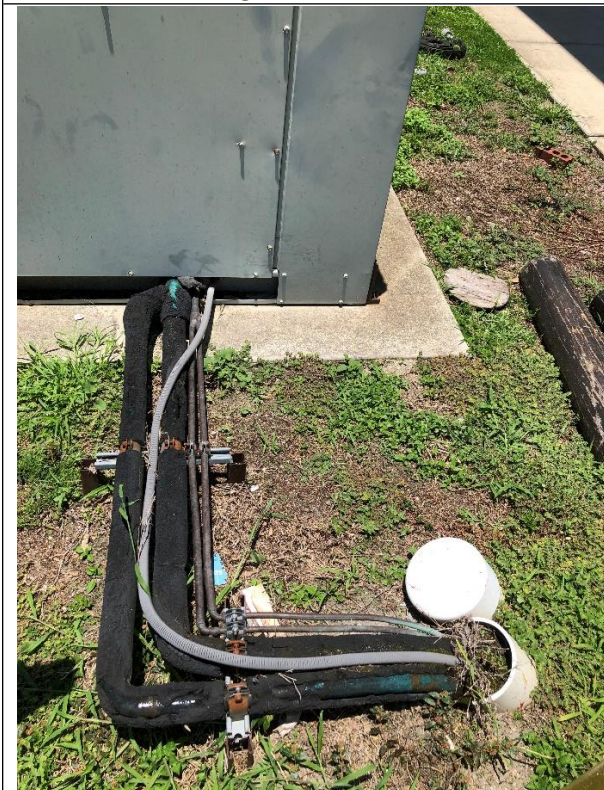
Figure 5 – CU-2 Liquid Line Deteriorating

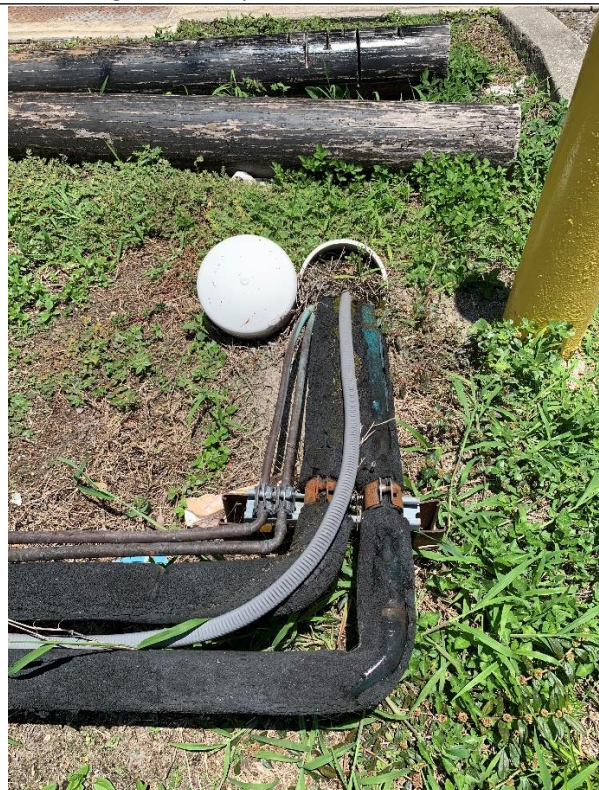
Figure 6 - CU-2 Liquid Line to AHU-2
