Smart Start Business Incubator Roof Assessment

Chris Hanning, P.E.
Assistant Public Works Director
City of New Port Richey
November 24, 2015

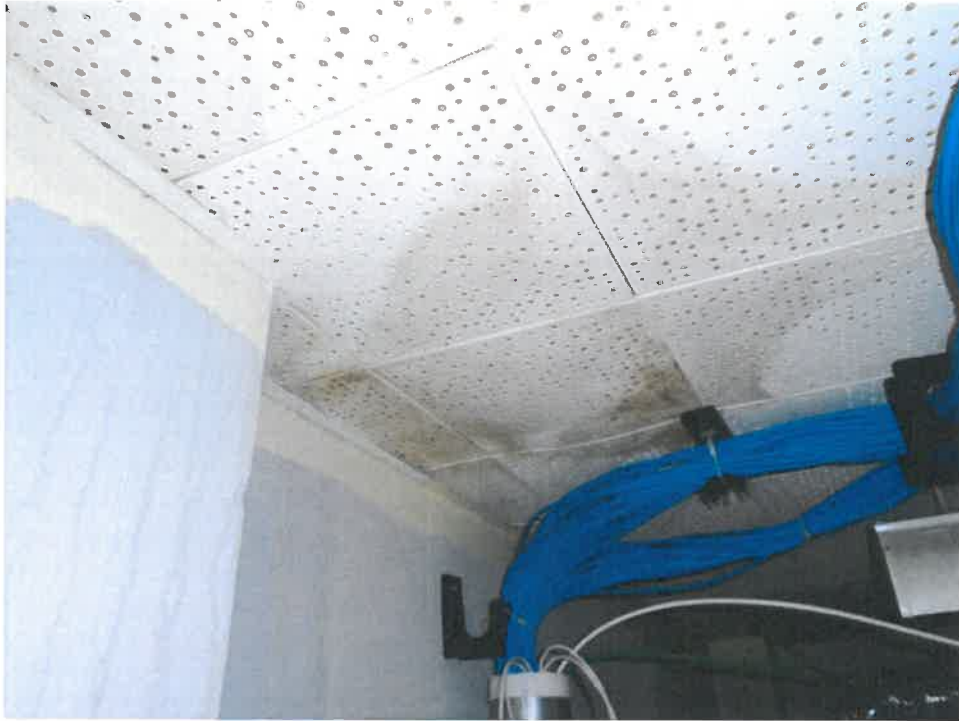
Figure 1: Stains are visible on the original ceiling in a utility room under the north section of roof along the east wall of the building.

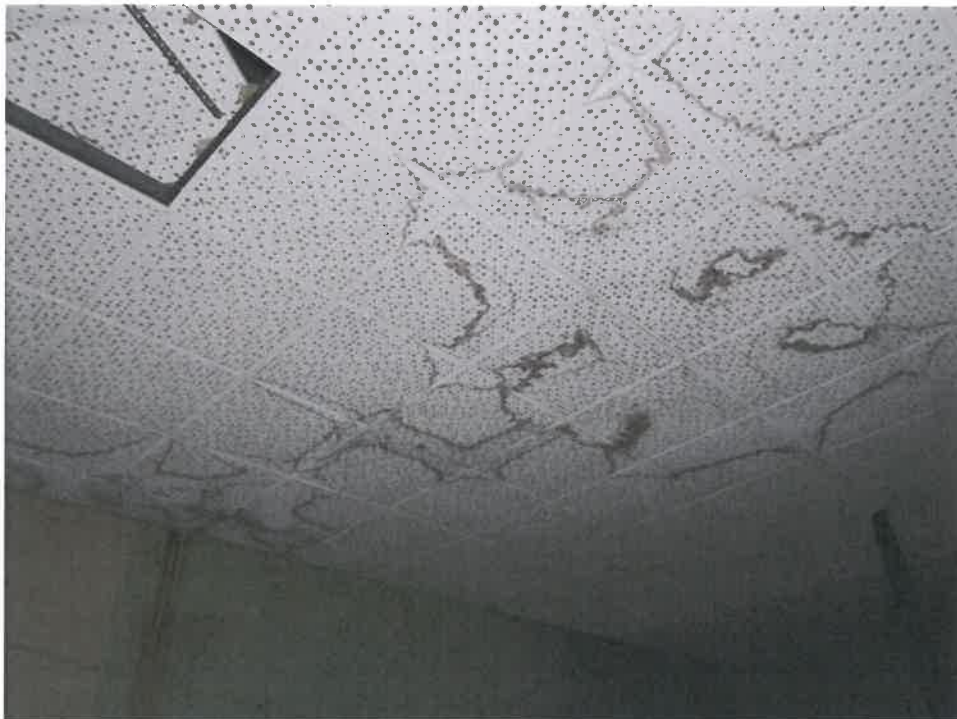
Figure 2: Stains on the original ceiling are visible in a hallway under the north section of roof.

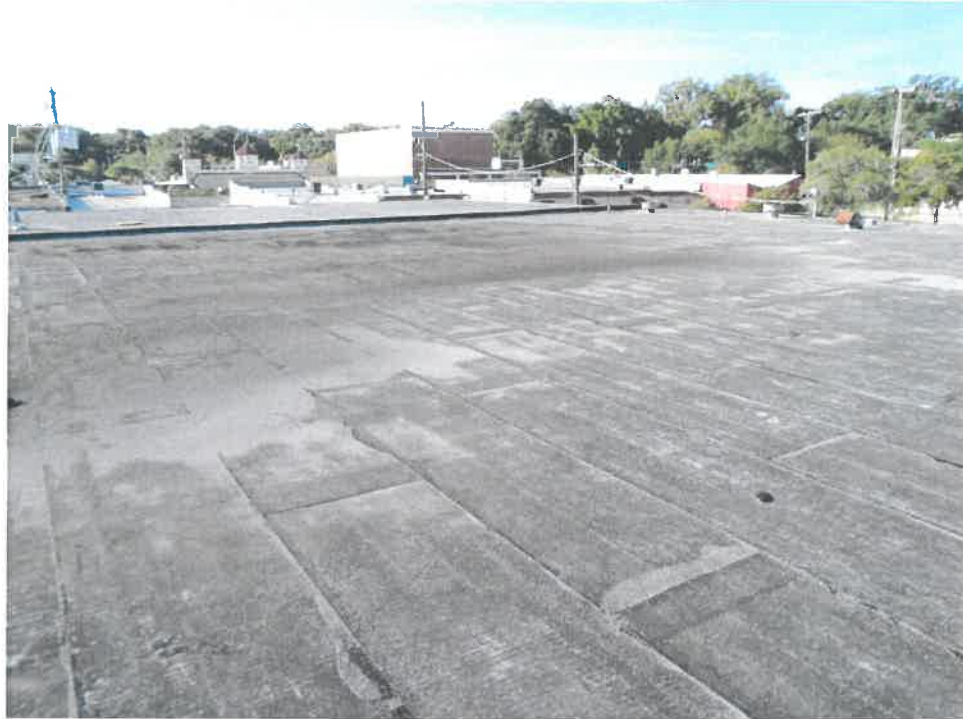
Figure 3: North section of the roof looking south.

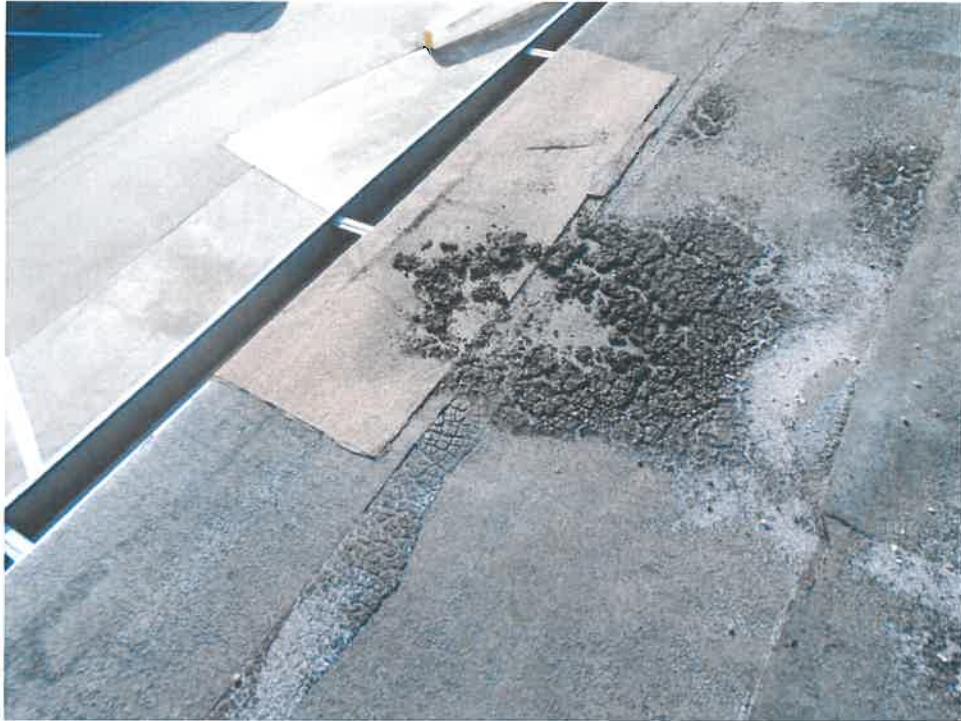
Figure 5: New patch, loose granules, and deteriorated sealant are found over the utility room where water was leaking from the ceiling.

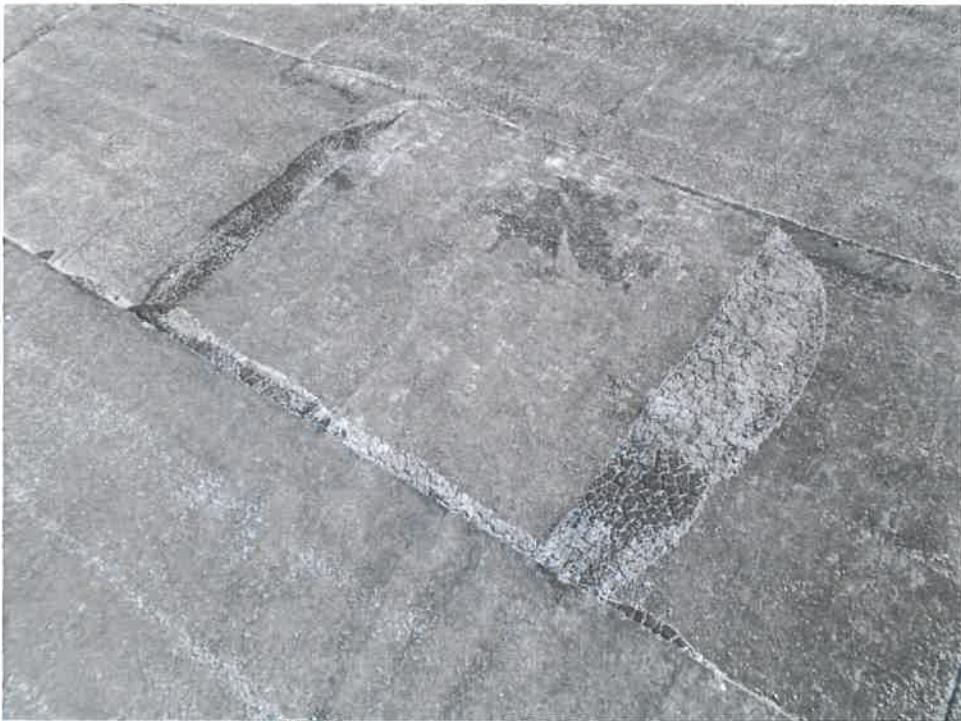
Figure 6: Extensive granule loss, deteriorated sealant, and patches are found on the north section of roof.

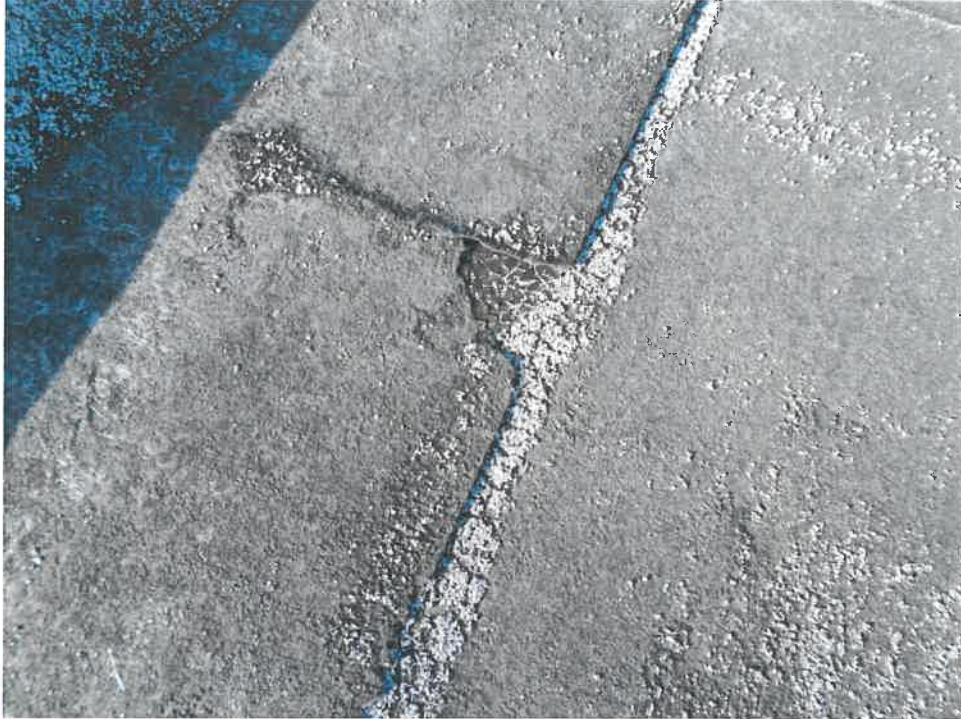
Figure 7: Deteriorated membrane and extensive granule loss are visible on the north section of roof.

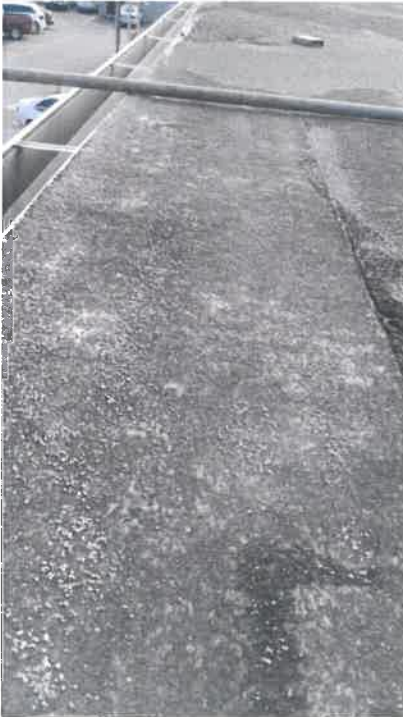
Figure 8: A small depression extends around the perimeter of the north section of roof.

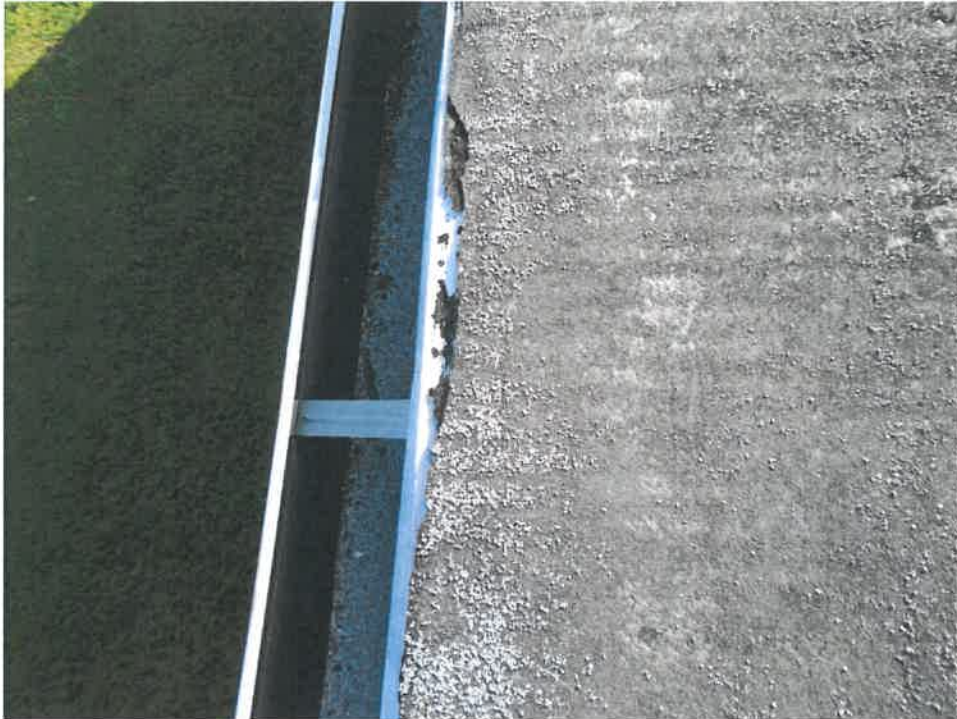
Figure 9: Torn and deteriorated membrane reveals portion of the drip edge around the perimeter of the roof.

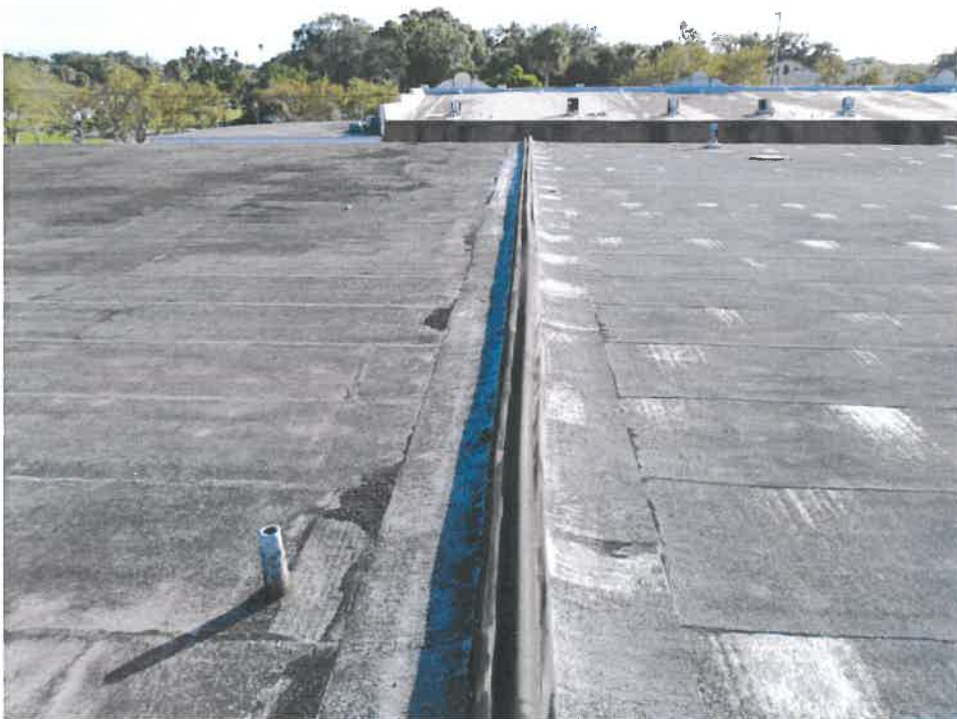
Figure 10: The expansion joint divides the north (left) section from the south (right) section of the roof.

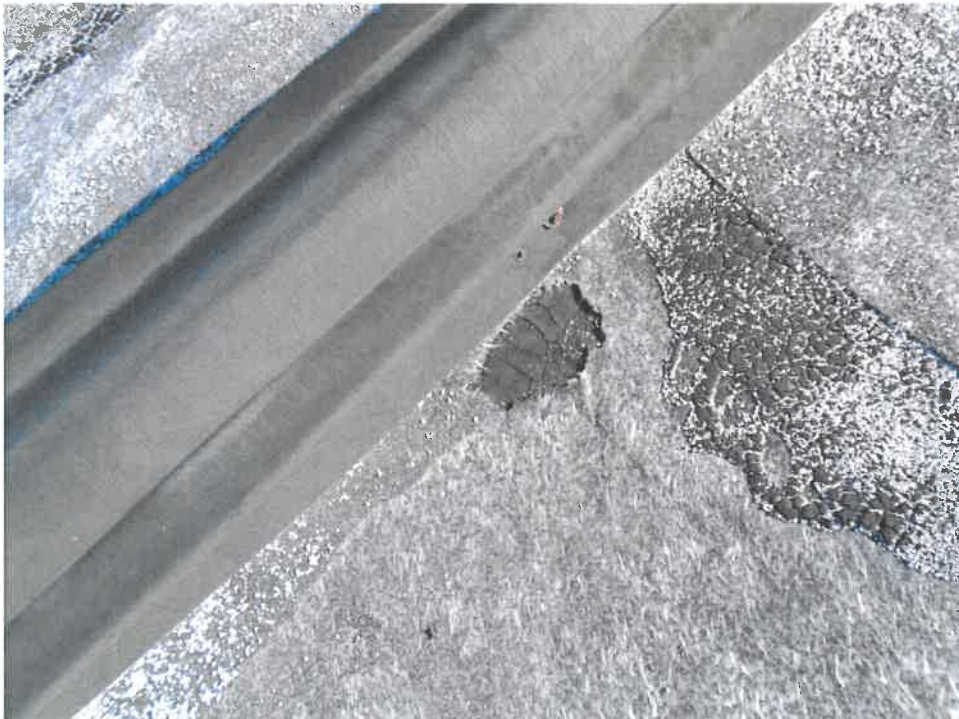
Figure 14: Small areas of deteriorated membrane are visible near the expansion joint.
