# **Report of Roof System Condition Assessment**

**Incubator Building – North Roof Area**  
6345 Grand Blvd.  
New Port Richey, FL 34652

Issue Date:  
December 2, 2016

BillerReinhart Project No. 16-502

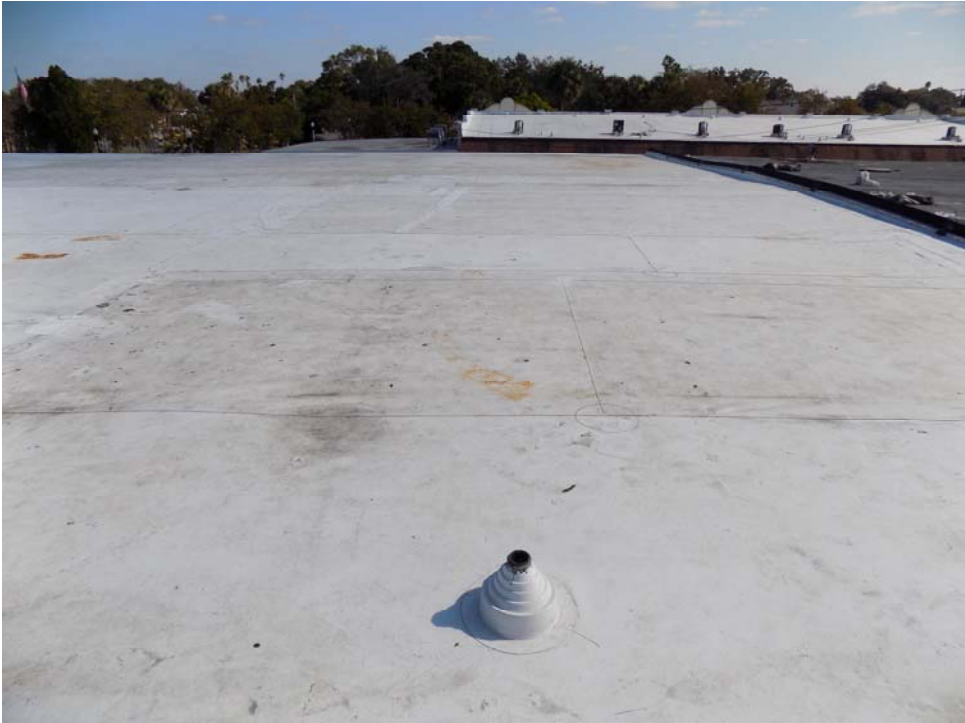
**Figure A- 1**

1. The roof system was observed to consist of a TPO roofing system. Refer to *Figure A-1*.
2. Areas of standing water and evidence of water staining were observed along the perimeter of the roof areas – typical condition along the roof perimeter. Refer to *Figure A-2*, *Figure A-3*, and *Figure A-4*.

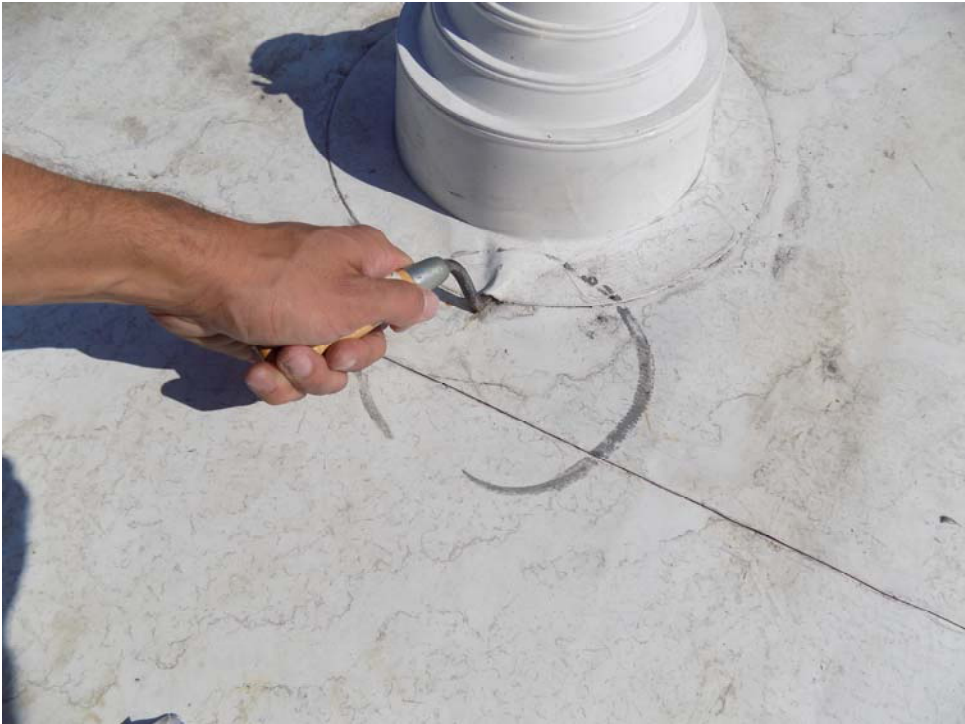
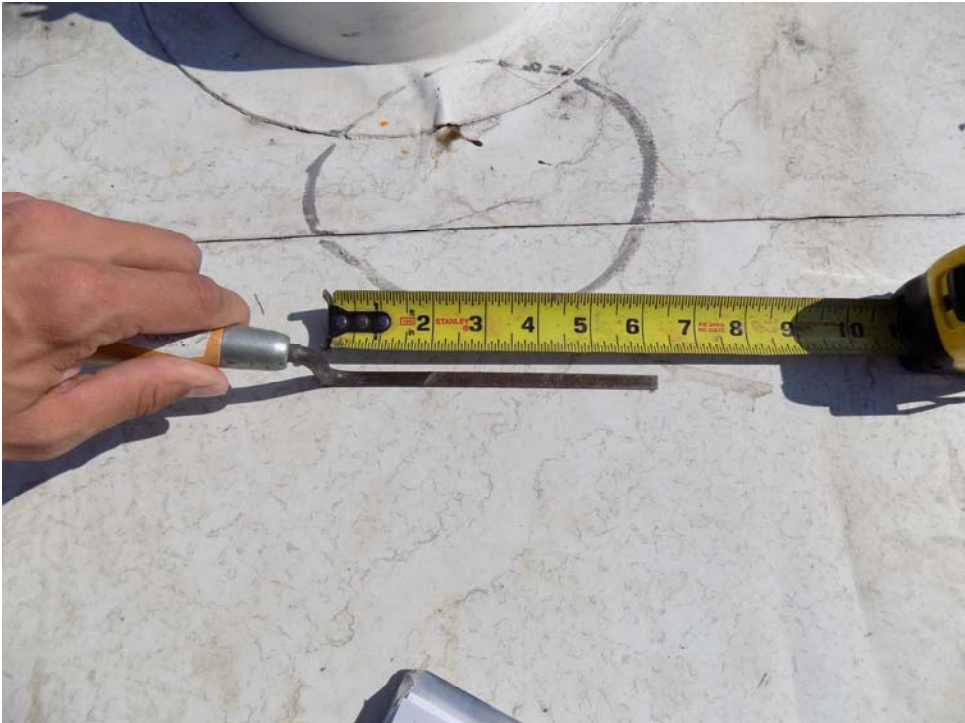
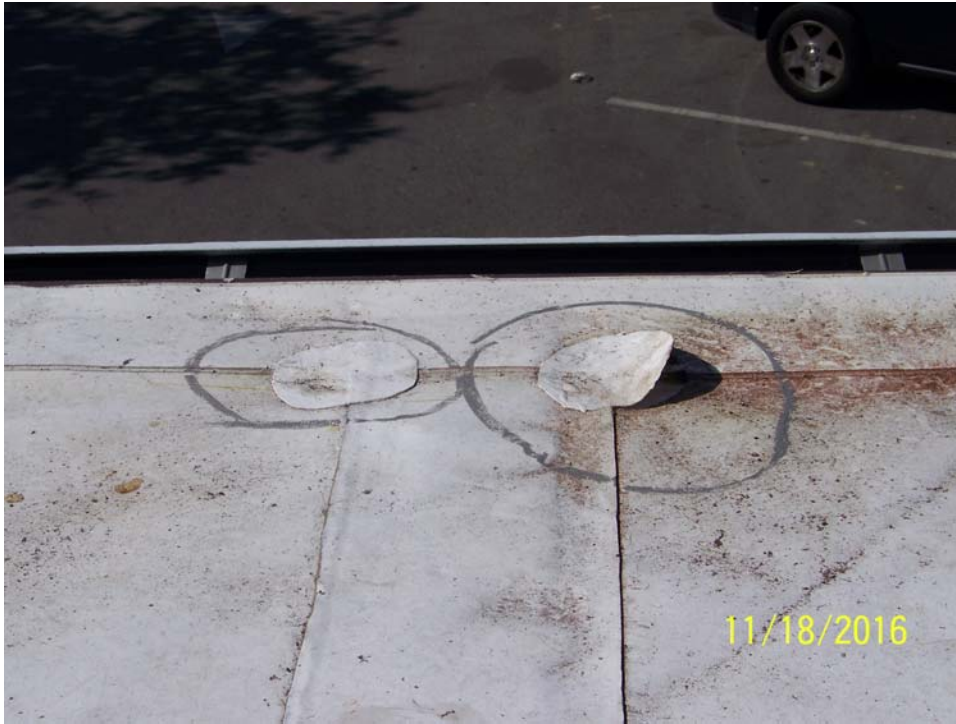
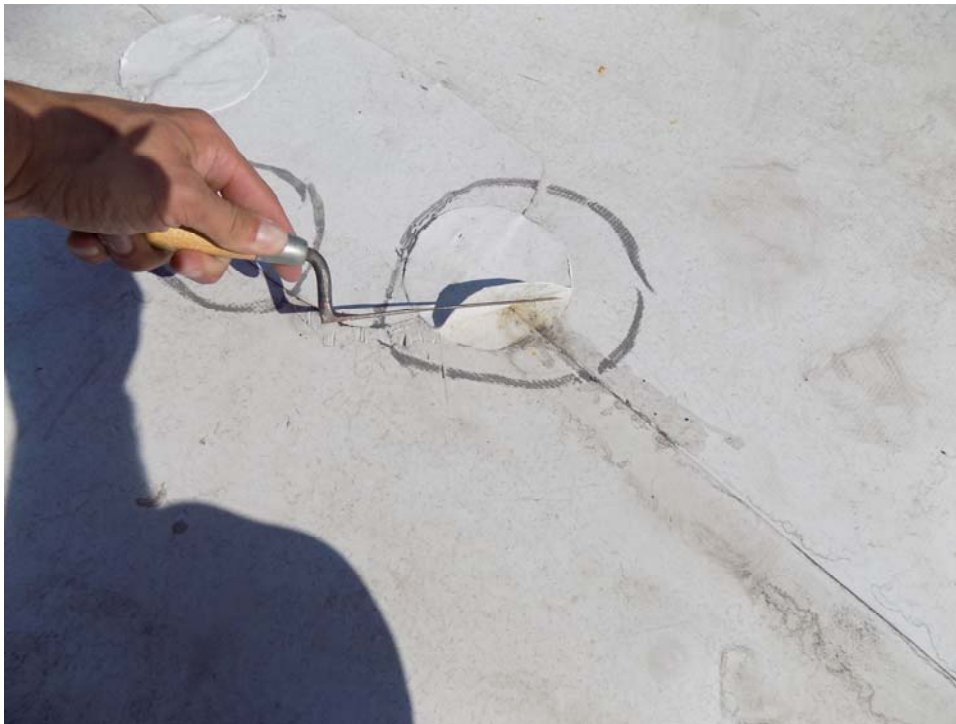
3. Voids in seams of the membrane / hot air welds were observed throughout the roof. Seam welds must be a minimum 1-1/2 inches wide and free of voids. Refer to *Figure A-5* through *Figure A-8*.

BillerReinhart recommends that the existing TPO roofing system be removed and replaced.

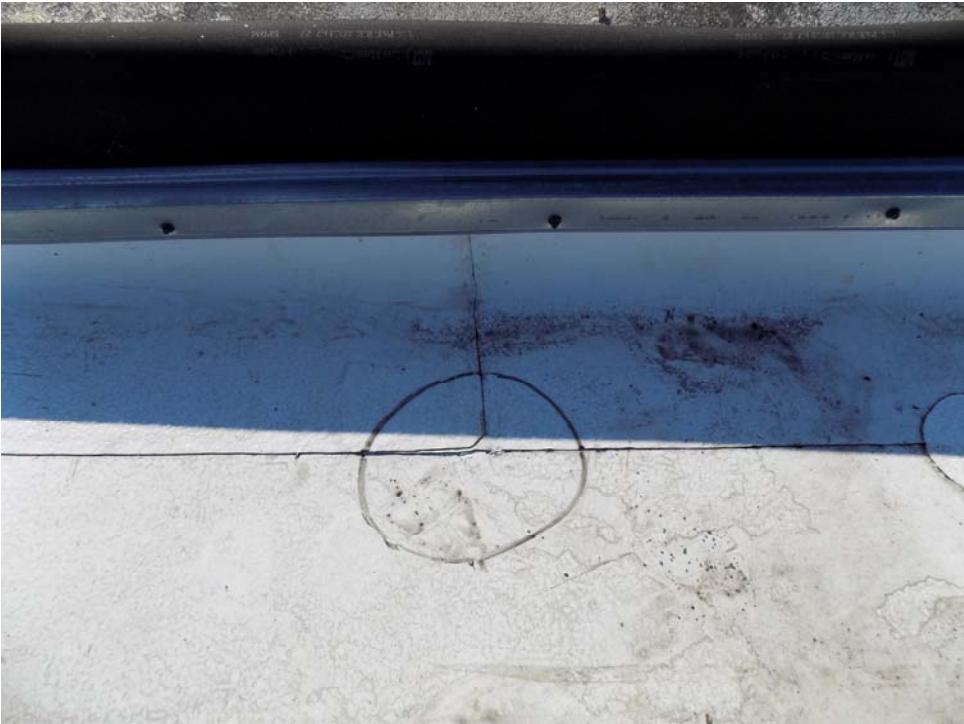
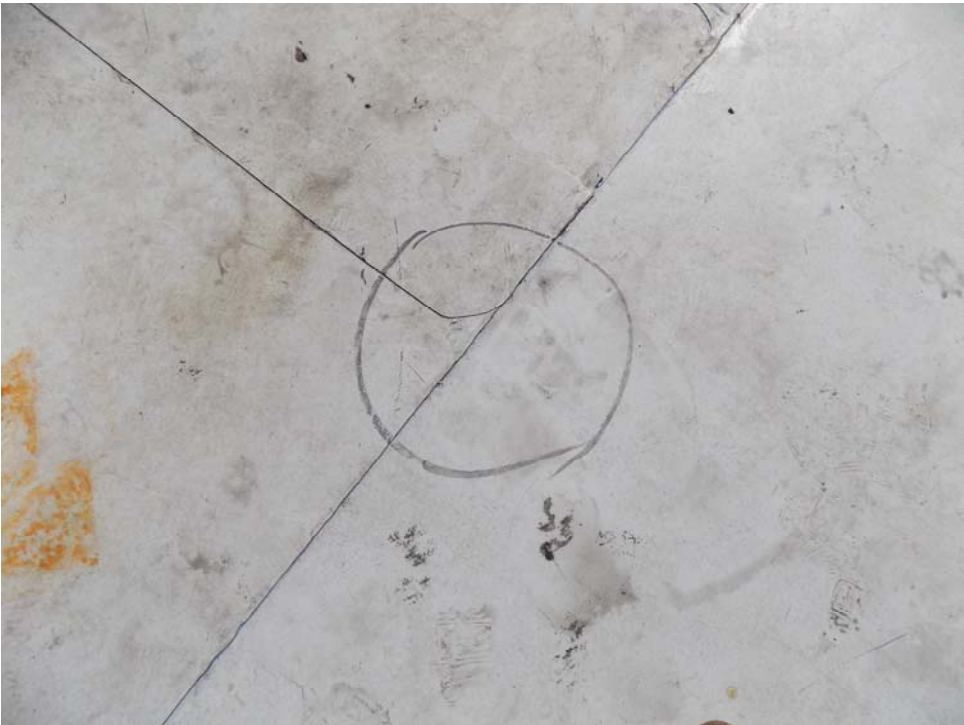
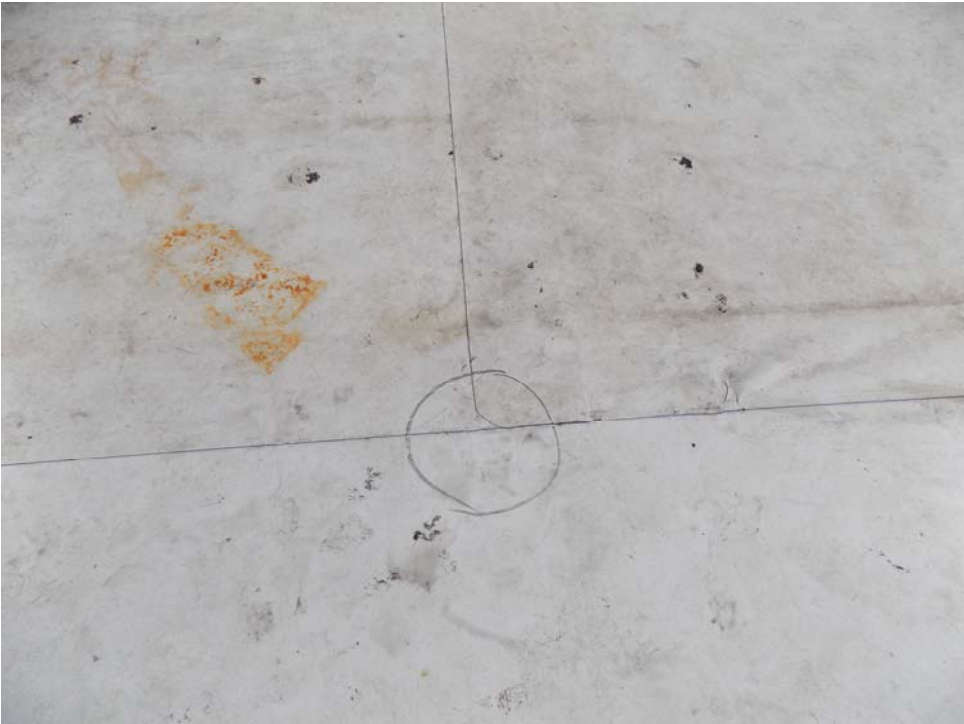
4. “T” Patches are missing at numerous joints throughout the roof. “T” Patches are required on all 60 mil membranes to be welded directly over a “T” joint. Refer to *Figure A-9* through *Figure A-11*.

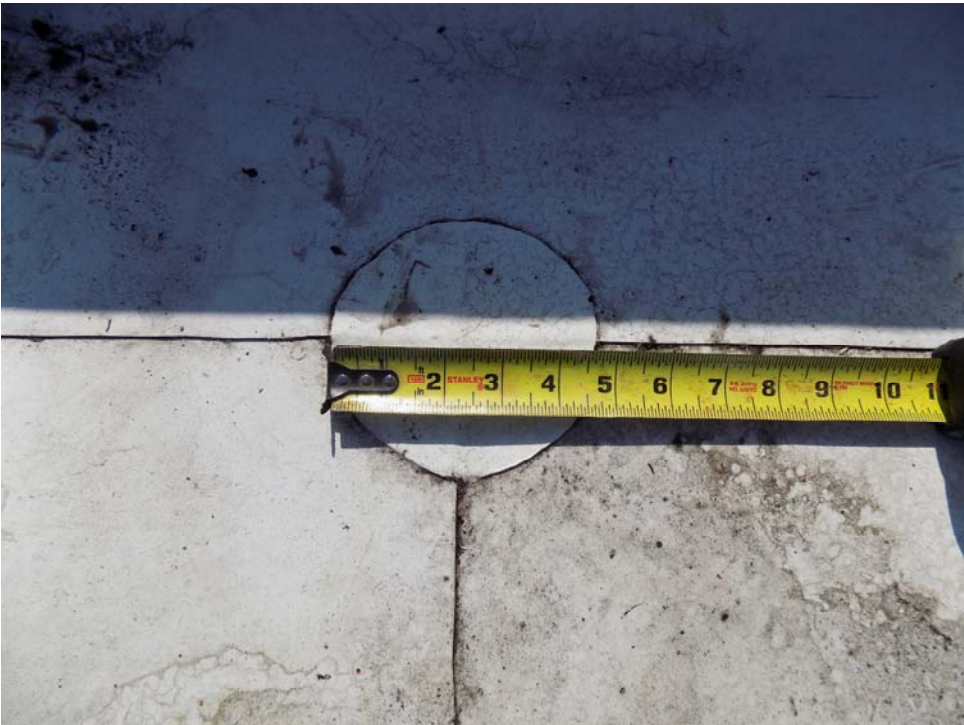
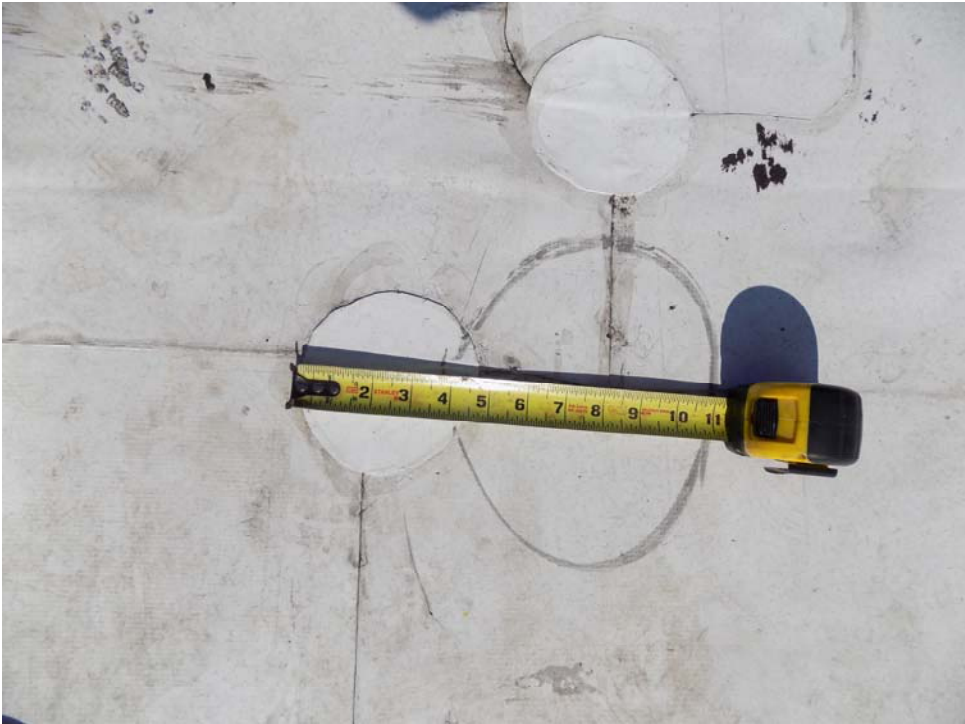
5. “T” Patches were observed to be 5-inch diameter circle patches. “T” Patches are required to be minimum 6-inch x 6-inch non-reinforced TPO membrane centered over a “T” joint and hot air welded. Refer to *Figure A-12* and *Figure A-13*.

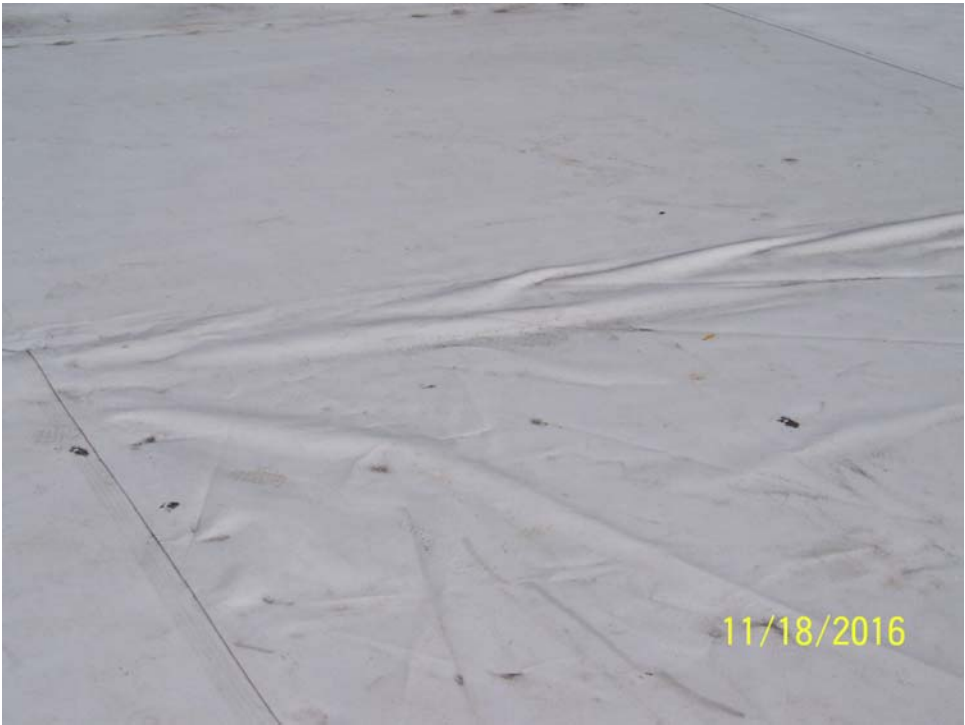
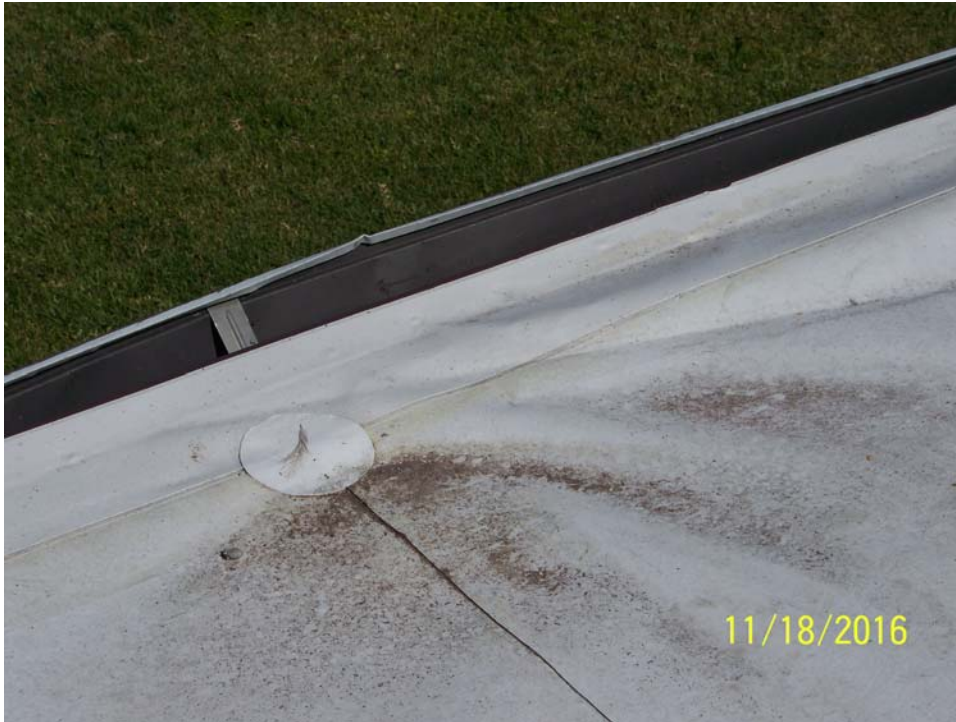
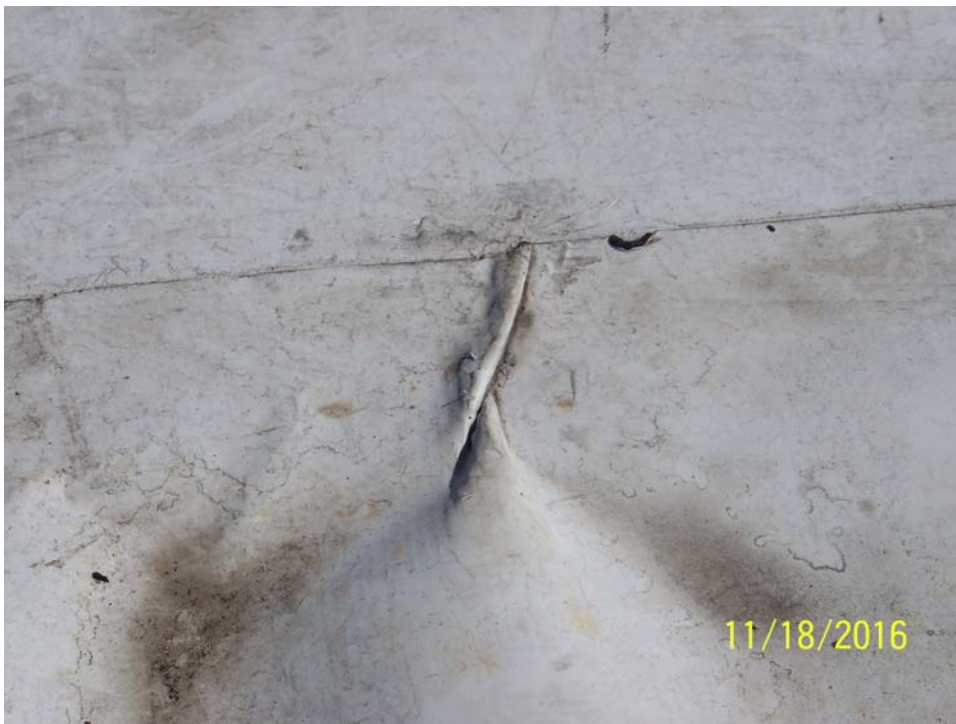
6. Wrinkles were observed throughout the TPO membrane and seams. The presence of wrinkles indicates an improper installation. Refer to *Figure A-14* through *Figure A-16*.

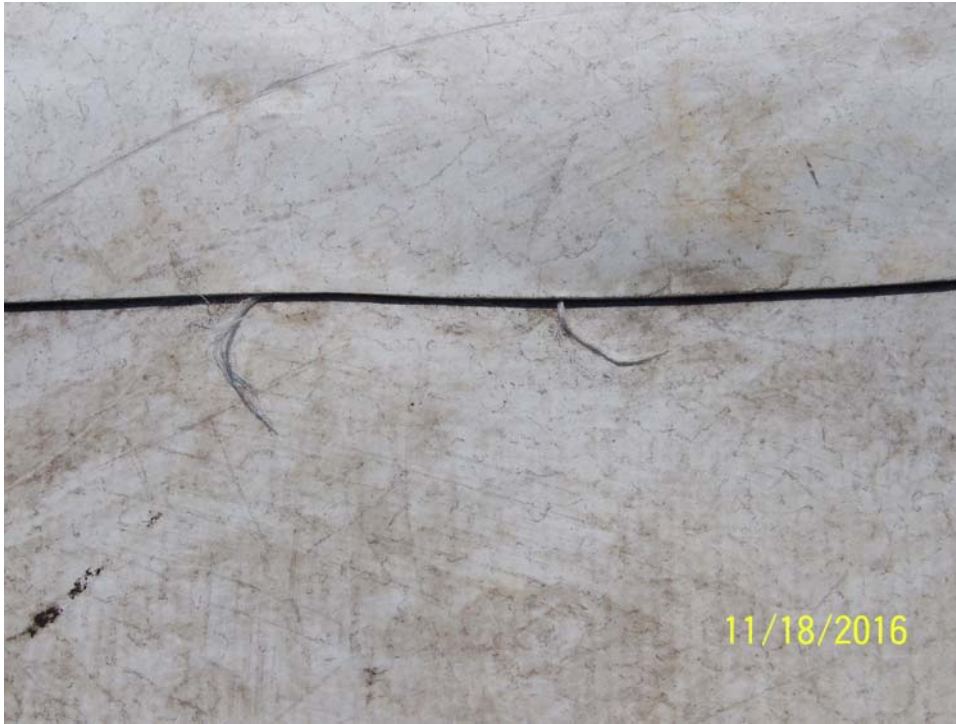
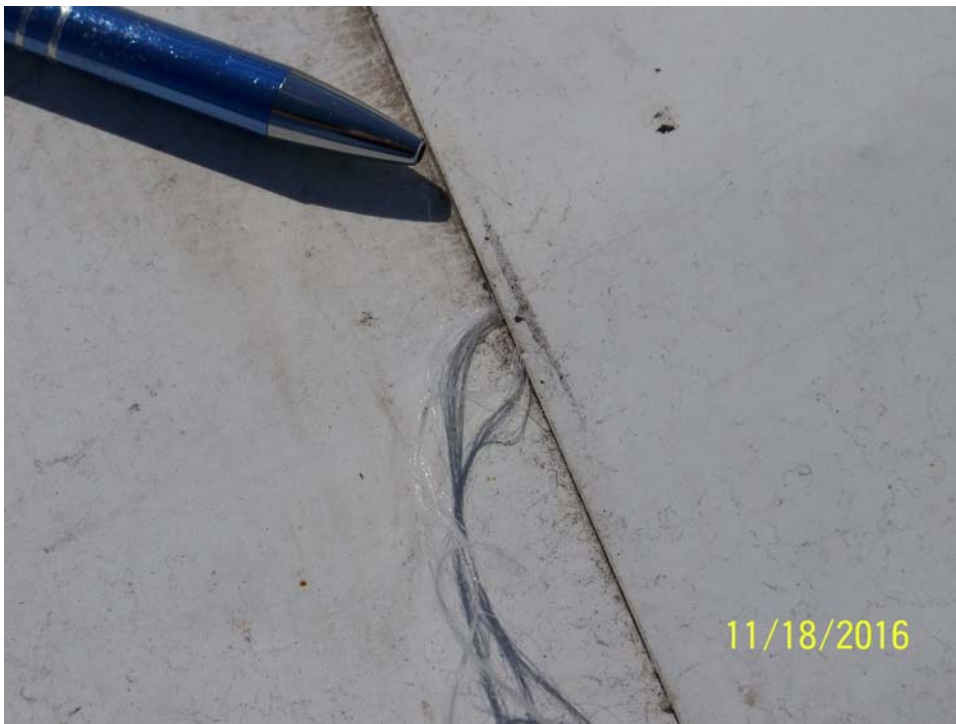
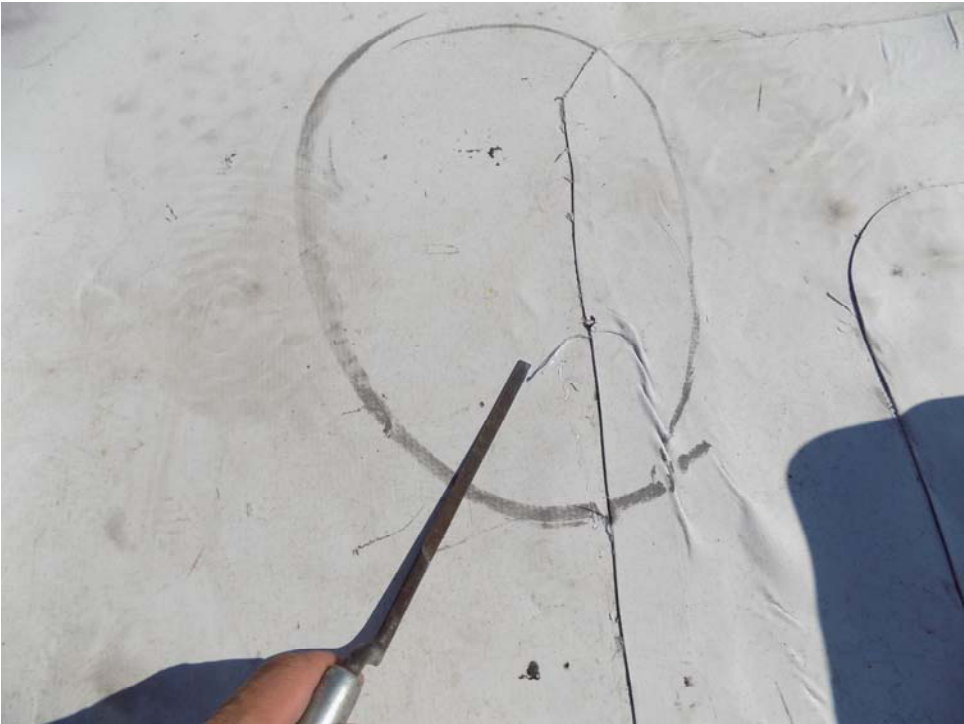
7. Cut edges of TPO membrane were observed to be installed without the required Mule-Hide TPO Cut-Edge Sealant. Mule-Hide Cut-Edge Sealant is required to seal all cut edges of the membrane (seams, patches, and flashing) where the reinforcing scrim fibers are exposed to weather. Fibers of the cut edge were observed to be sticking out and can act as a wick for water intrusion. Refer to *Figure A-17* through *Figure A-19*.

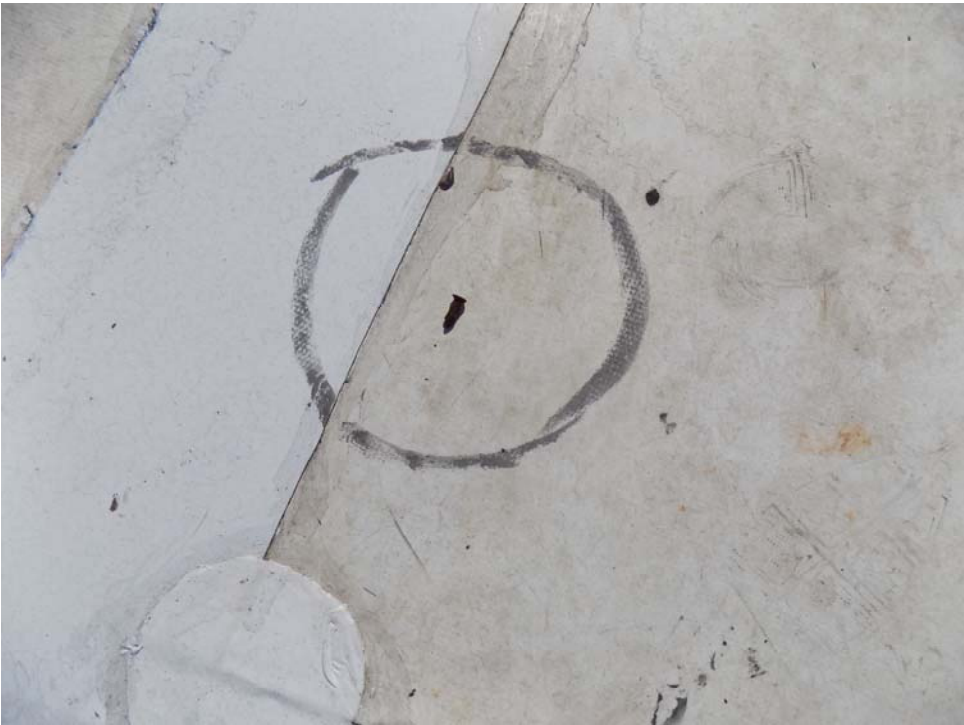
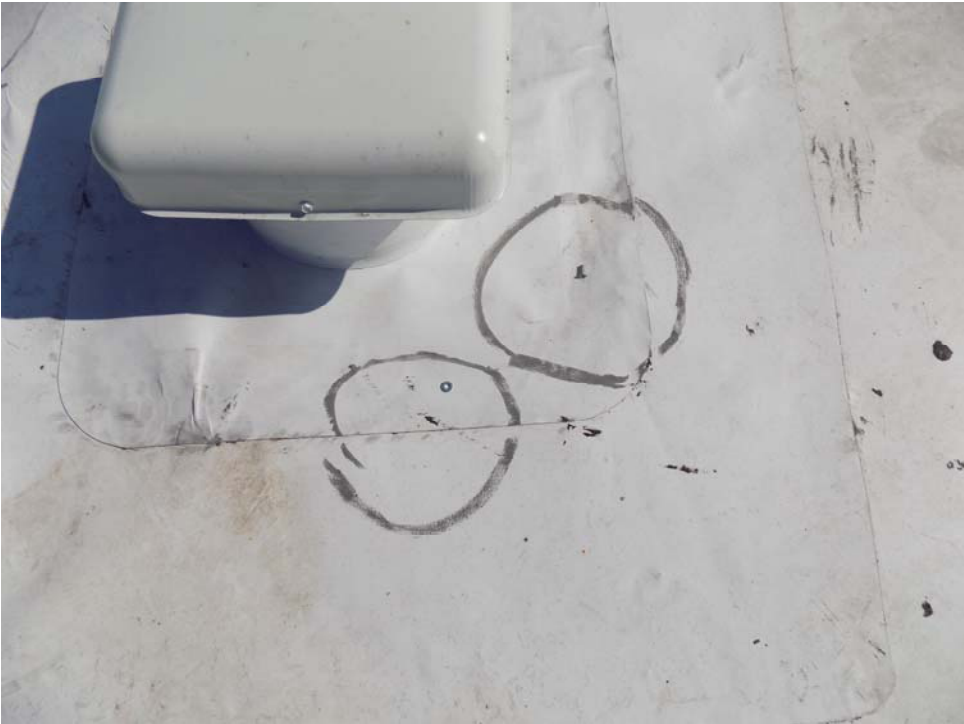
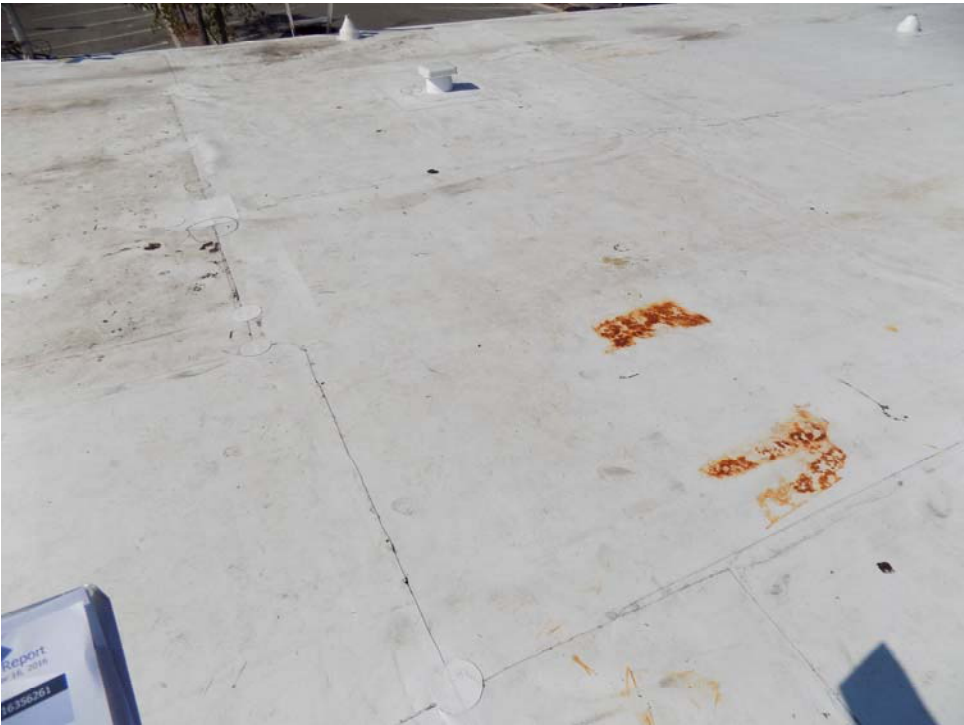
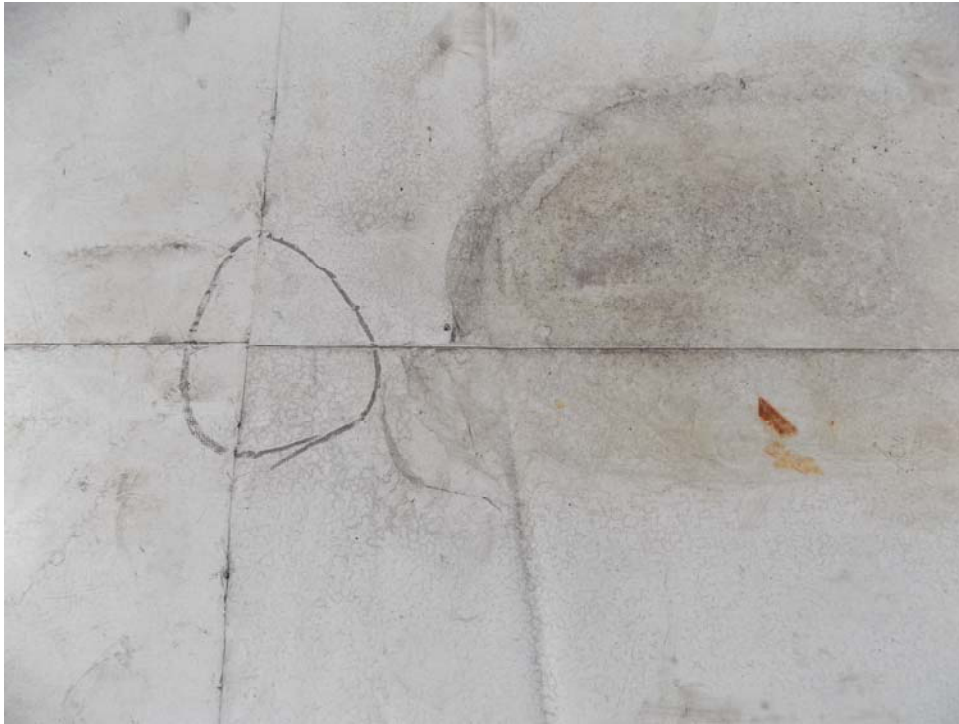
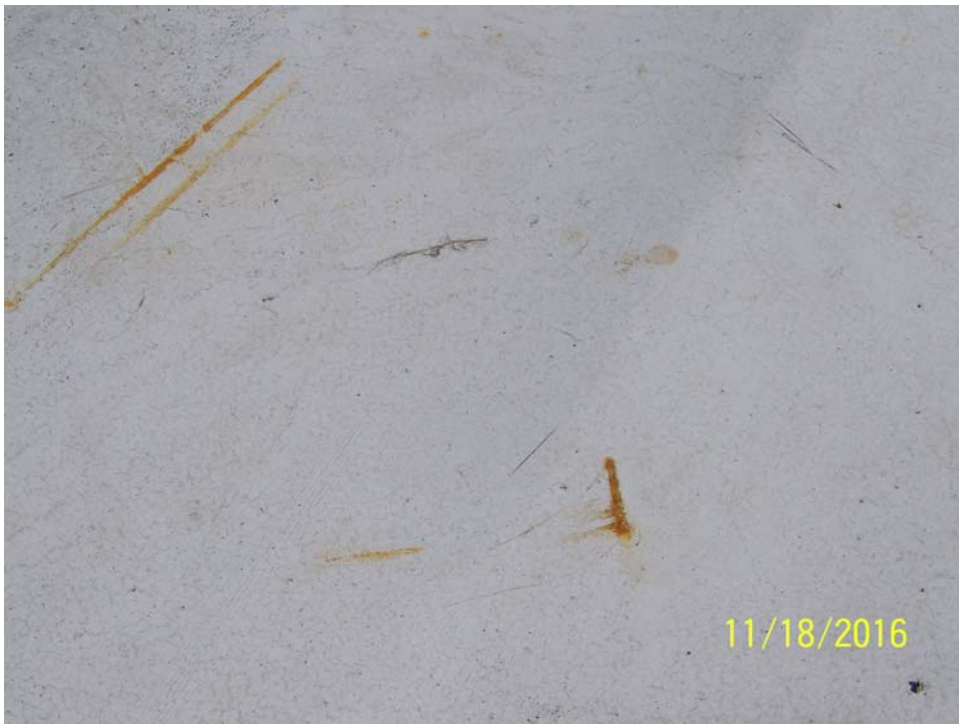
8. Miscellaneous metal screws, washers, razor blades, and other metal objects were left on the TPO membrane which could potentially cause a

- tear in the membrane as well as leave rust staining on the brand new TPO membrane. Refer to *Figure A-20* through *Figure A-24*.
9. Voids in the membrane where reinforcing fibers are exposed were observed in the middle and east side of the roof. A patch must be 3-inches larger in all directions than the void. Refer to *Figure A-25* and *Figure A-26*.

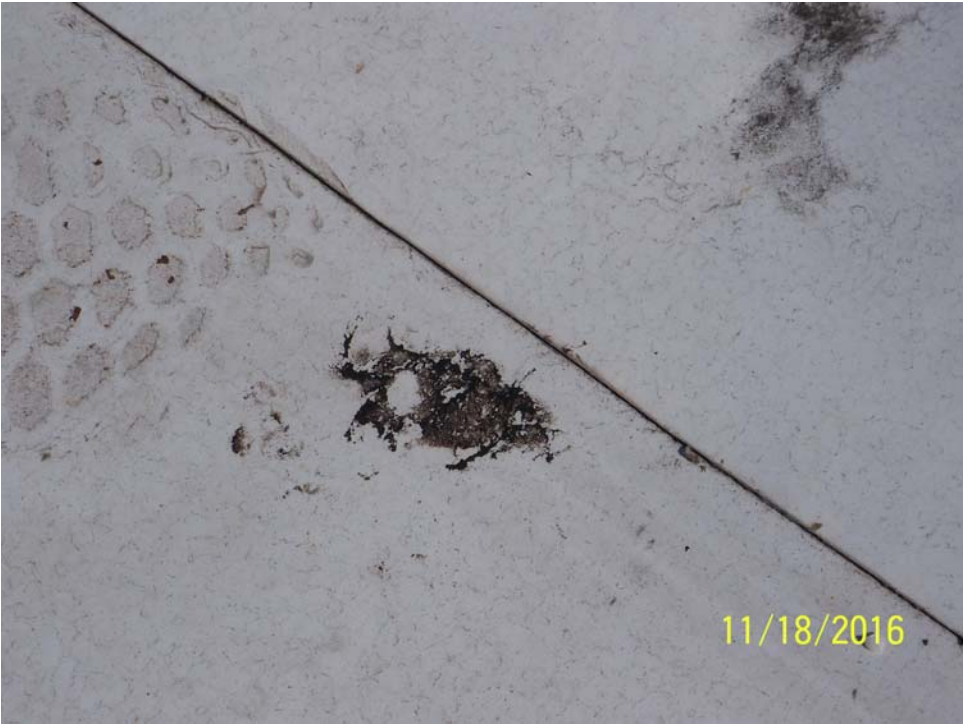
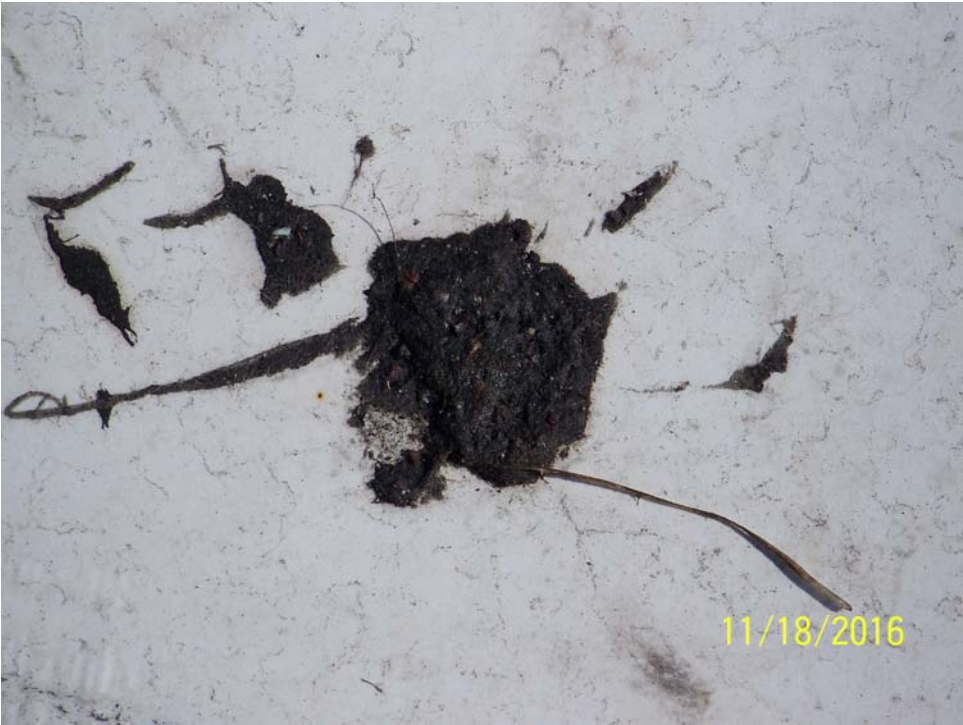
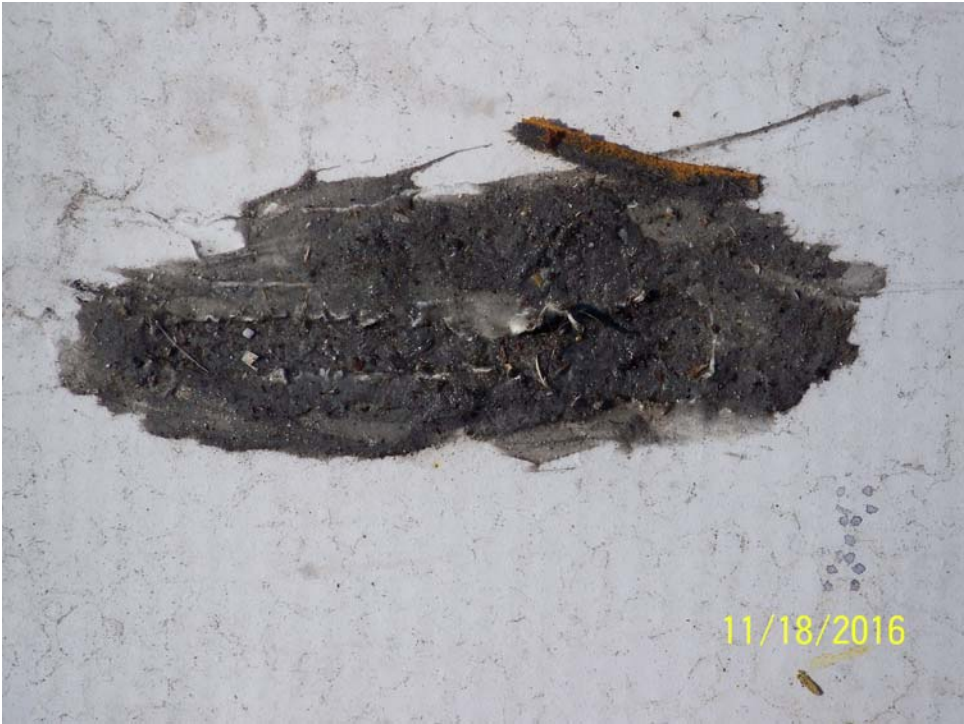
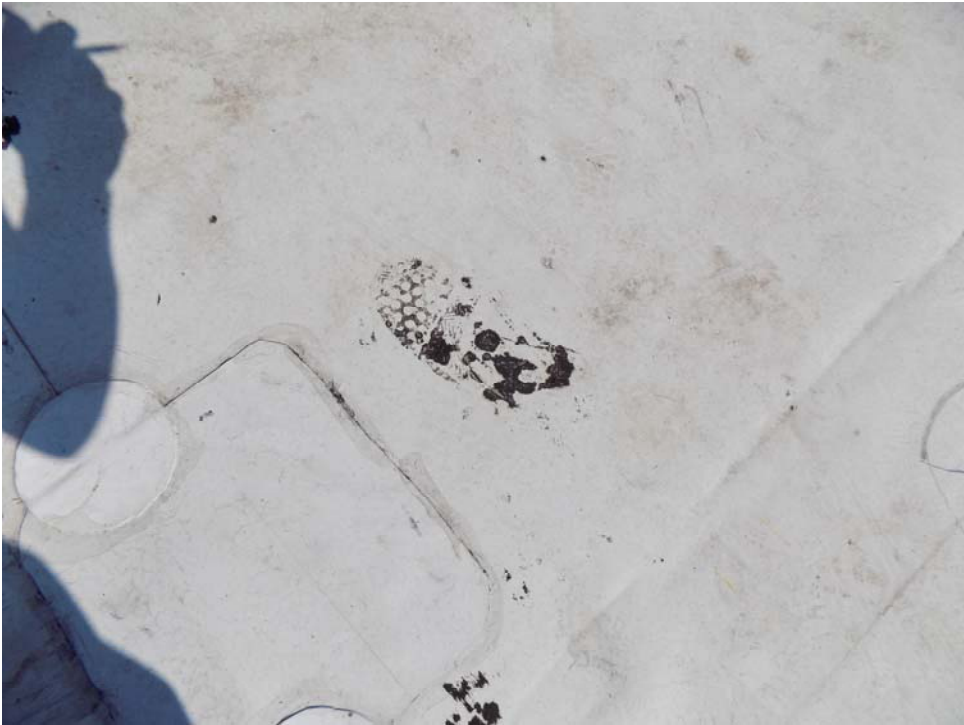
10. Asphalt petroleum based products were observed throughout the roof membrane. Per Mule-Hide Products Co., Inc., no asphalt or petroleum based products should be used on any single-ply roof as it will degrade the membrane. Refer to *Figure A-27* through *Figure A-30*.

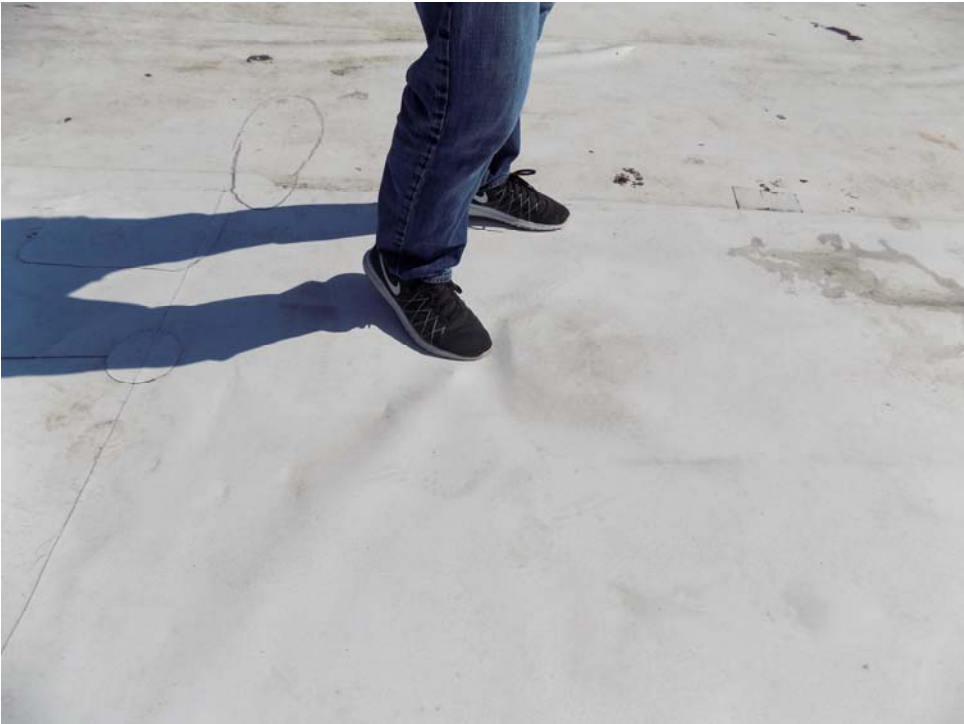
Figure A- 31

11. Depressions in the Iso tapered insulation board were observed/detected in sporadic areas throughout the roof membrane. Refer to *Figure A-31*.
  12. A fastener was missing in the termination metal flashing at the expansion joint near the center of the roof. Refer to *Figure A-32*.

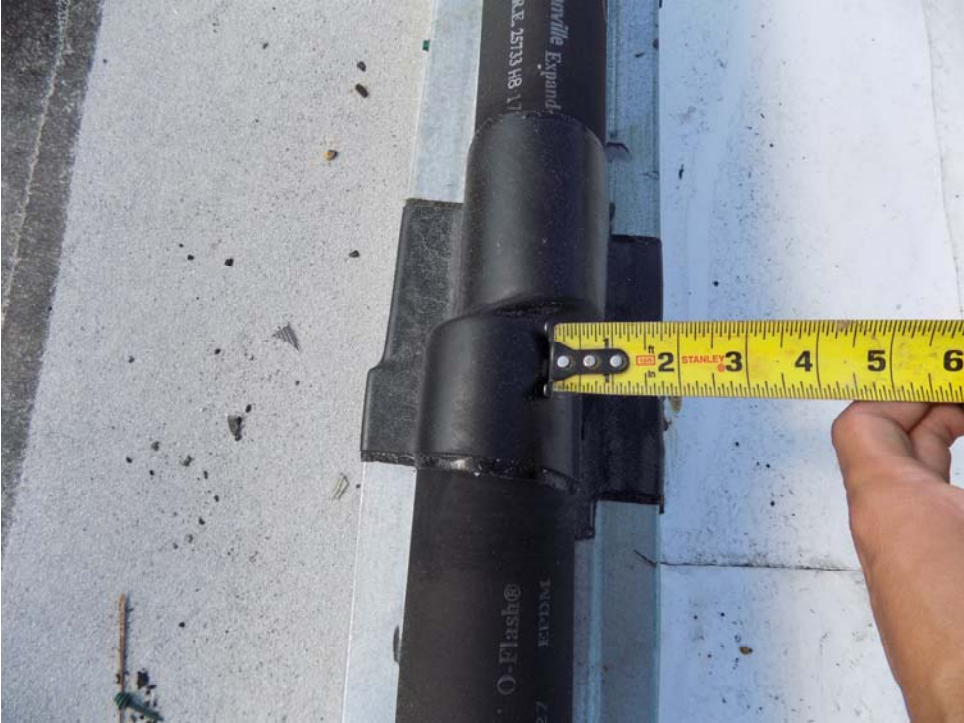
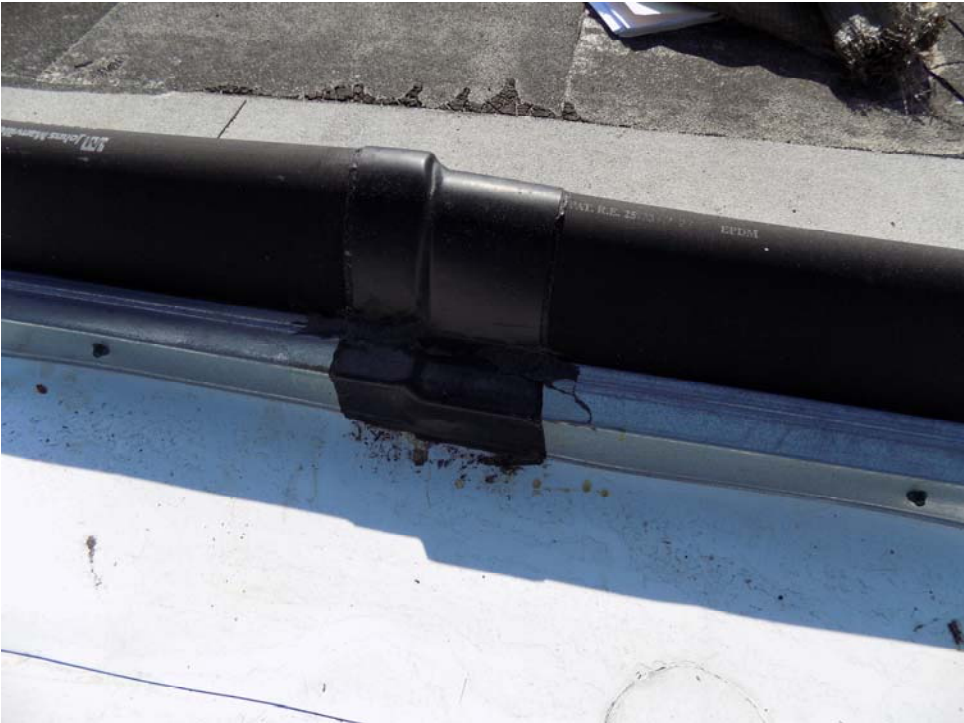
13. The Johns Manville Expand-O-Flash Expansion Joint Cover splice connections were observed to be out of line by one-inch or more in areas throughout the expansion joint run. According to John Manville installation guidelines adjacent sections shall be aligned and uniform in profile. Refer to *Figure A-33* and *Figure A-34*.
