# CITY OF NEW PORT RICHEY PARKS SEAWALL CONDITION ASSESSMENT REPORT

CITY OF NEW PORT RICHEY  
DEPARTMENT OF PUBLIC WORKS

STROUD ENGINEERING CONSULTANTS, INC.  
10503 Cyndee Lane  
Odessa, Florida 33556

June 2017

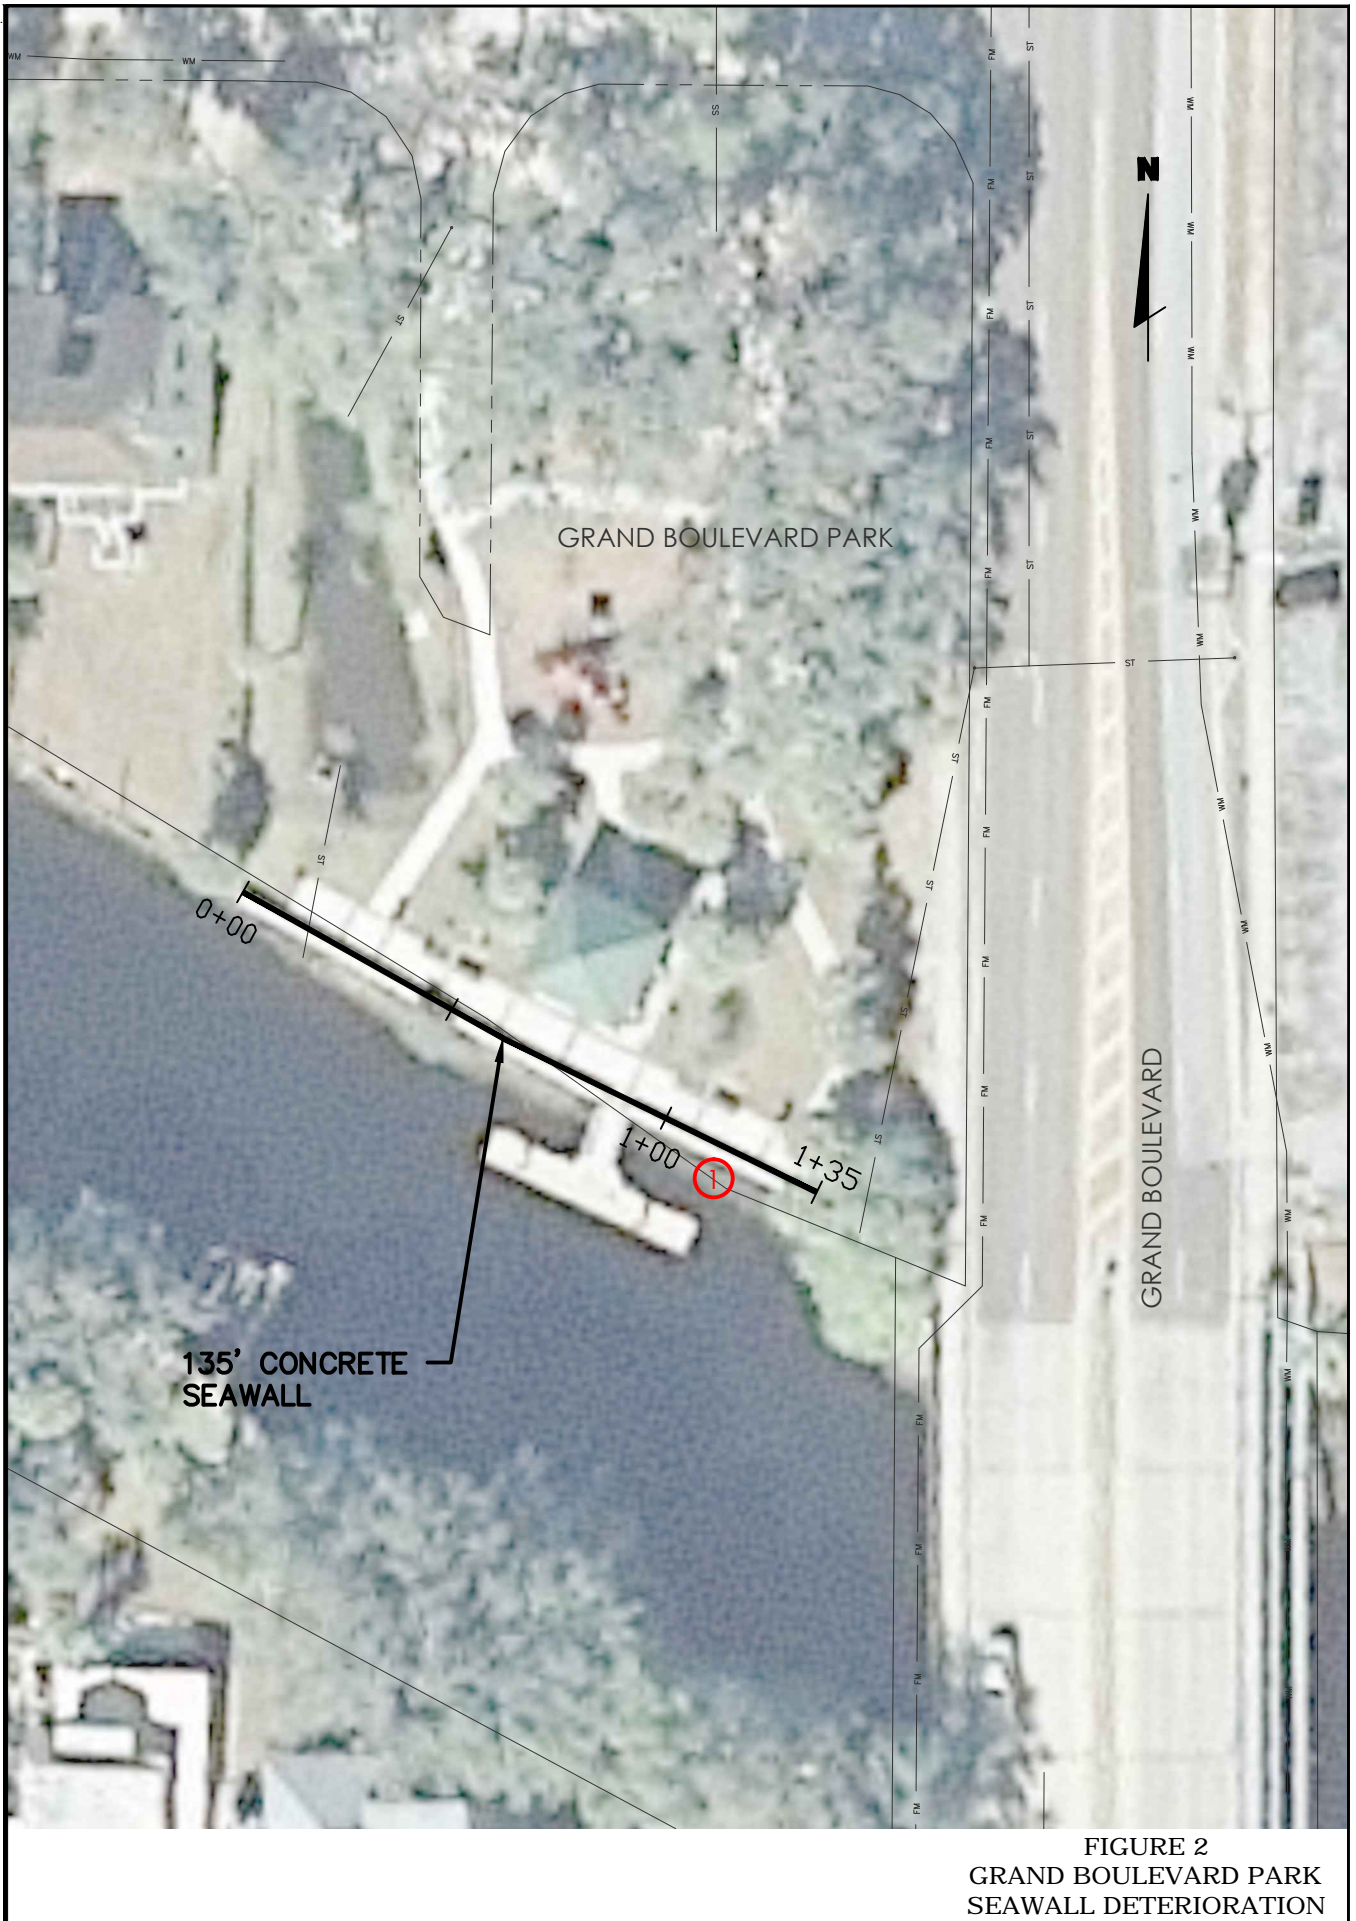
FIGURE 2  
GRAND BOULEVARD PARK  
SEAWALL DETERIORATION

Item No.	Description of Seawall Deterioration	Station
1	Wall Crack at Base – Vertical	1+26

Other deficiencies of this wall include the lack of drainage pipes to allow groundwater to drain from behind the wall into the river. This condition creates hydrostatic pressure behind the wall and exerts forces that can contribute to wall cracks.

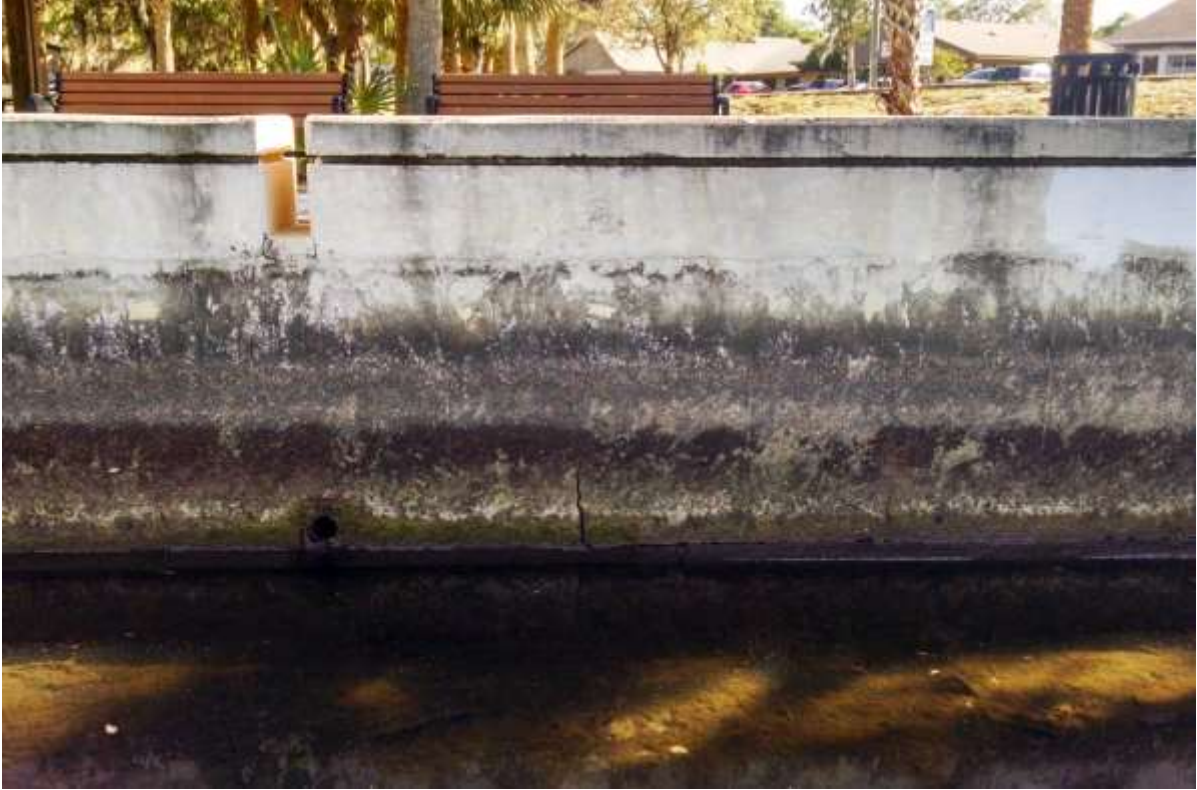
Figure 3 – Wall Crack at Base/Waterline

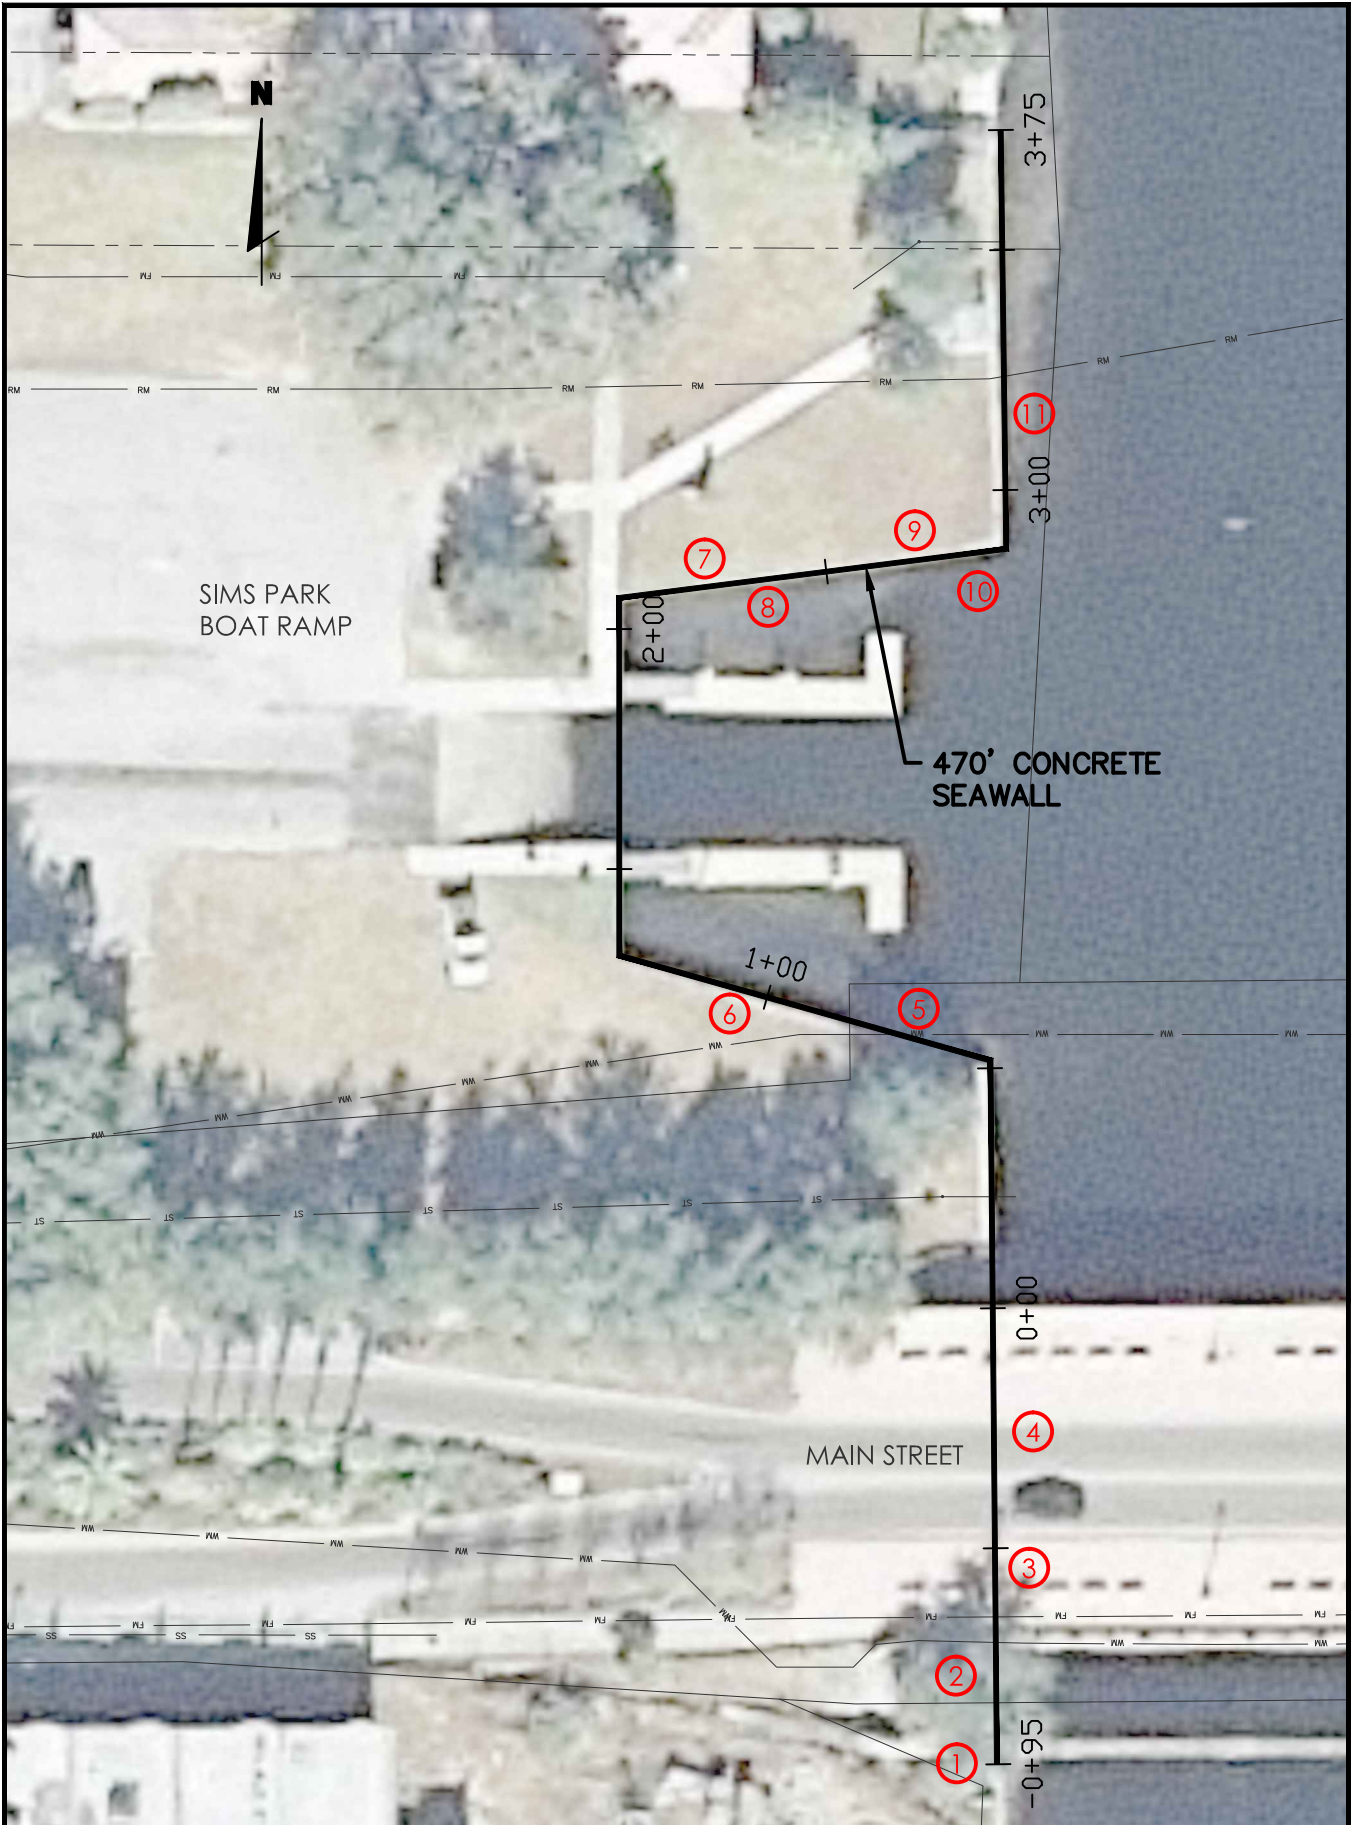
**FIGURE 4**  
**SIMS PARK BOAT RAMP**  
**SEAWALL DETERIORATION**

Item No.	Description of Seawall Deterioration	Station
1	Erosion at Wall Joint	-0+95
2	Erosion Behind Wall	-0+95 to -0+75
3	Crack at Wall Cap – Horizontal	-0+75 to -0+30
4	Cap Damage – Spalling	-0+25
5	Cap Damage – Spalling	0+80
6	Erosion at Wall Joint	1+02
7	Crack at Wall – Vertical	2+28
8	Cap Damage – Spalling	2+41
9	Erosion at Wall Joint – Possible Void Detected	2+61
10	Cap Damage - Spalling	2+85
11	Cap Cracking, Wall Joint Separation, Exposed Rebar	3+08

There are drainage pipes in the wall, however, the condition and construction details of the drain pipes are not known. In addition, the location and number of drain pipes appear to be insufficient for proper drainage of groundwater from behind the wall.

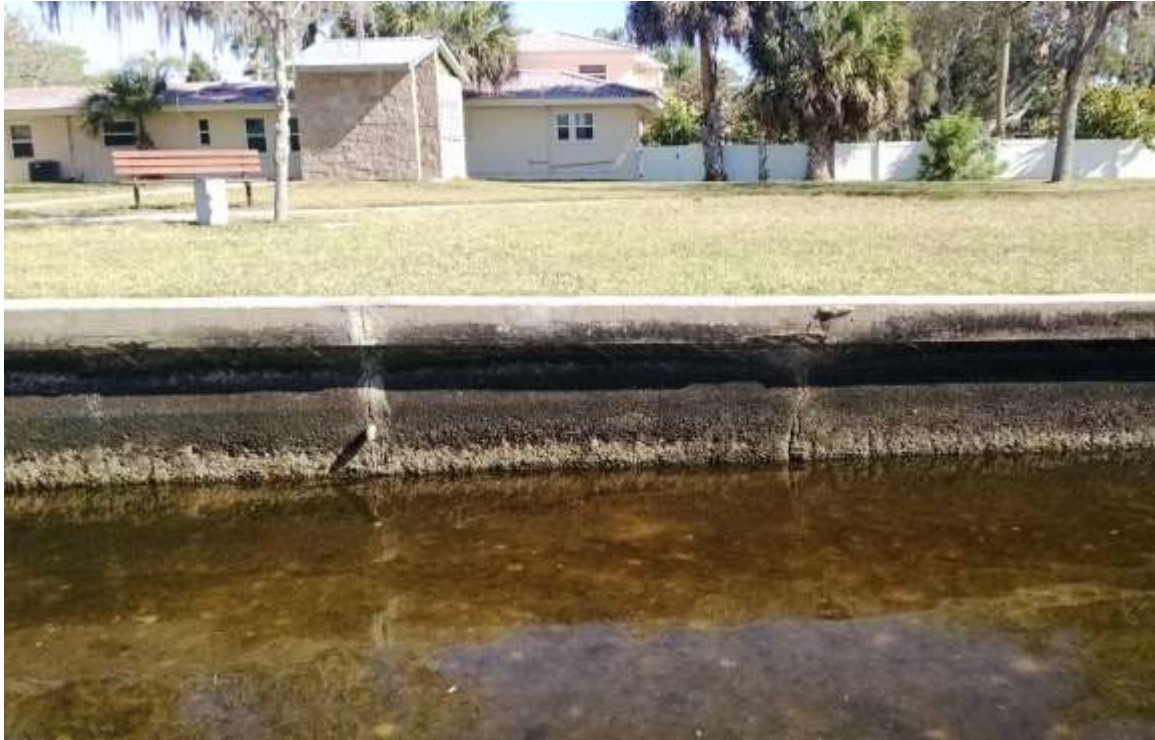
**Figure 5 – Vertical Wall Crack**

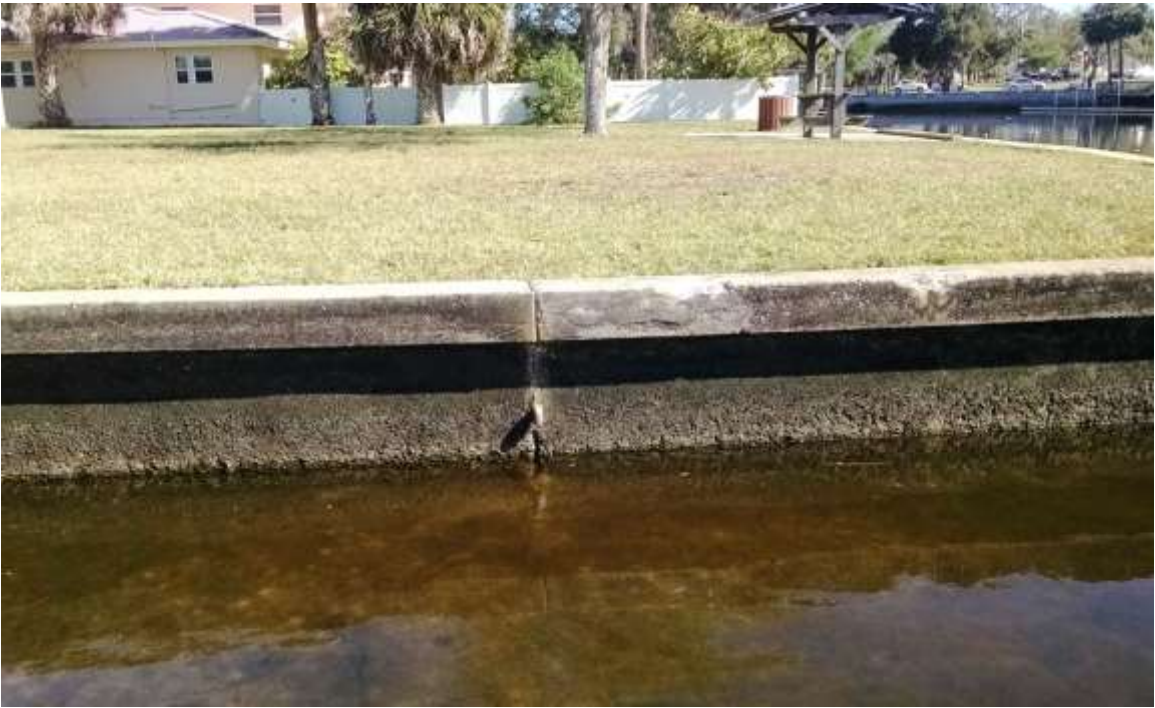
**Figure 6 - Drainage Pipe at Wall Joint**

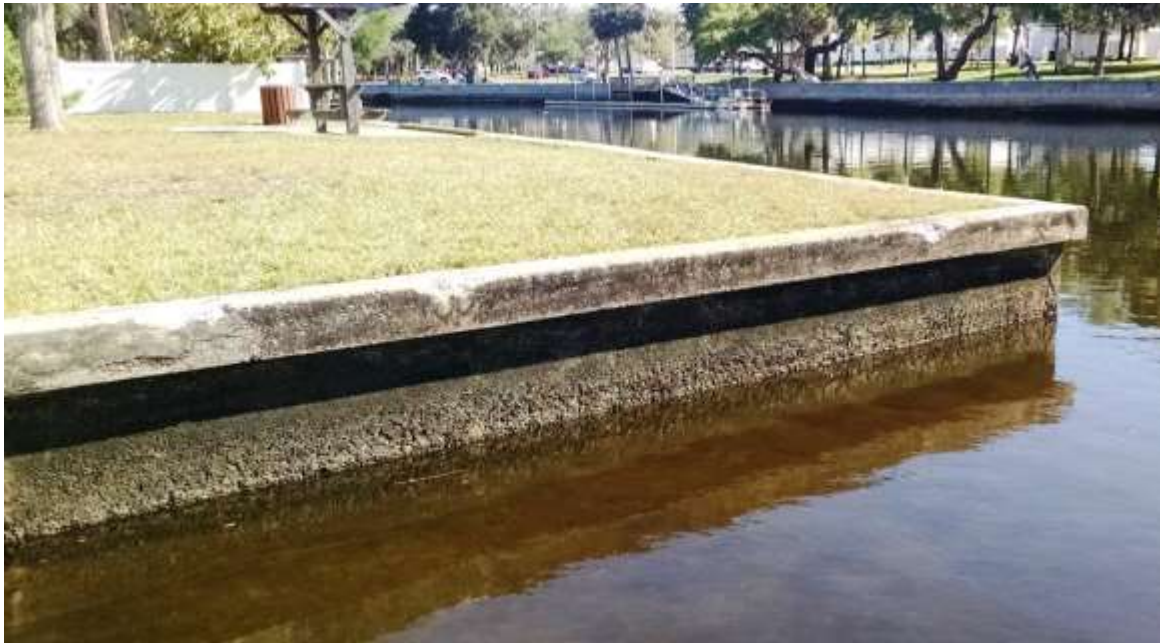
**Figure 7 - Damaged Wall Caps**

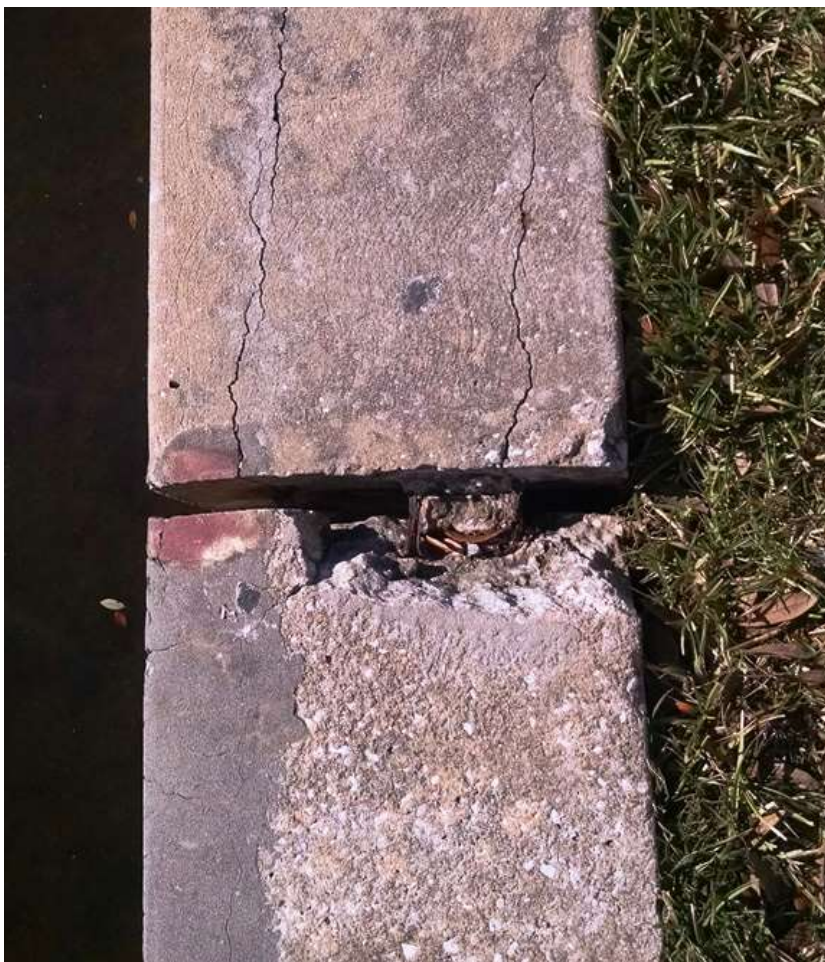
**Figure 8 - Deterioration at Wall Joint**

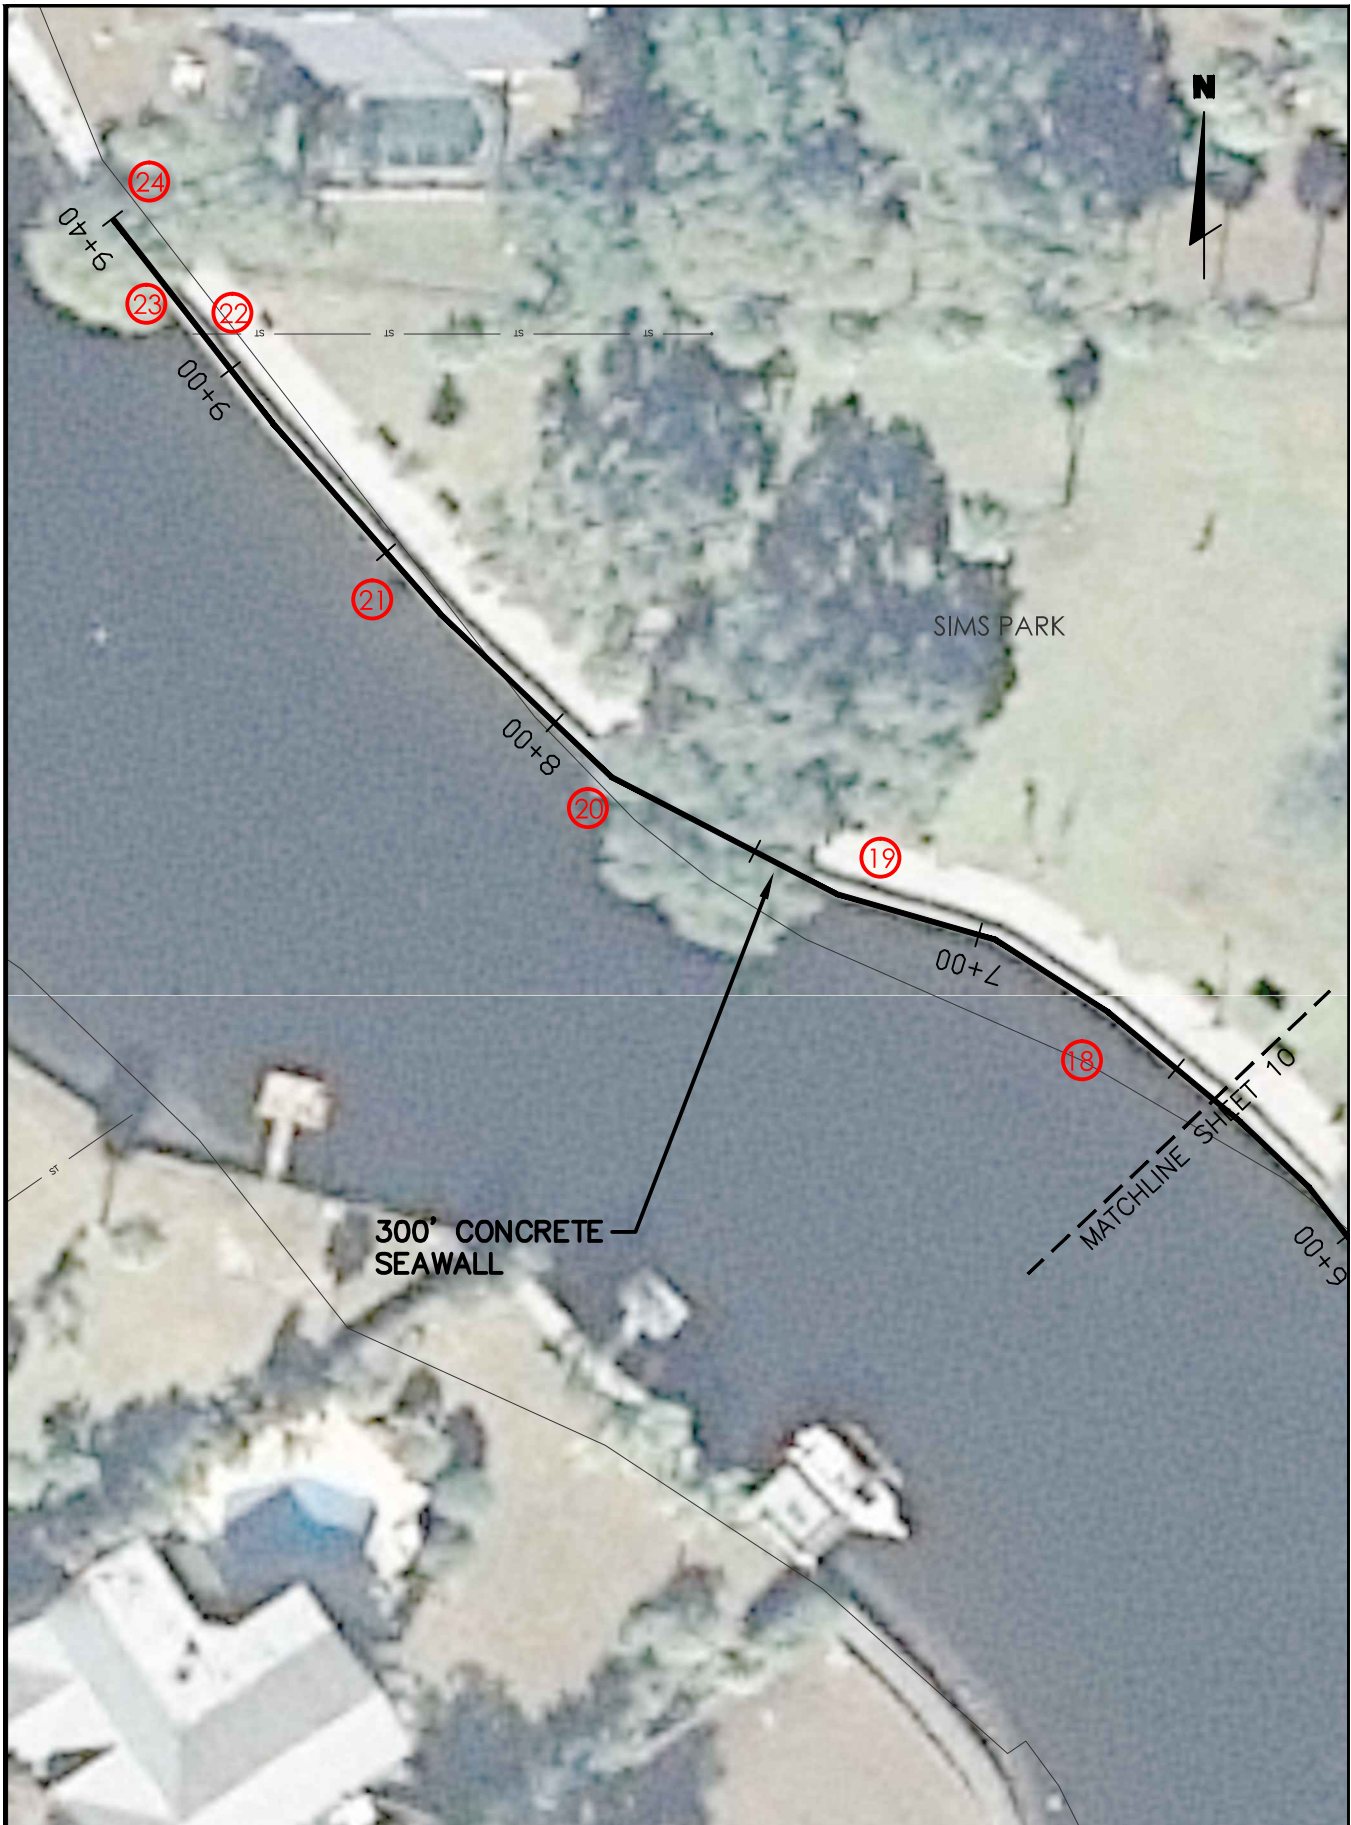
FIGURE 11  
SIMS PARK SEAWALL  
DETERIORATION

Item No.	Description of Seawall Deterioration	Station
1	Wall cap crack - horizontal	-0+60 to 0+00
2	Loss of expansion joint between wall cap and sidewalk	0+58
3	Sidewalk settlement at spillway – minor crack on old wall cap	1+06
4	Wall crack – vertical	1+21
5	Sidewalk settlement at spillway – water ponding	1+33
6	Wall crack – vertical – possible void detected (GPR)	1+54
7	Cap damage – spalling at wall joint	1+66
8	Wall cap crack	1+97
9	Possible void detected – erosion channel visible inside wall	2+38
10	Large crack at wall joint, wall cap spalling	2+42
11	Possible void detected (GPR)	2+42
12	Wall joint separation/spalling	2+71
13	Wall crack – vertical, wall appears to be leaning at crack	3+14
14	Wall joint separation	3+75
15	Wall crack at joint	4+37
16	Possible void detected (GPR)	4+65
17	Wall crack – vertical, located next to outfall pipe	5+80
18	Wall joint separation	6+75

19	Wall to sidewalk joint separation and void	7+30 to 7+60
20	Wall joint separation/spalling	7+80
21	Wall crack at joint	8+48
22	Wall crack – vertical	9+12
23	Wall damage – spalling	9+22
24	Wall crack at end of wall joint	9+42

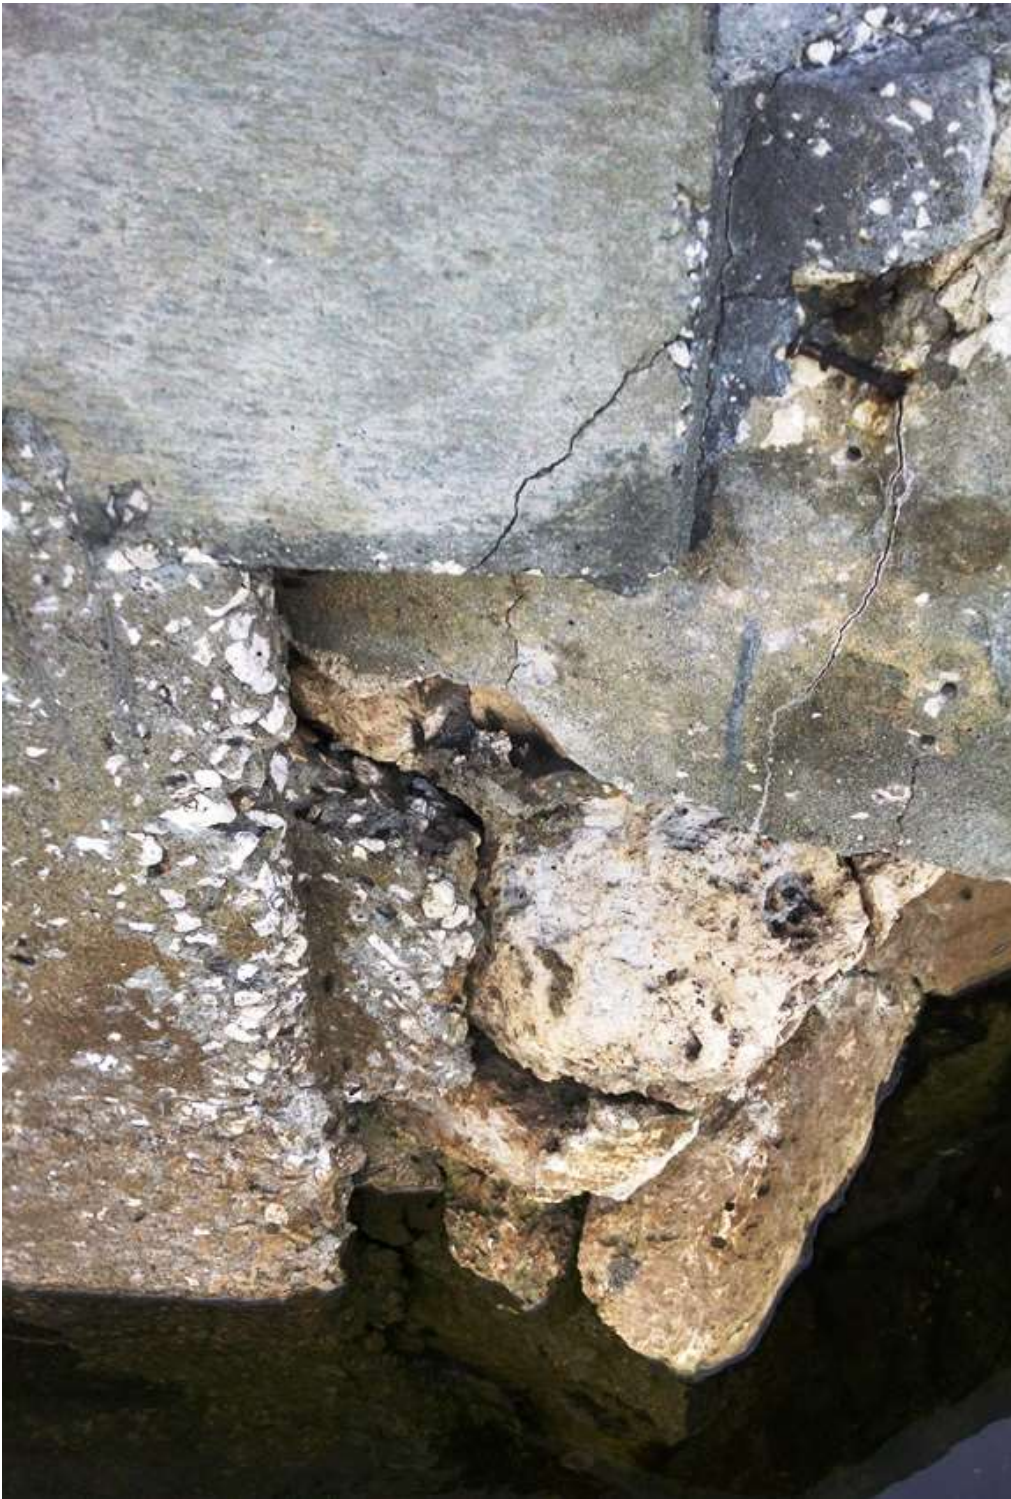
**Figure 12 – Wall Crack/Spalling**

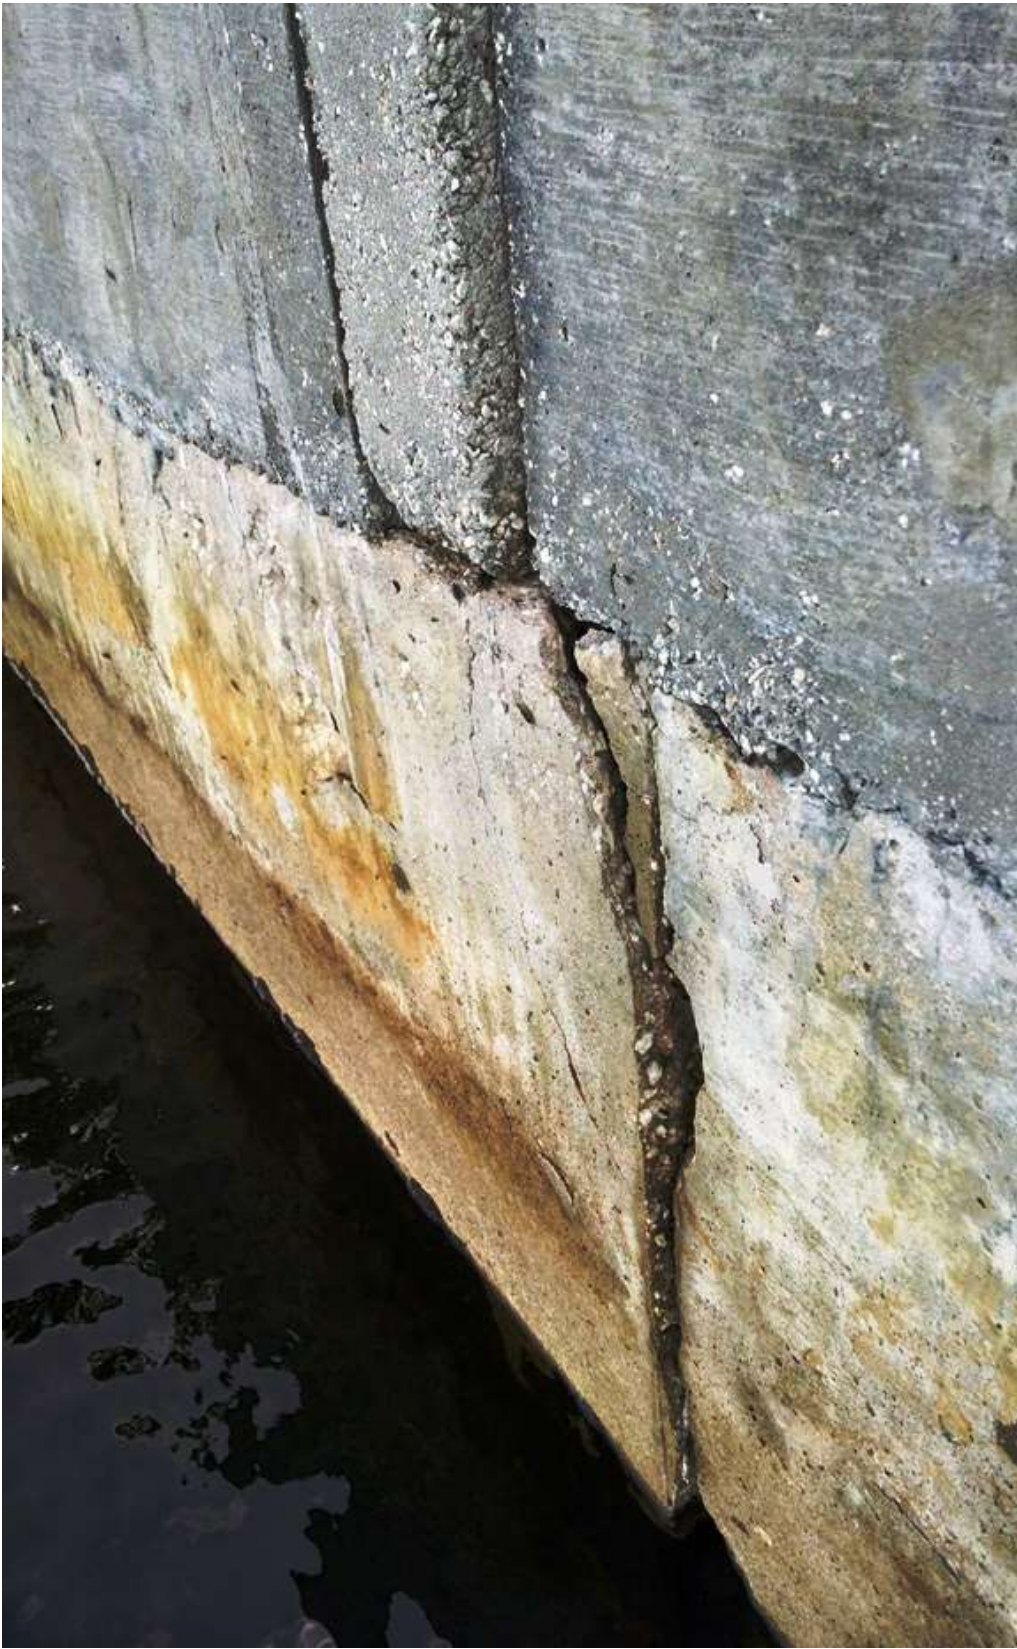
Figure 13 – Wall Crack/Shifting Outward
