# CITY OF NEW PORT RICHEY PARKS SEAWALL CONDITION ASSESSMENT REPORT

CITY OF NEW PORT RICHEY  
DEPARTMENT OF PUBLIC WORKS

STROUD ENGINEERING CONSULTANTS, INC.  
10503 Cyndee Lane  
Odessa, Florida 33556

June 2017

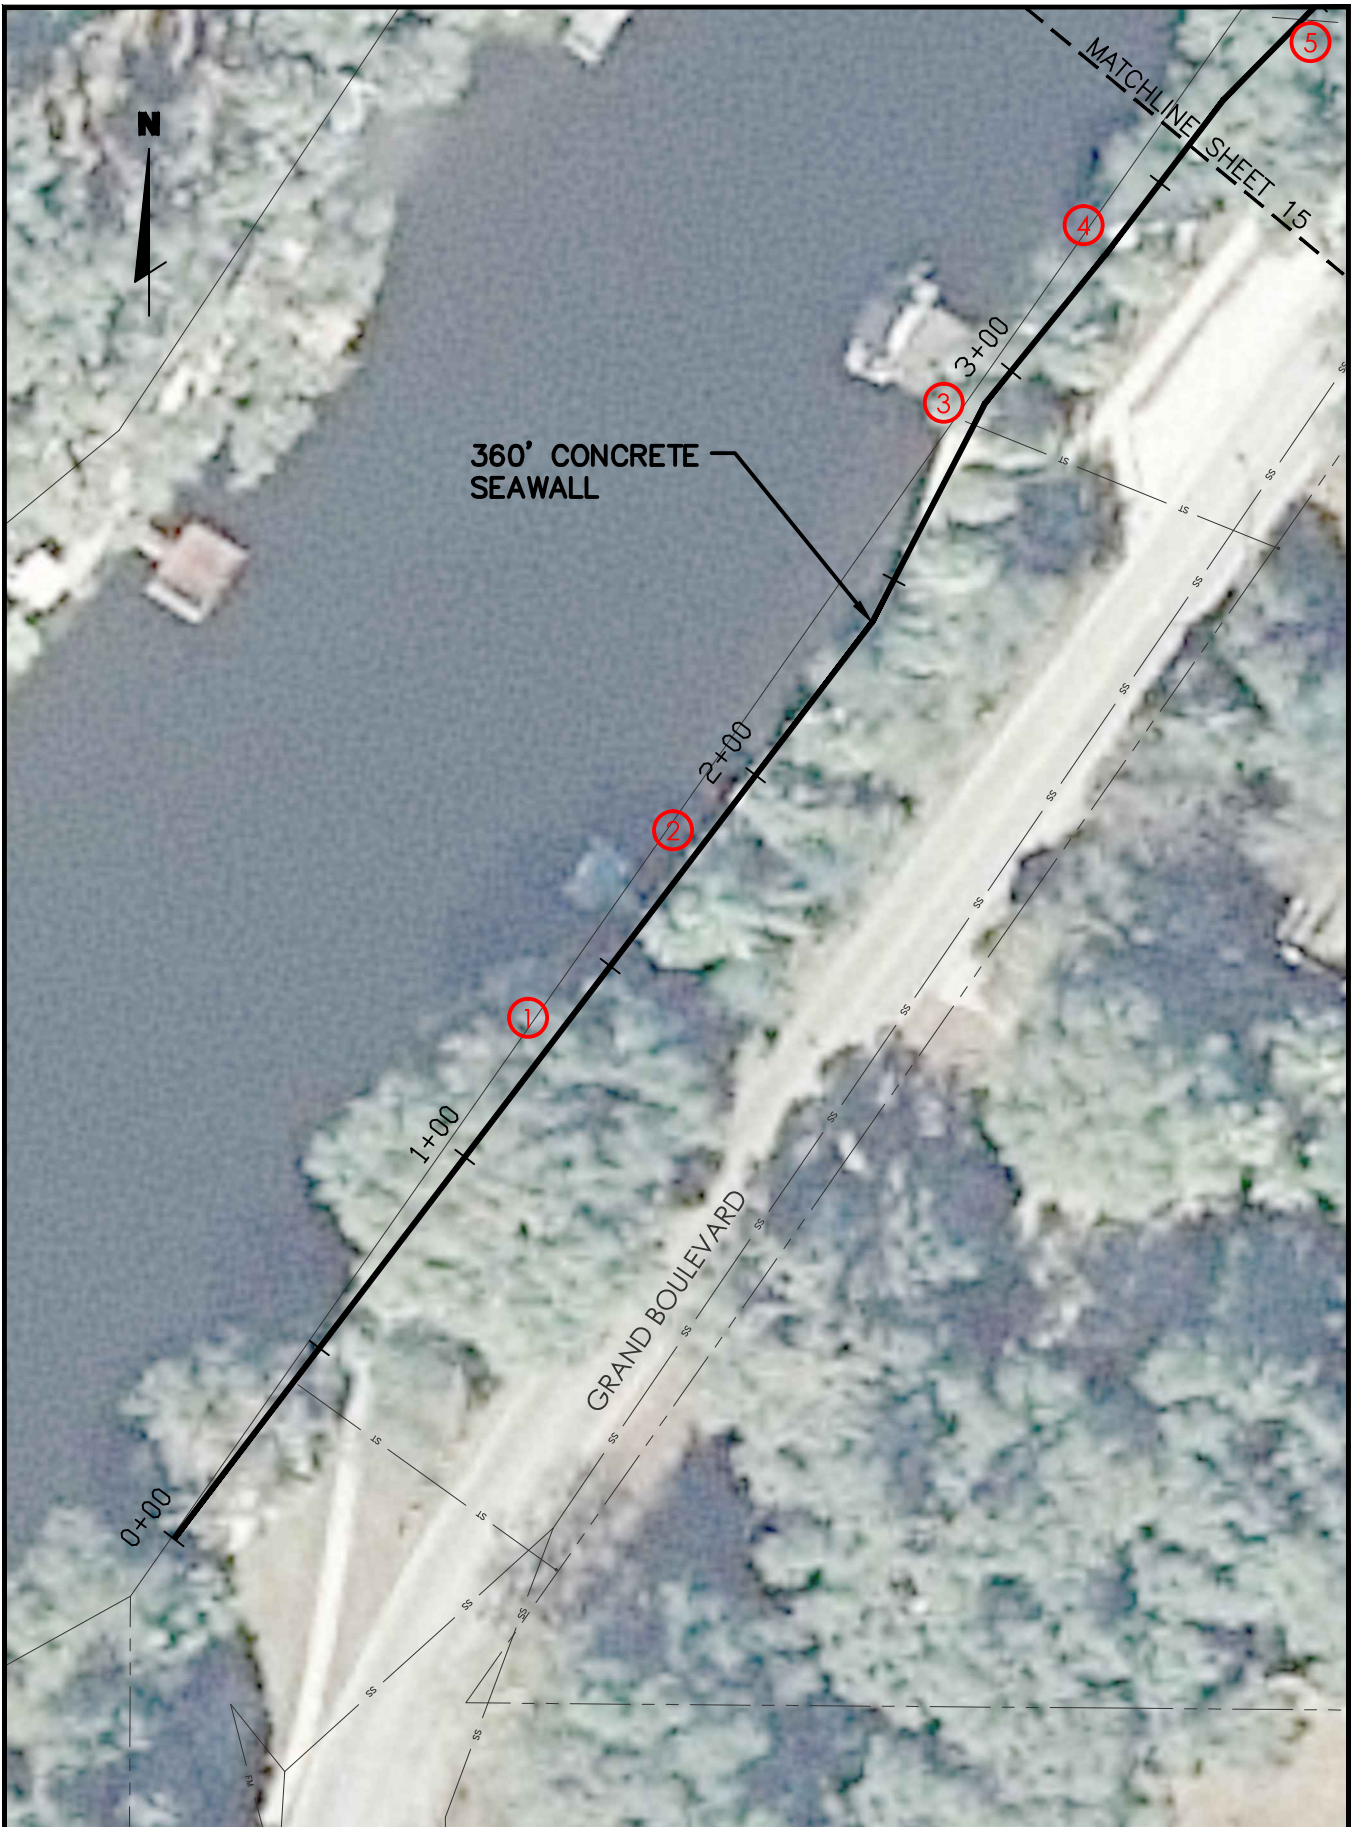
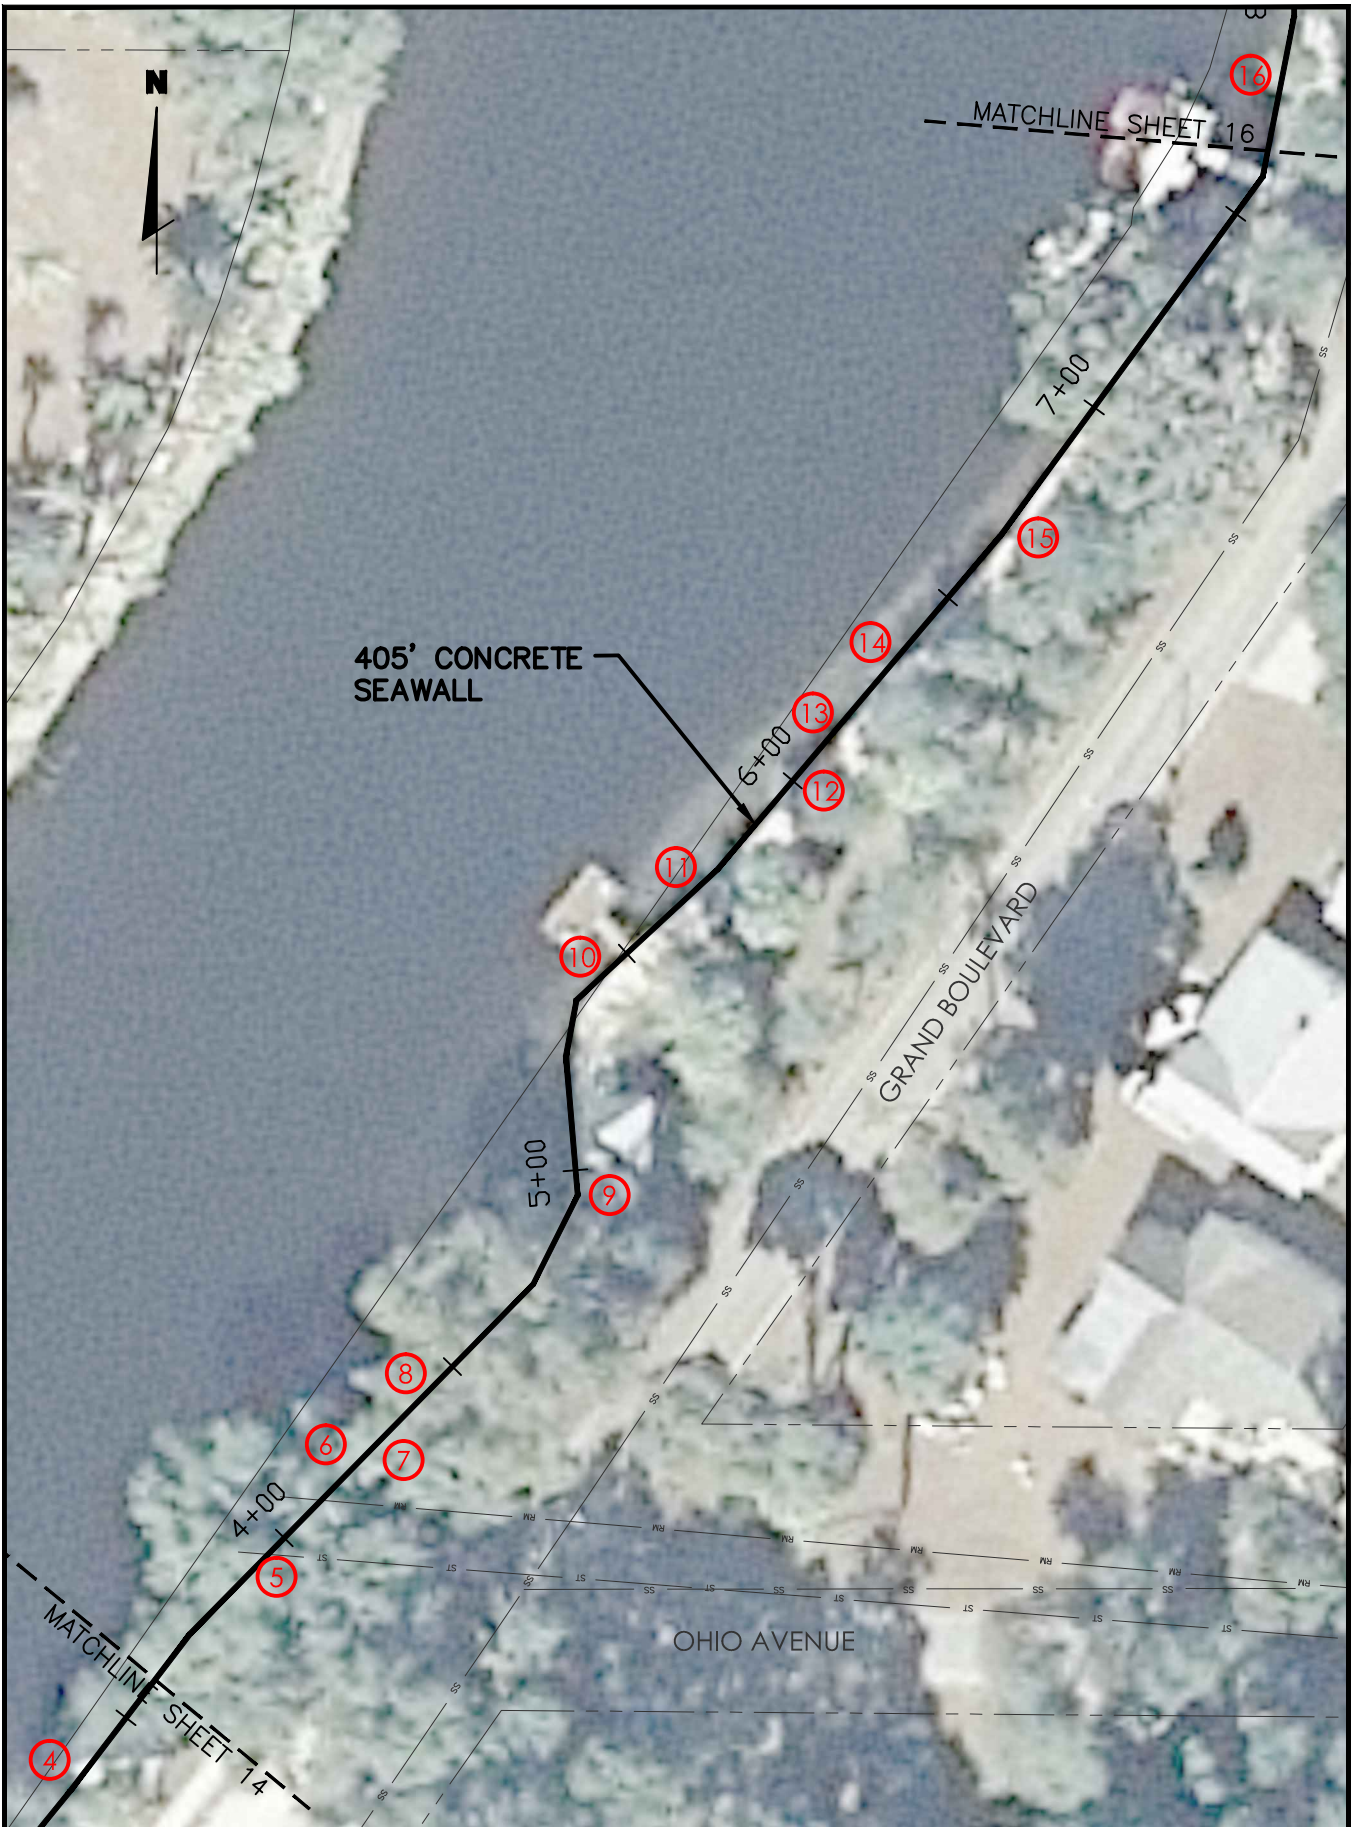
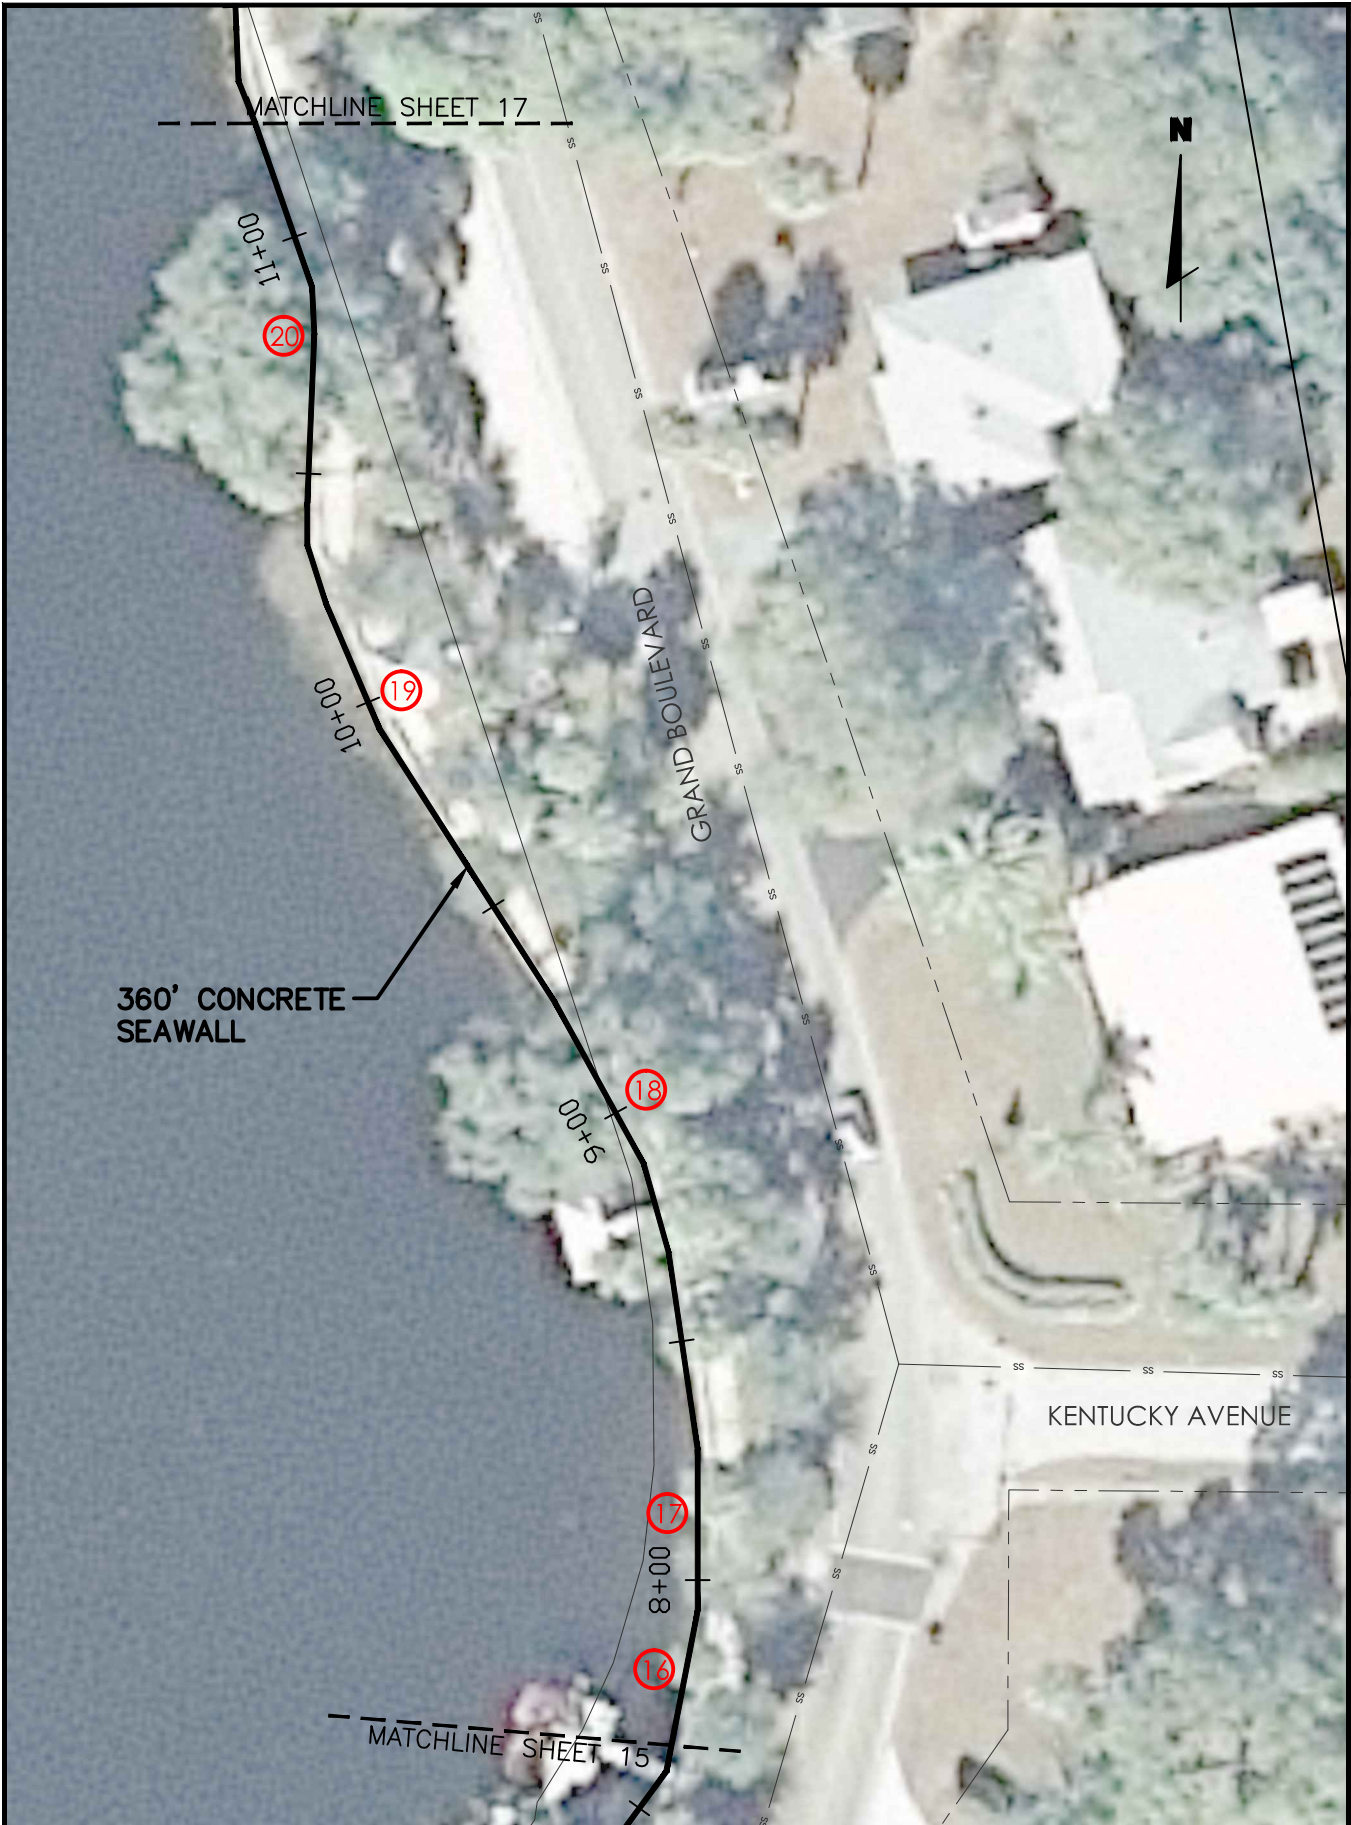
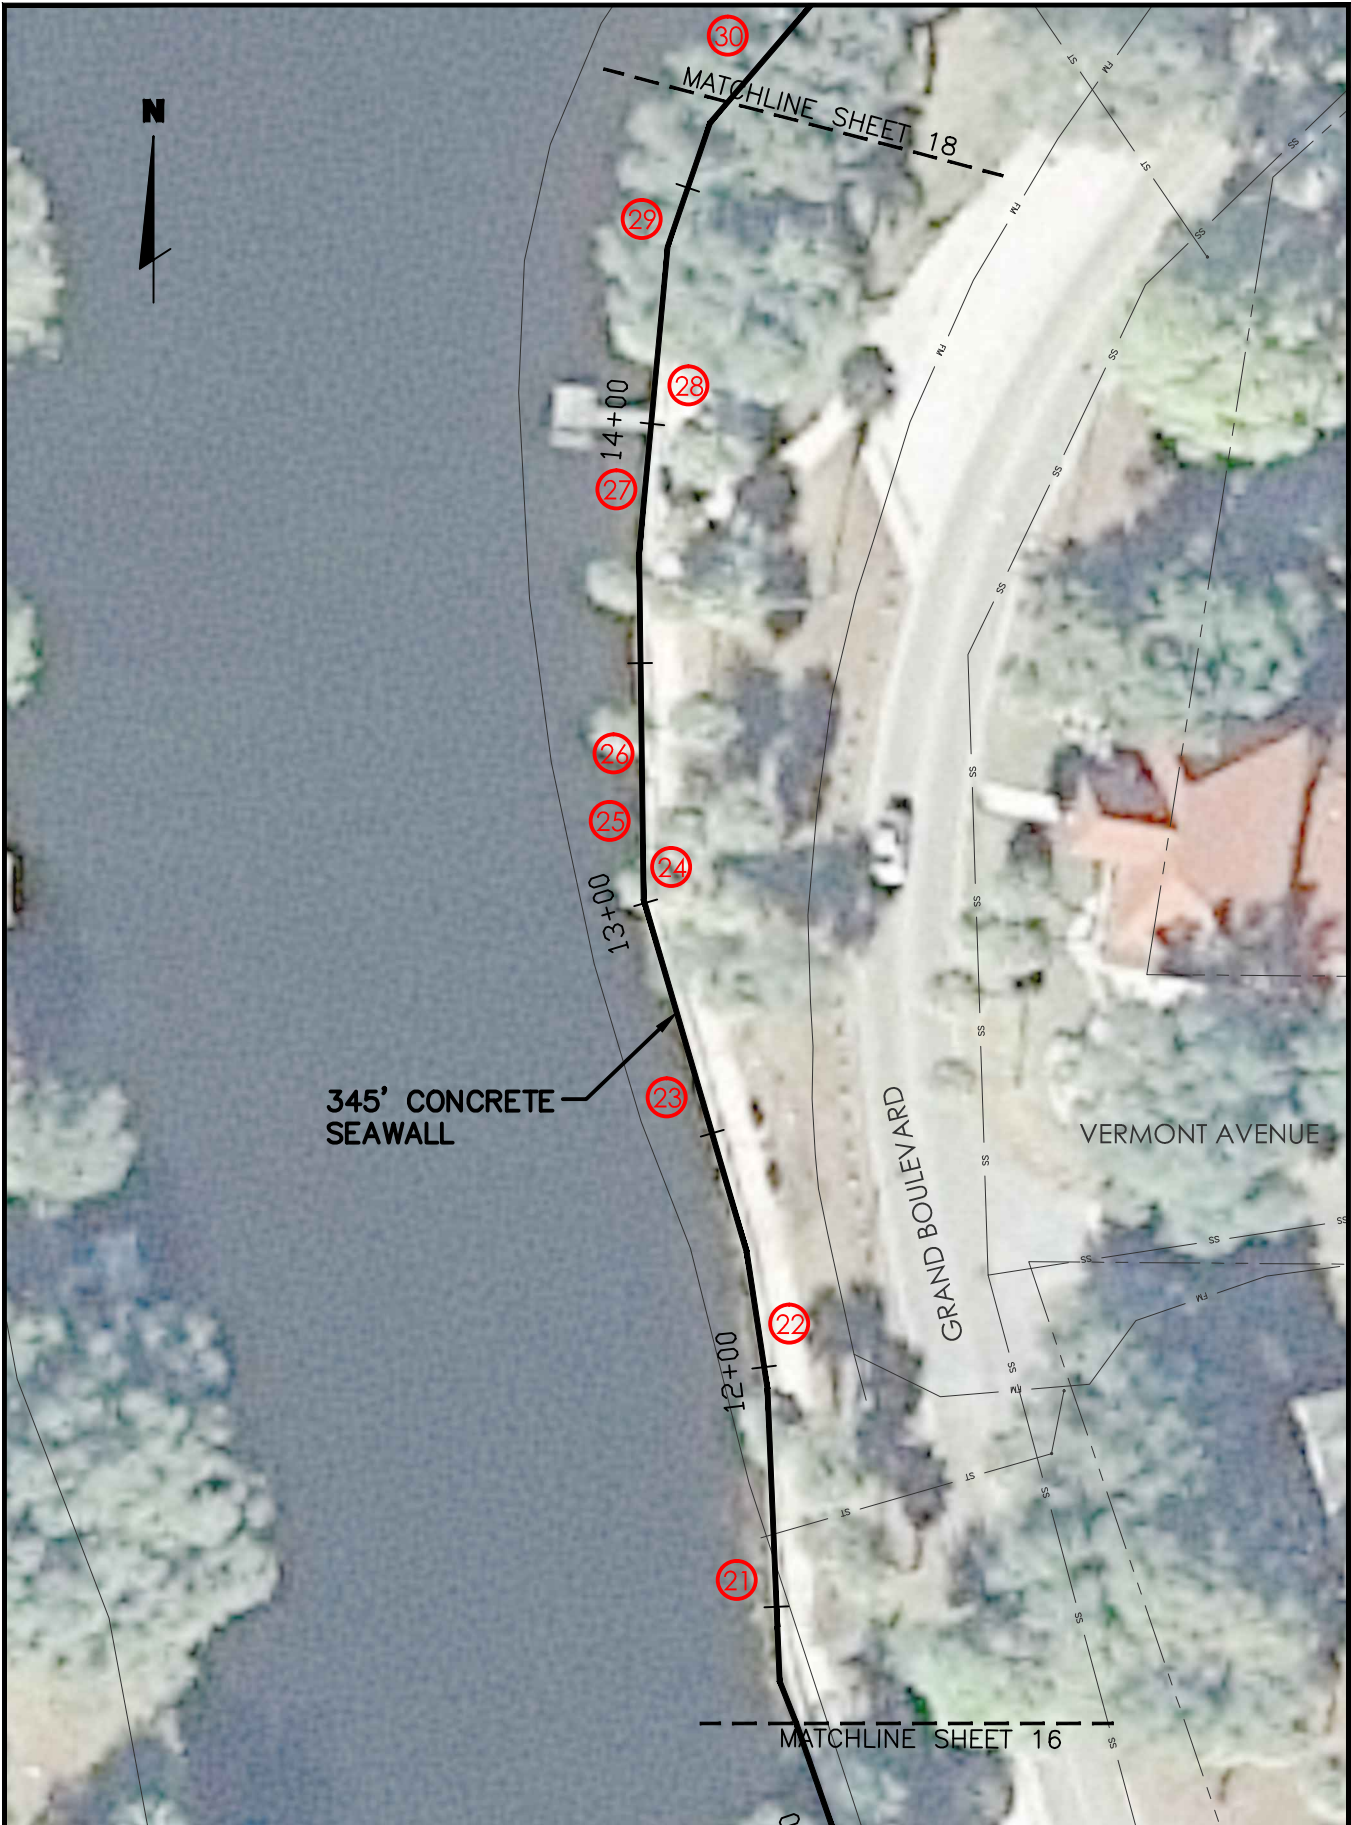
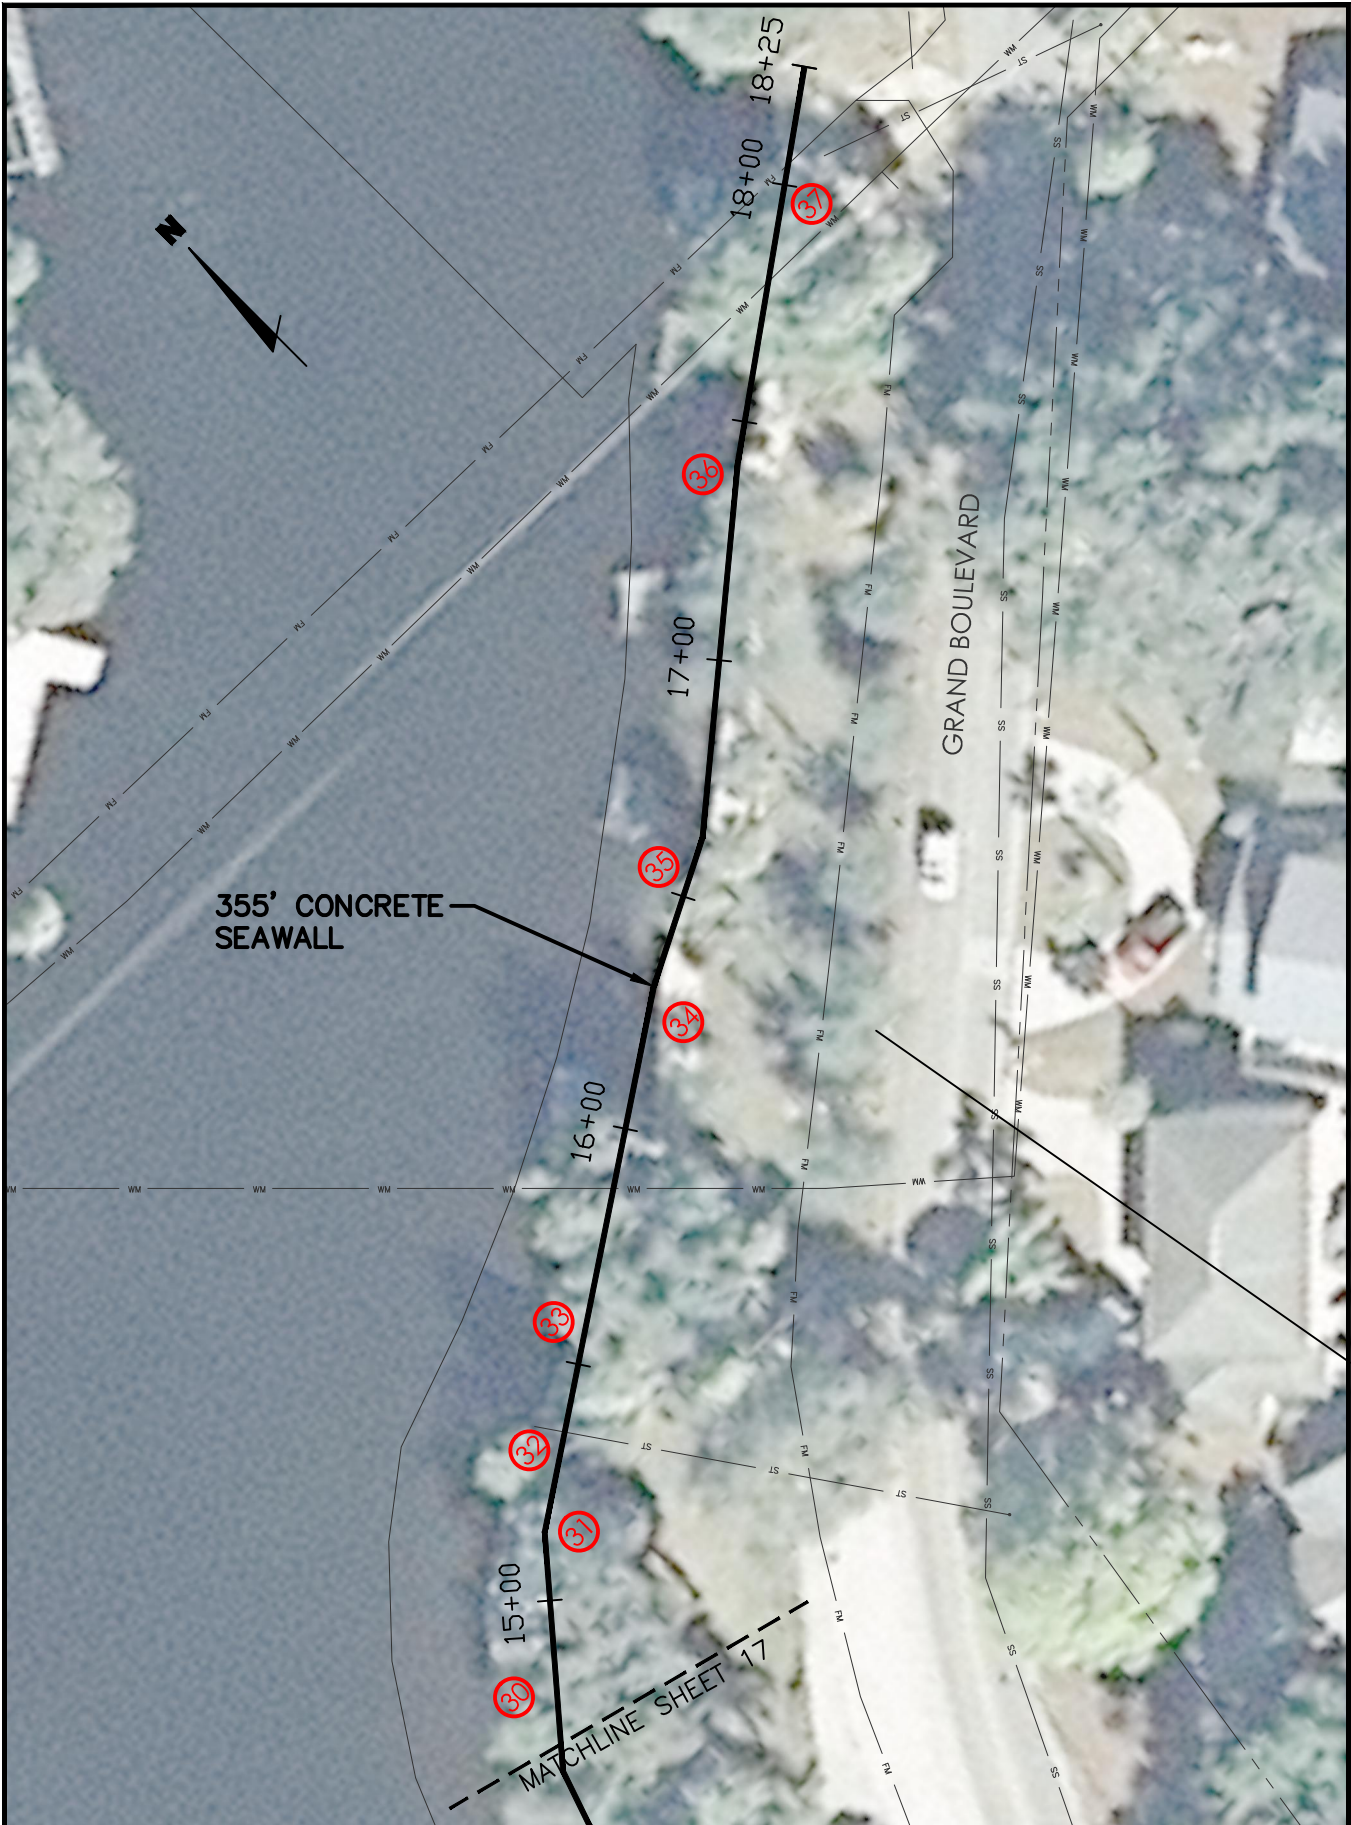
Item No.	Description of Seawall Deterioration	Station
1	Wall cap spillway crack - horizontal	1+35
2	Minor cracking at wall cap and seawall	1+85
3	Wall cap crack - minor	2+95
4	Wall cap spillway crack - horizontal	3+30
5	Horizontal crack at wall cap spillway and vertical crack at storm drain wall penetration	3+90
6	Wall cap spillway crack – horizontal	4+20
7	Wall cap crack – minor	4+36
8	Crack at wall – vertical	4+45
9	Wall cap crack – minor	4+99
10	Wall cap spillway crack - horizontal	5+44
11	Wall joint separation	5+68
12	Wall cap spillway crack – horizontal Wall cap damage - spalling	6+02
13	Wall crack – horizontal approx.. 4' long	6+08
14	Wall cap spillway – sidewalk settlement	6+32
15	Wall joint separation	6+77
16	Wall joint separation	7+75
17	Wall cap spillway crack – horizontal Settlement of adjacent sidewalk	8+13
18	Wall joint separation	9+00
19	Wall joint separation Wall foundation crack	10+00

20	Wall cap spillway – sidewalk settlement	10+82
21	Wall cap crack – minor	11+58
22	Wall joint separation	12+06
23	Crack at wall – vertical	12+65
24	Wall joint separation Wall joint deterioration	13+04
25	Separation of wall and sidewalk	13+10
26	Wall cap spillway crack – horizontal Wall crack - vertical	13+24
27	Wall cap spillway crack – horizontal Wall crack - vertical	13+84
28	Wall joint separation	14+06
29	Wall cap spillway crack – horizontal Wall crack - vertical	14+43
30	Wall and foundation crack - irregular	14+80
31	Wall joint separation	15+12
32	Wall crack – irregular	15+33
33	Wall cap spillway crack – horizontal Wall crack – vertical	15+60
34	Wall joint separation	16+25
35	Wall cap spillway crack – horizontal Wall crack – vertical	16+54
36	Wall joint separation	17+42
37	Wall cap spillway crack – horizontal Wall crack – vertical	18+12

Other deficiencies of this wall include the lack of drainage pipes to allow groundwater to drain from behind the wall into the river. This condition creates hydrostatic pressure behind the wall and exerts forces that can contribute to wall cracks. While the wall has no drainage pipes, the park designer did provide for overland stormwater runoff by sloping the sidewalks to the wall cap spillways.

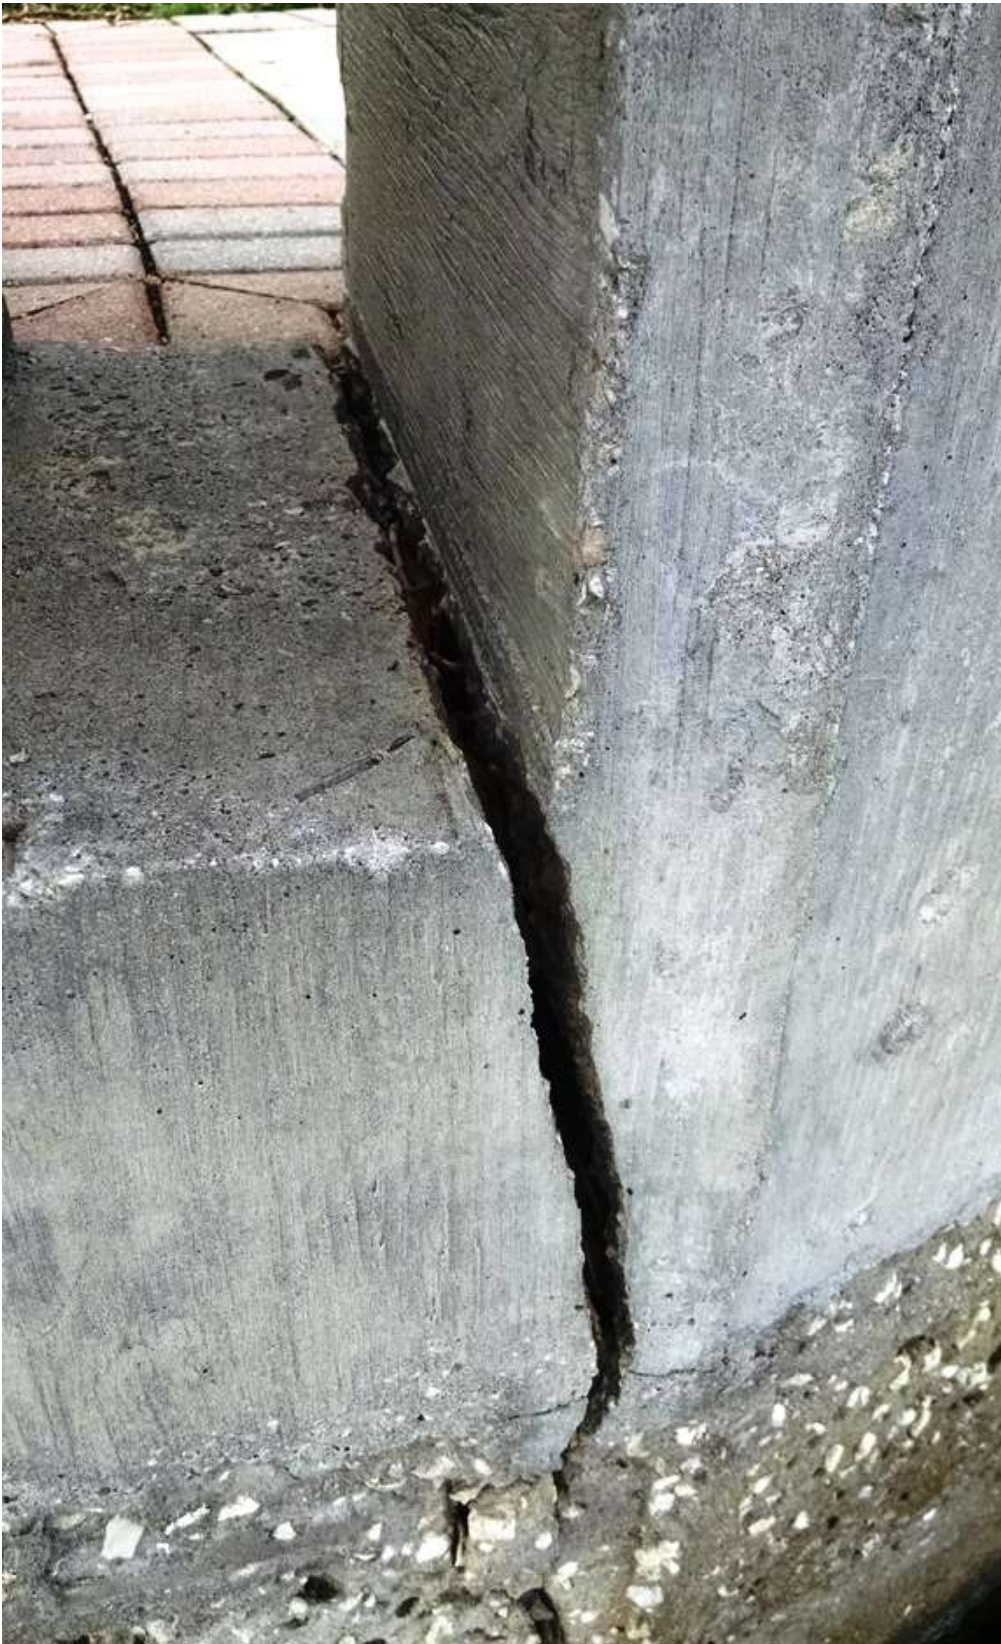
**Figure 19 – Wall Crack at Spillway**

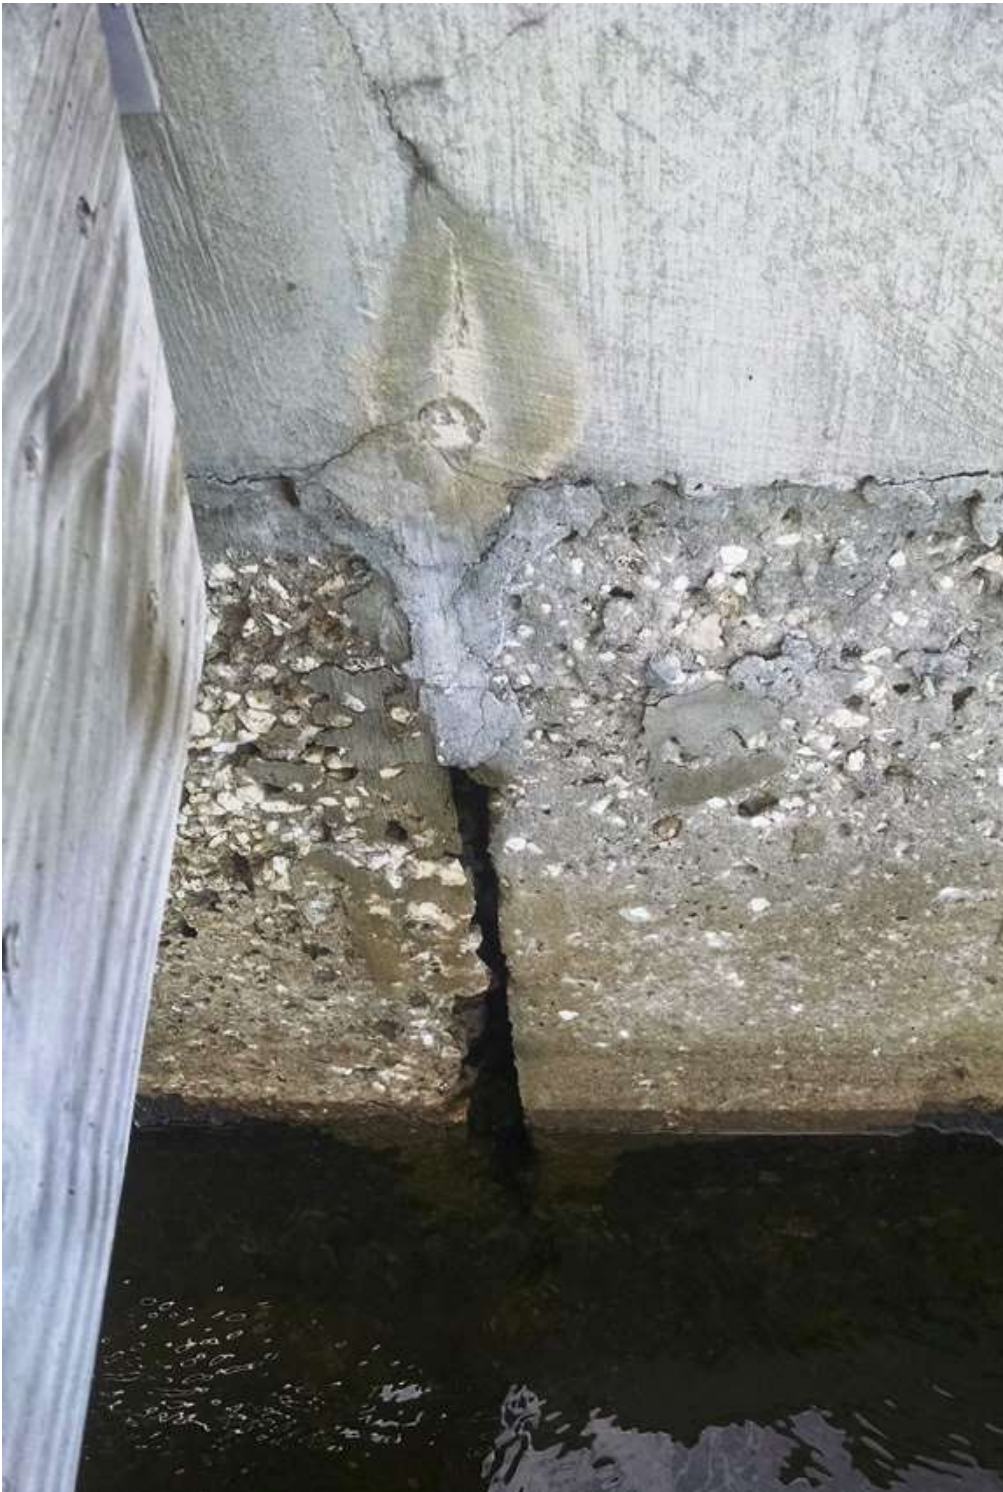
**Figure 20 – Wall Joint Separation/Spalling**

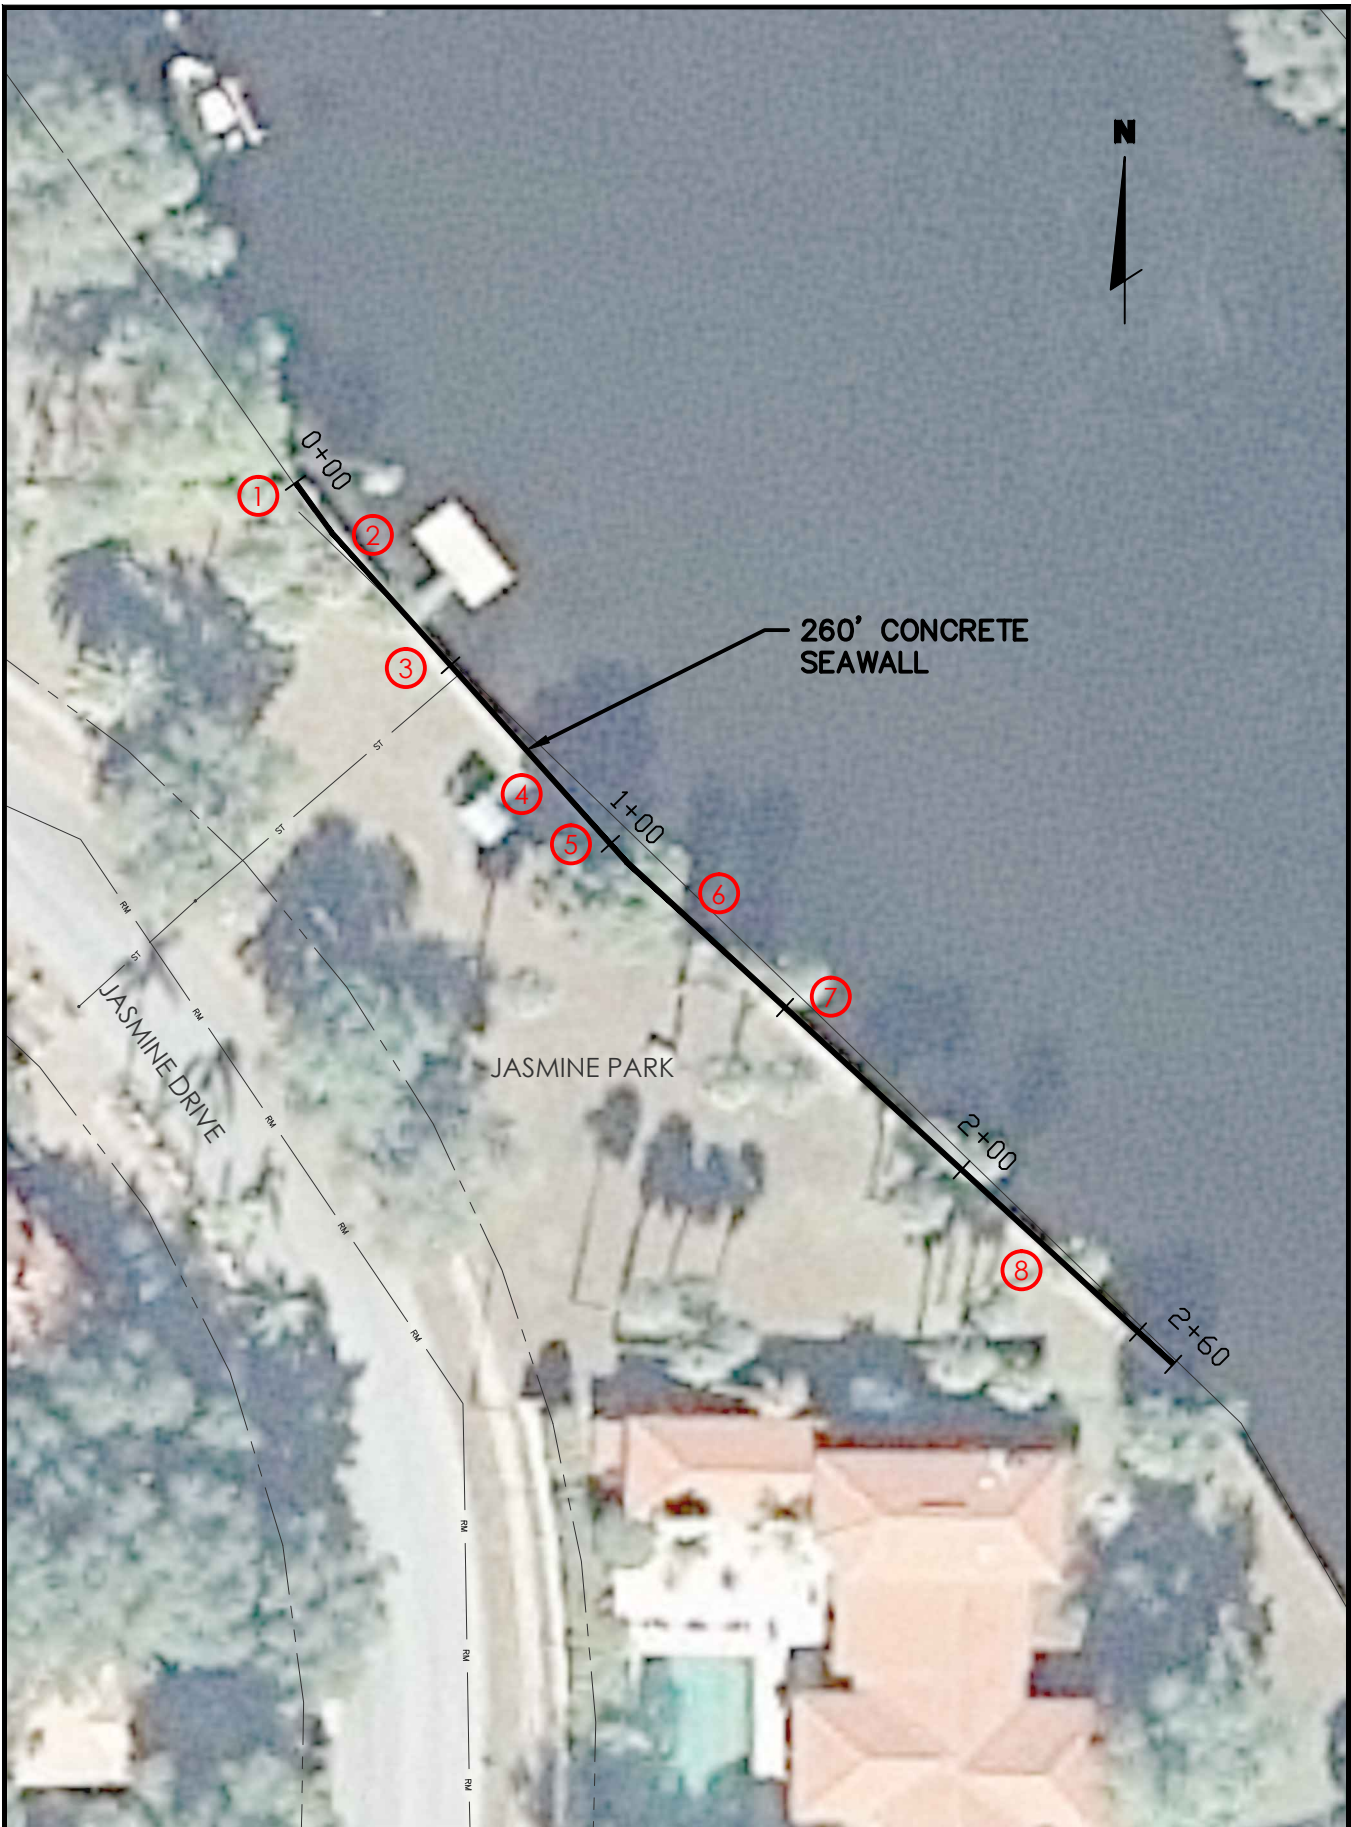
FIGURE 21  
JASMINE PARK SEAWALL  
DETERIORATION

Item No.	Description of Seawall Deterioration	Station
1	Wall Joint Damage - Erosion	0+00
2	Wall Cap Damage - Spalling	0+10 to 0+33
3	Possible Void Detected	0+40 to 0+70
4	Wall Leaning Outward 2-3 Degrees	0+70 to 0+97
5	Wall Crack – Vertical	0+97
6	Possible Void Detected	0+97 to 1+31
7	Wall Leaning Outward 4-5 Degrees	1+31 to 1+75
8	Possible Void Detected	2+10 to 2+30

In addition to the repair or replacement of the seawalls, the City plans to construct new wall caps and sidewalks. These improvements are intended to match the decorative and design features of the other riverfront parks. However, we recommend additional investigation of the seawall foundation be conducted during the design phase to assure the wall is capable of supporting the new wall cap structure. It may be necessary to provide additional structural support or seawall replacement prior to constructing the wall cap and sidewalk additions.

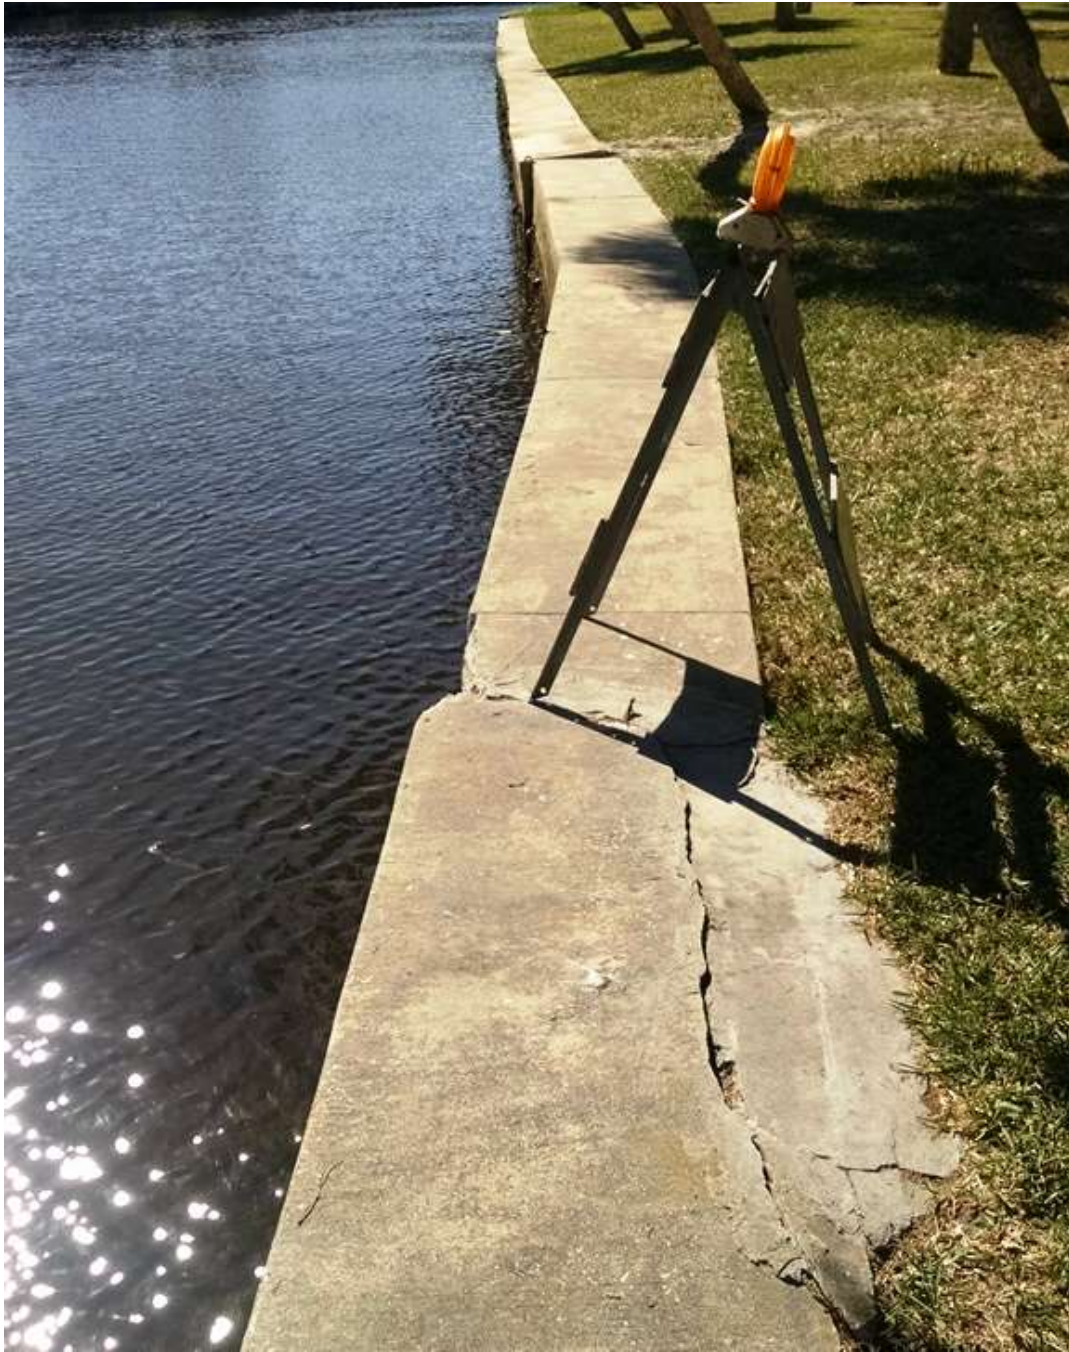
**Figure 22 - Wall Failure/Crack**

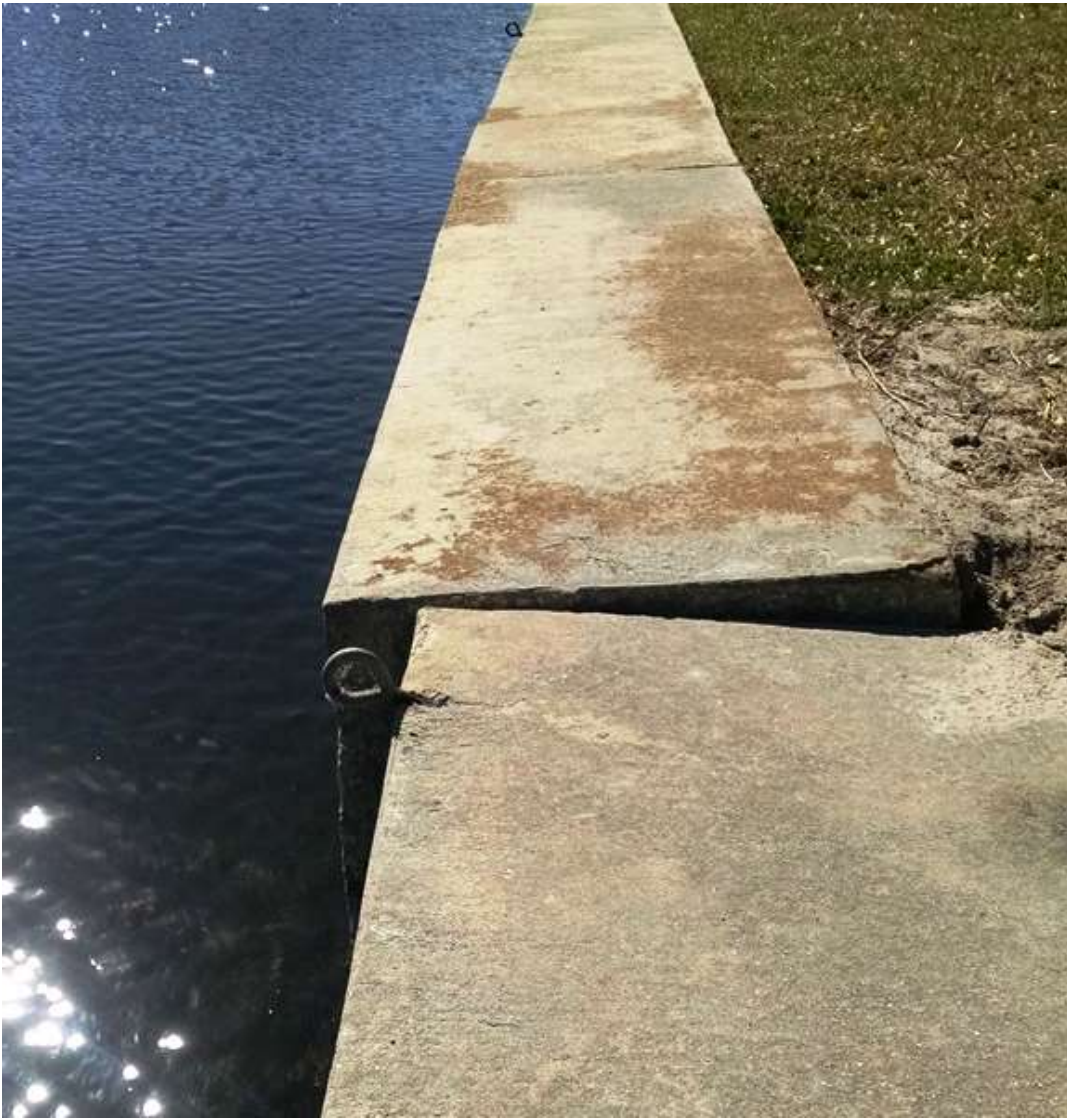
**Figure 23 - Wall Leaning Toward River – Separation at Construction Joint (Looking South)**

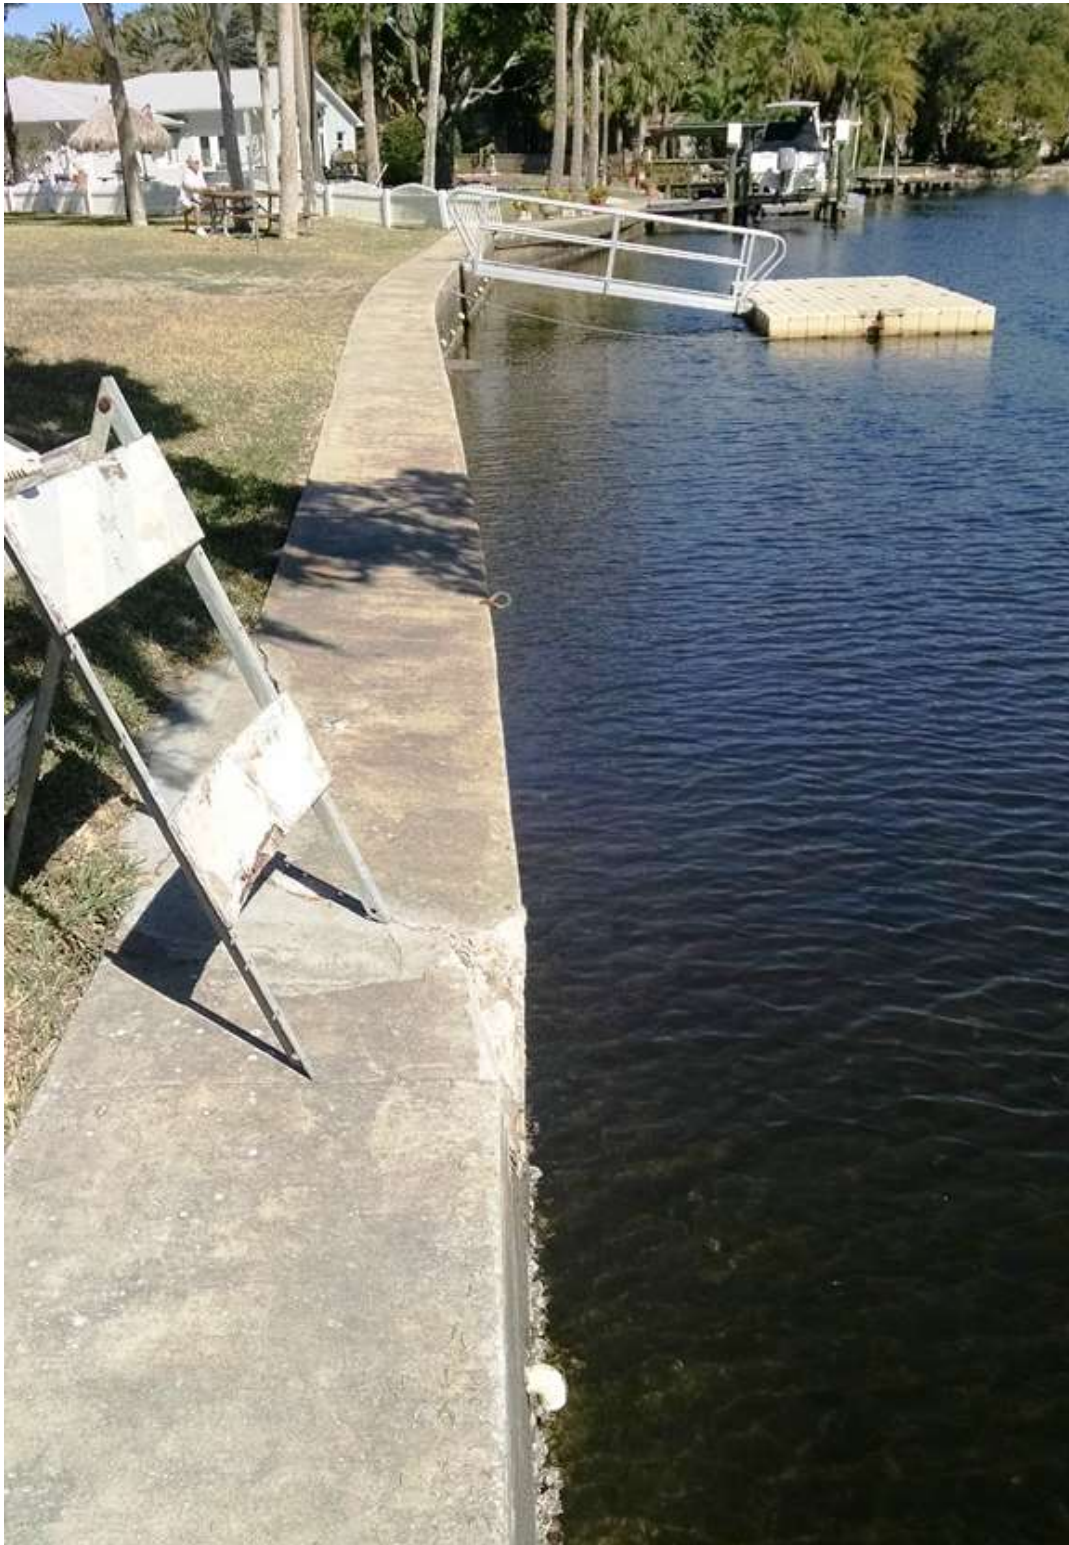
**Figure 24 - Wall Leaning Toward River – Vertical Wall Crack (Looking North)**
