# CITY OF NEW PORT RICHEY PARKS SEAWALL CONDITION ASSESSMENT REPORT

CITY OF NEW PORT RICHEY  
DEPARTMENT OF PUBLIC WORKS

STROUD ENGINEERING CONSULTANTS, INC.  
10503 Cyndee Lane  
Odessa, Florida 33556

June 2017

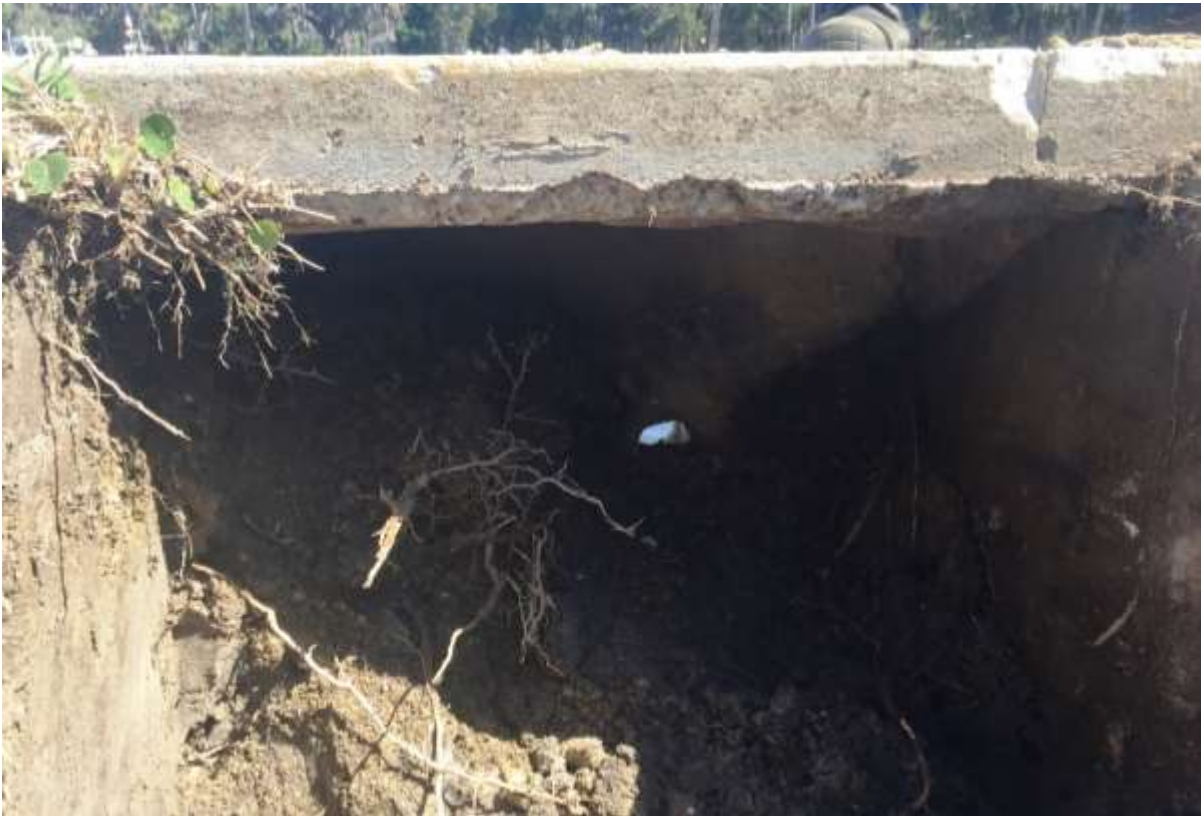
The City performed an excavation of an existing tie-back for both an original concrete wall tie-back and one of the retrofitted steel rod tie-backs. The excavation also exposed one of the 2" diameter drainage holes in the wall, which revealed the lack of a soil filter to prevent erosion through the hole. It is possible this condition exists for the other drainage holes.

**Figure 25 - Jasmine Park Seawall Drainage Hole Excavation – No Filter or Slotted Pipe Protection to Prevent Soil Erosion Through Hole**

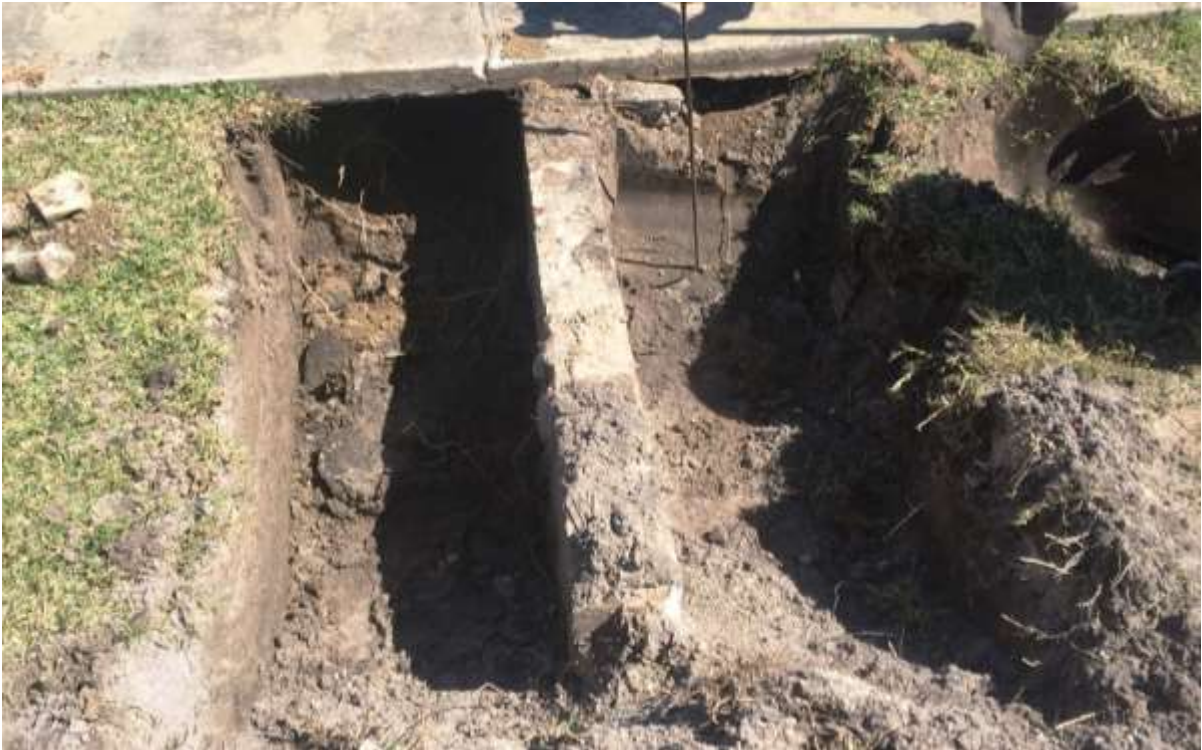
**Figure 26 - Jasmine Park Bulkhead Concrete Tie-Back Excavation**

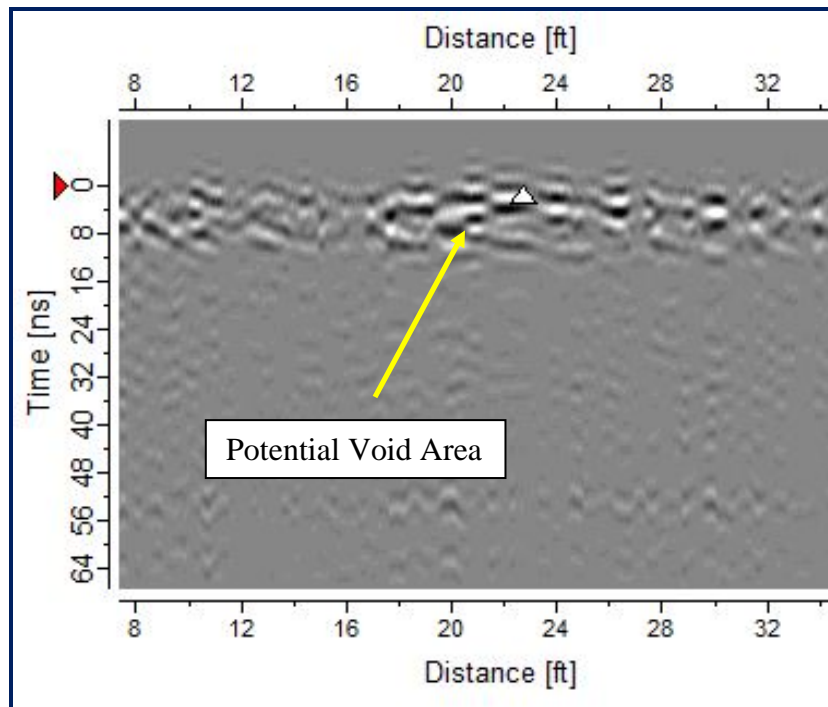
**Radargram 6 – Showing potential void along the seawall at Sims Boat Ramp.**

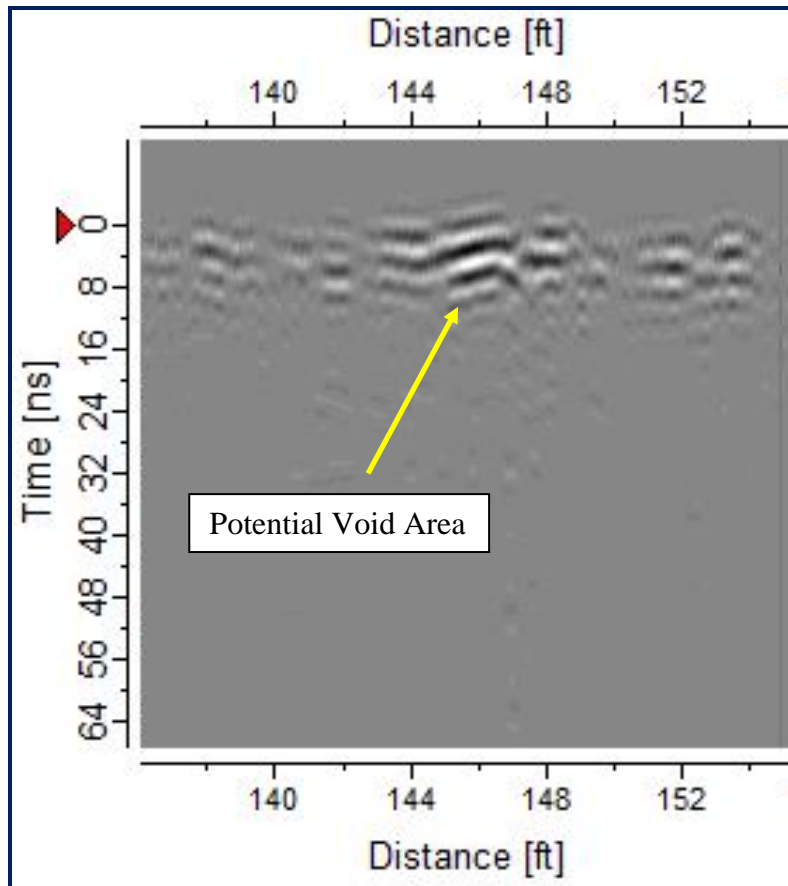
**Radargram 30 – Showing potential void along the seawall at Sims Park.**

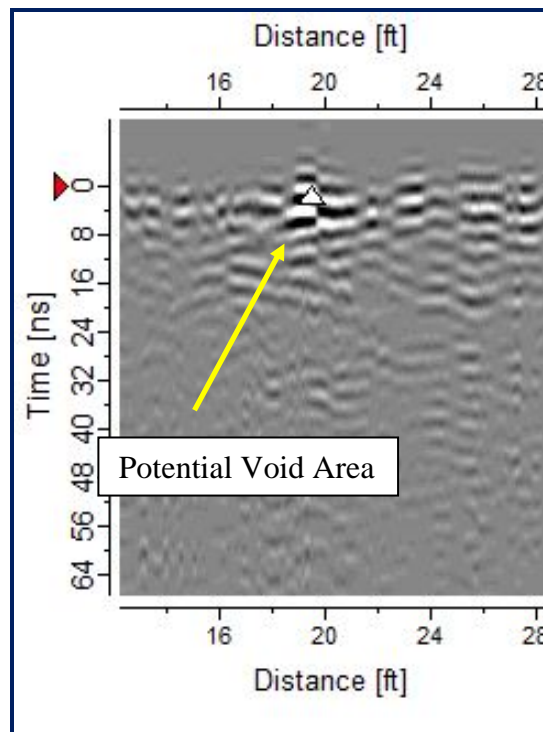
**Radargram 31 – Showing potential void along the seawall at Sims Park.**

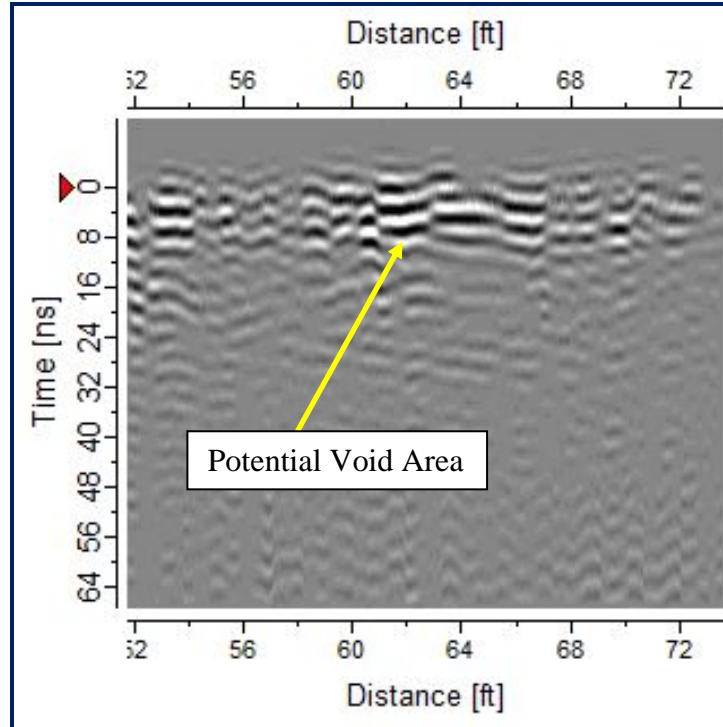
**Radargram 35 – Showing potential void along the seawall at Sims Park.**

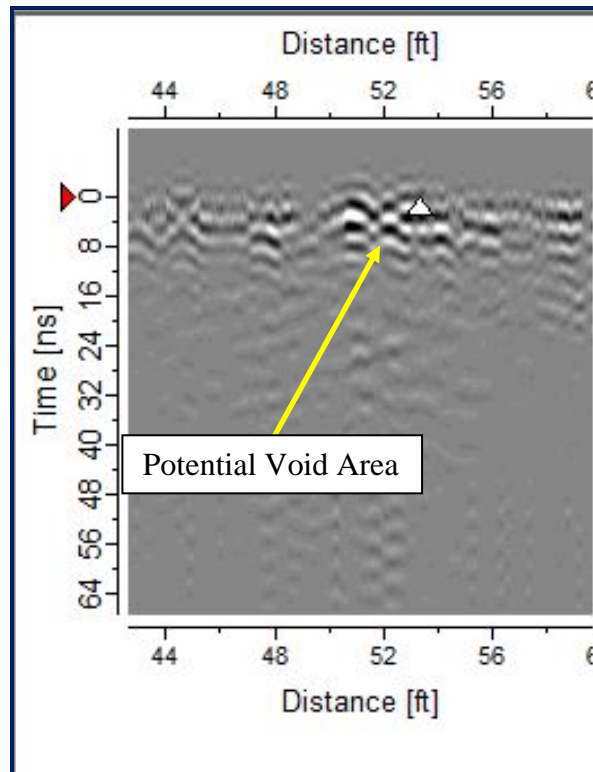
**Radargram 39 – Showing potential void along the seawall at Sims Park.**

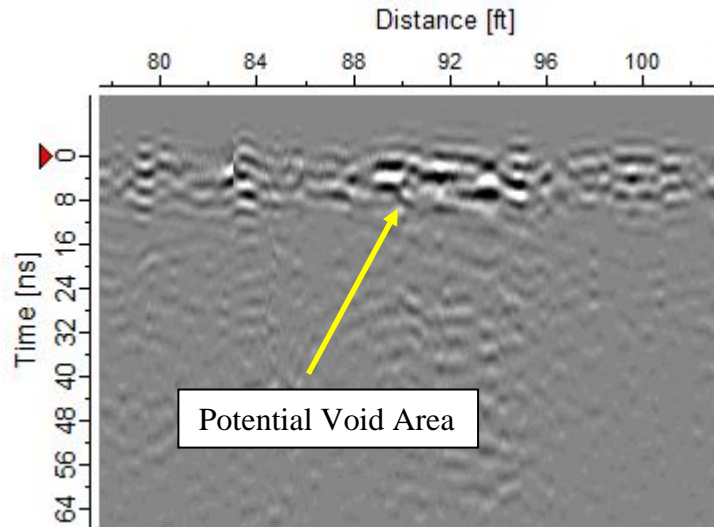
**Radargram 61 – Showing potential void along the seawall at Jasmine Park.**

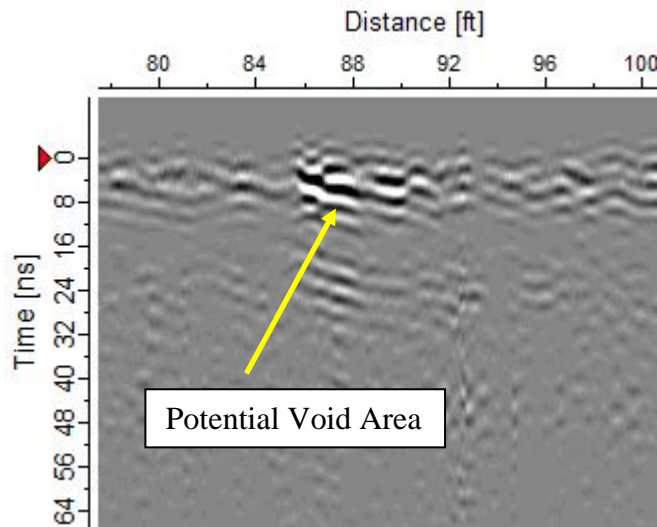
**Radargram 62– Showing potential void along the seawall at Jasmine Park.**
