**Subject: Field Report
Incubator Building – North Roof Area
6345 Grand Blvd.
New Port Richey, FL 34652
BillerReinhart Project No. 16-502**

Field Observation Report
Incubator Building – North Roof Area
6345 Grand Blvd.
New Port Richey, FL 34652
BillerReinhart Project No. 16-502

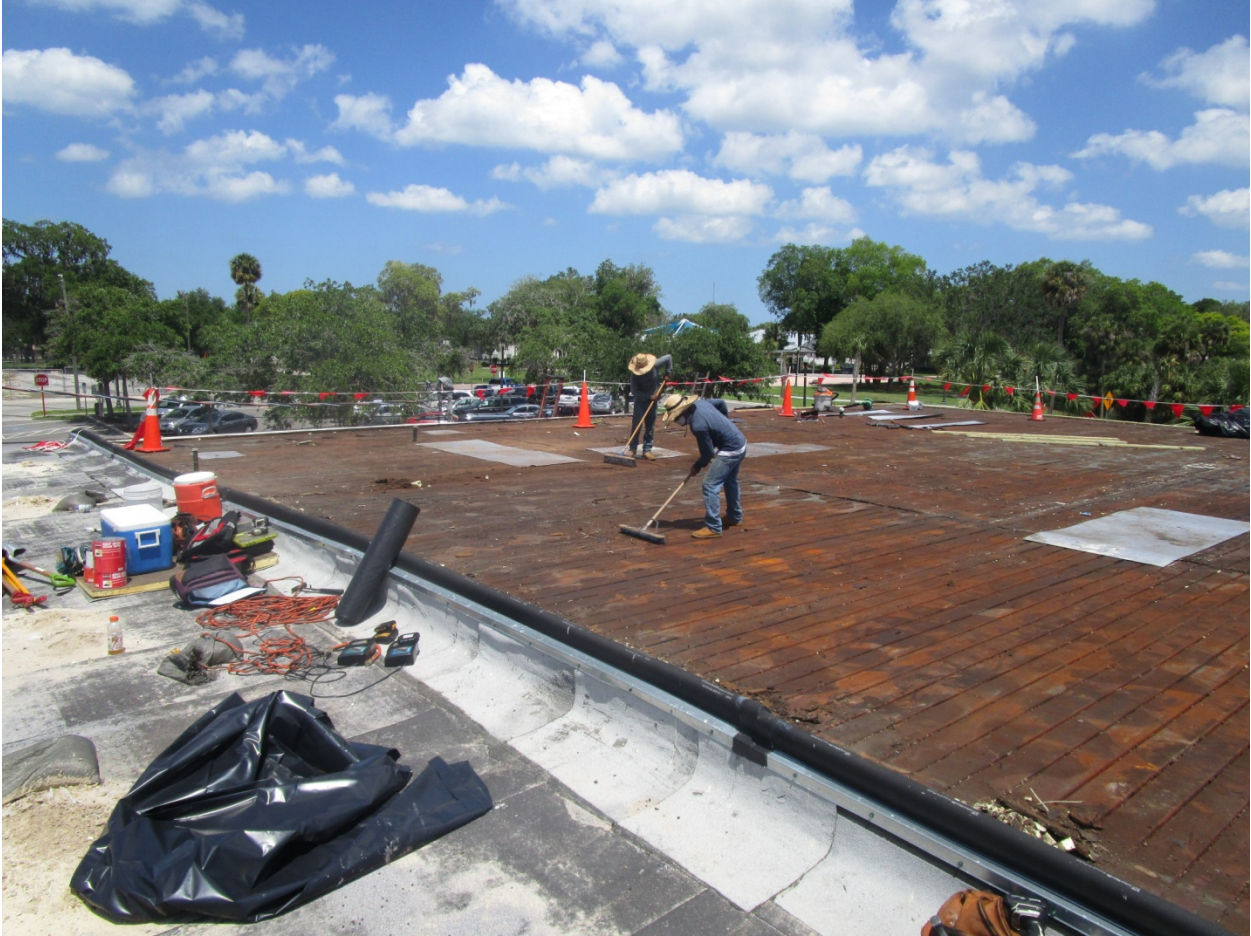
Figure 1 - North Roof Deck Area Looking NW

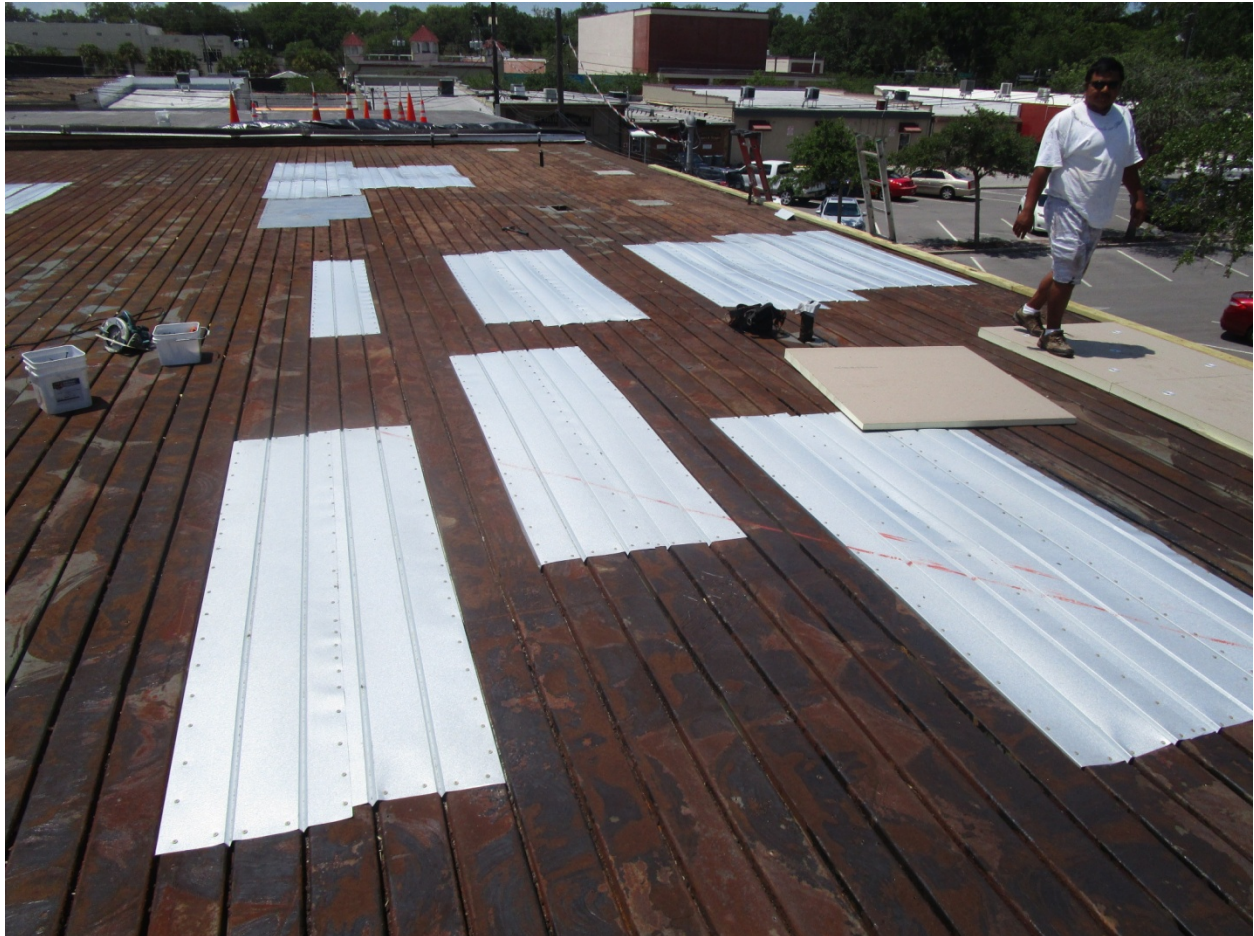
1. Tear off of the existing roof system was completed during the first two days of construction. The metal roof deck exhibited sporadic areas of surface corrosion, section loss and permanent deflection. The Contractor was directed to install supplemental 24 gauge galvanized metal plates fastened at 6" O.C. with #10 screws around the perimeter of each plate. The Contractor fabricated the plates and incorporated a profile similar to the existing decking which will provide for a stiffer section. Refer to Figure 1.
2. Debris was observed to be removed from the deck surface and supplemental steel panels were fastened to the deflected areas of existing decking and areas exhibiting section loss. Refer to Figure 2 and attached as-built drawing for locations. Pressure treated 2x6 members were installed along the perimeter edge with #12 screws staggered at 4" O.C.

Figure 2 – Installation of supplemental deck panels

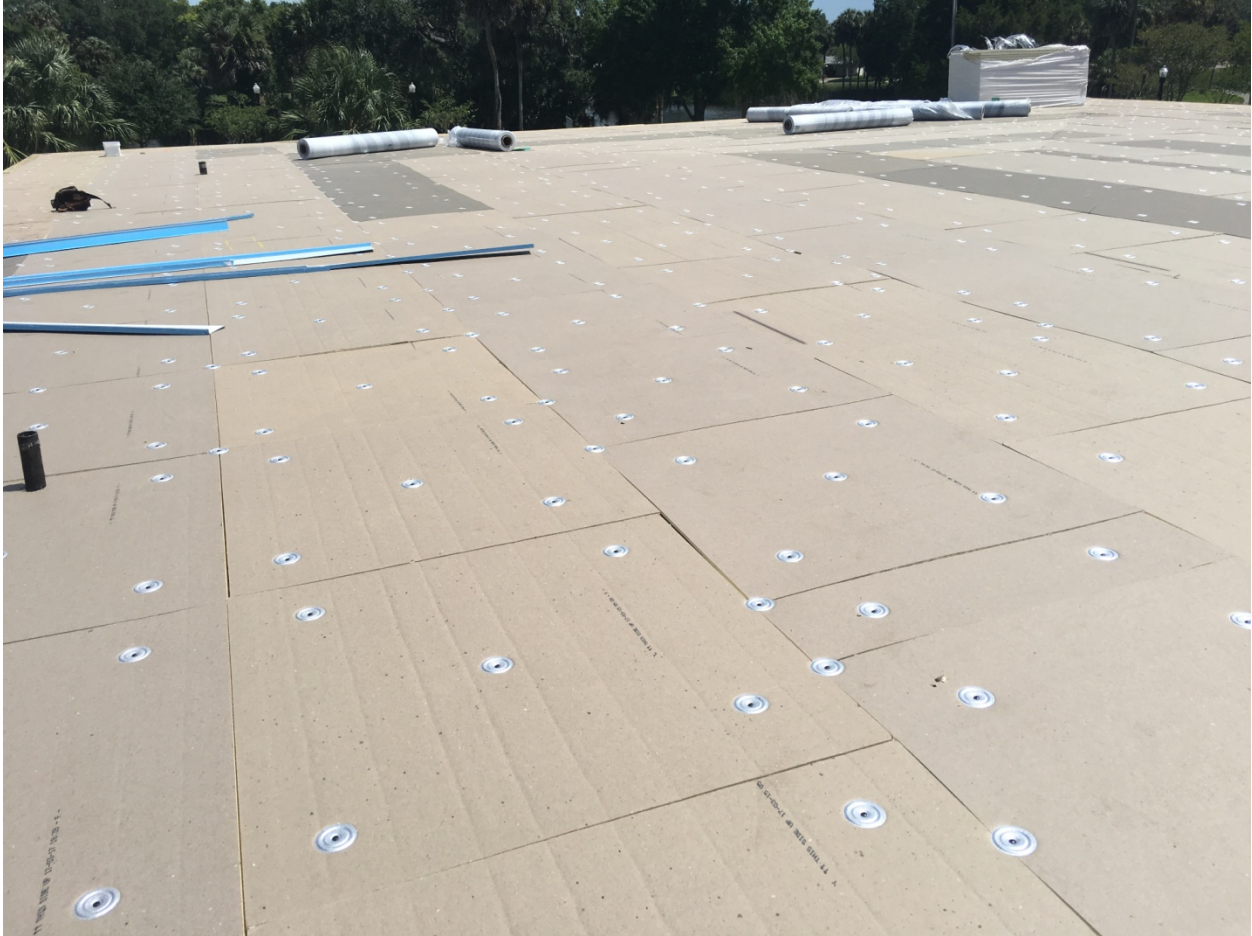
3. Fastening of the polyisocyanurate insulation board was observed to meet or exceed the specified requirements. The Contractor was directed to stagger the insulation boards and fill any gaps ¼” or greater. Refer to Figure 3.

Figure 3 – Mechanical fastening of insulation boards

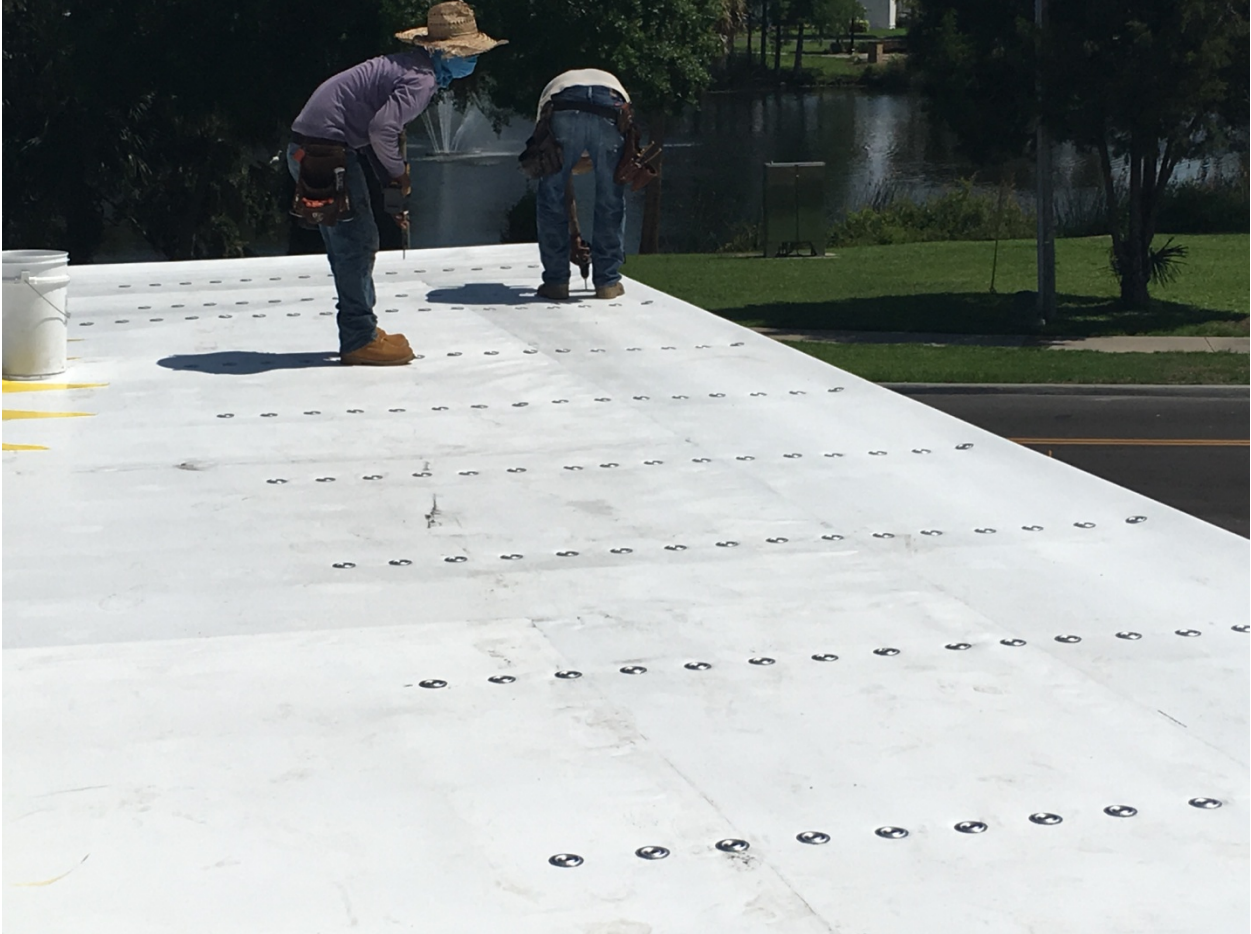
4. Installation of the roof membrane along the east and west perimeter edges was initially completed with a 4 foot wide membrane strip fastened at 6” O.C. parallel to the roof edge and steel deck flutes. BillerReinhart communicated to the Contractor that the fasteners needed to be installed perpendicular to the roof deck. As a result, additional fasteners were installed within the edge and corner zones of the roof in order to meet the requirements of the contract documents and ultimately the wind load requirements. The Mule-Hide manufacturer representative was contacted to confirm that the fastener spacing at 12” O.C. was adequate within the field zone and that the method used to apply the additional fasteners to the roof system within the edge and corner zones were methods than where in general conformance with installation requirements and did not adversely impact the systems warranty. Refer to Figure 4.

Figure 4 – Installation of Additional Membrane Fasteners Perpendicular to Roof Decking Flutes – Per Wind Uplift Requirements

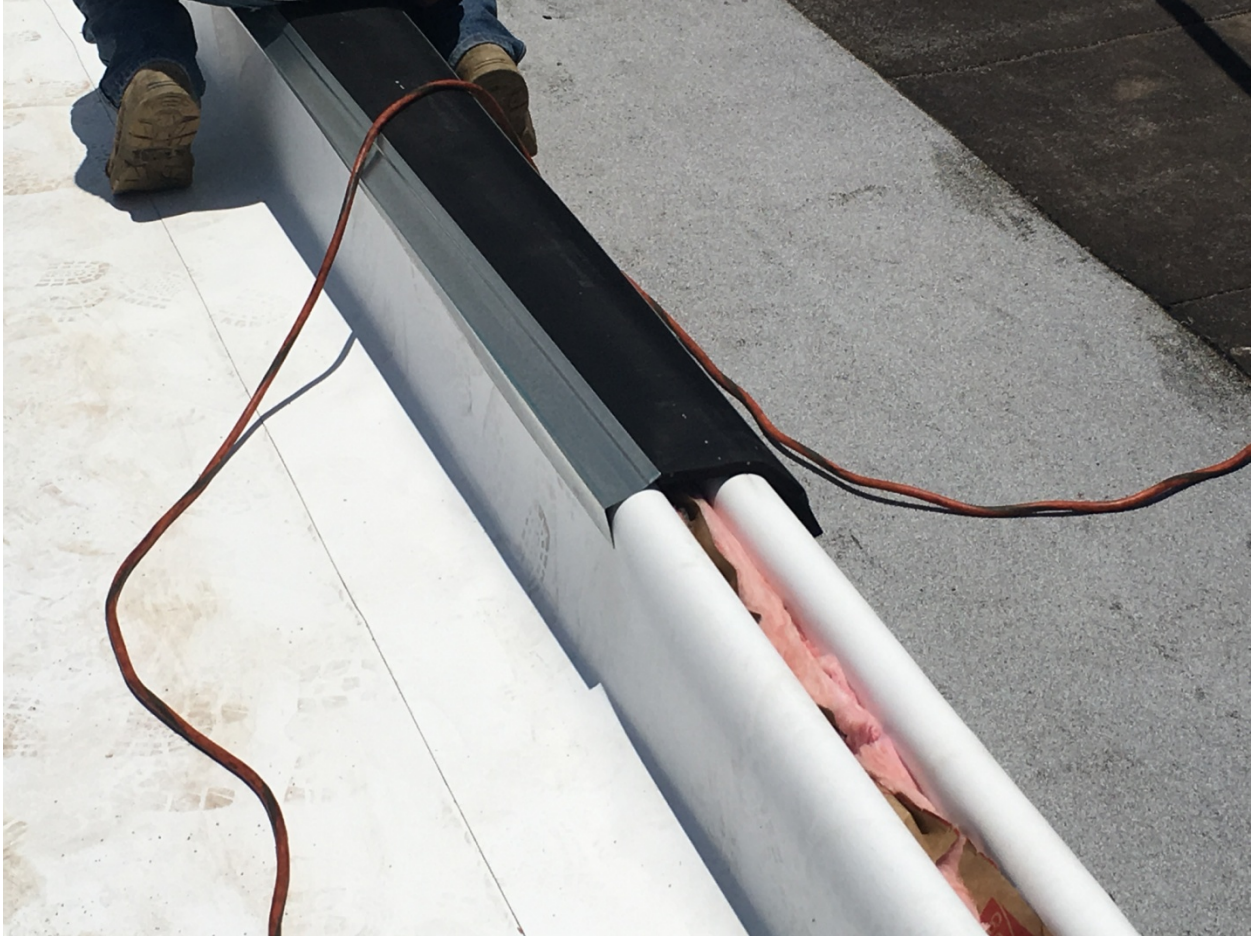
5. The expansion joint was rebuilt to create a level application of the John Manville Expand-o-Flash accessory. The TPO was observed to be draped within the joint to provide for an internal vapor barrier and batt insulation was installed within the joint prior to application of the Expand-o-Flash accessory.

6. Unsealed cut membrane edges were observed. Fastener spacing for the Expand-o-Flash accessory exceeded the minimum 8” O.C. specified. The Contractor was directed to rectify these items.

Figure 5 – Expansion Joint

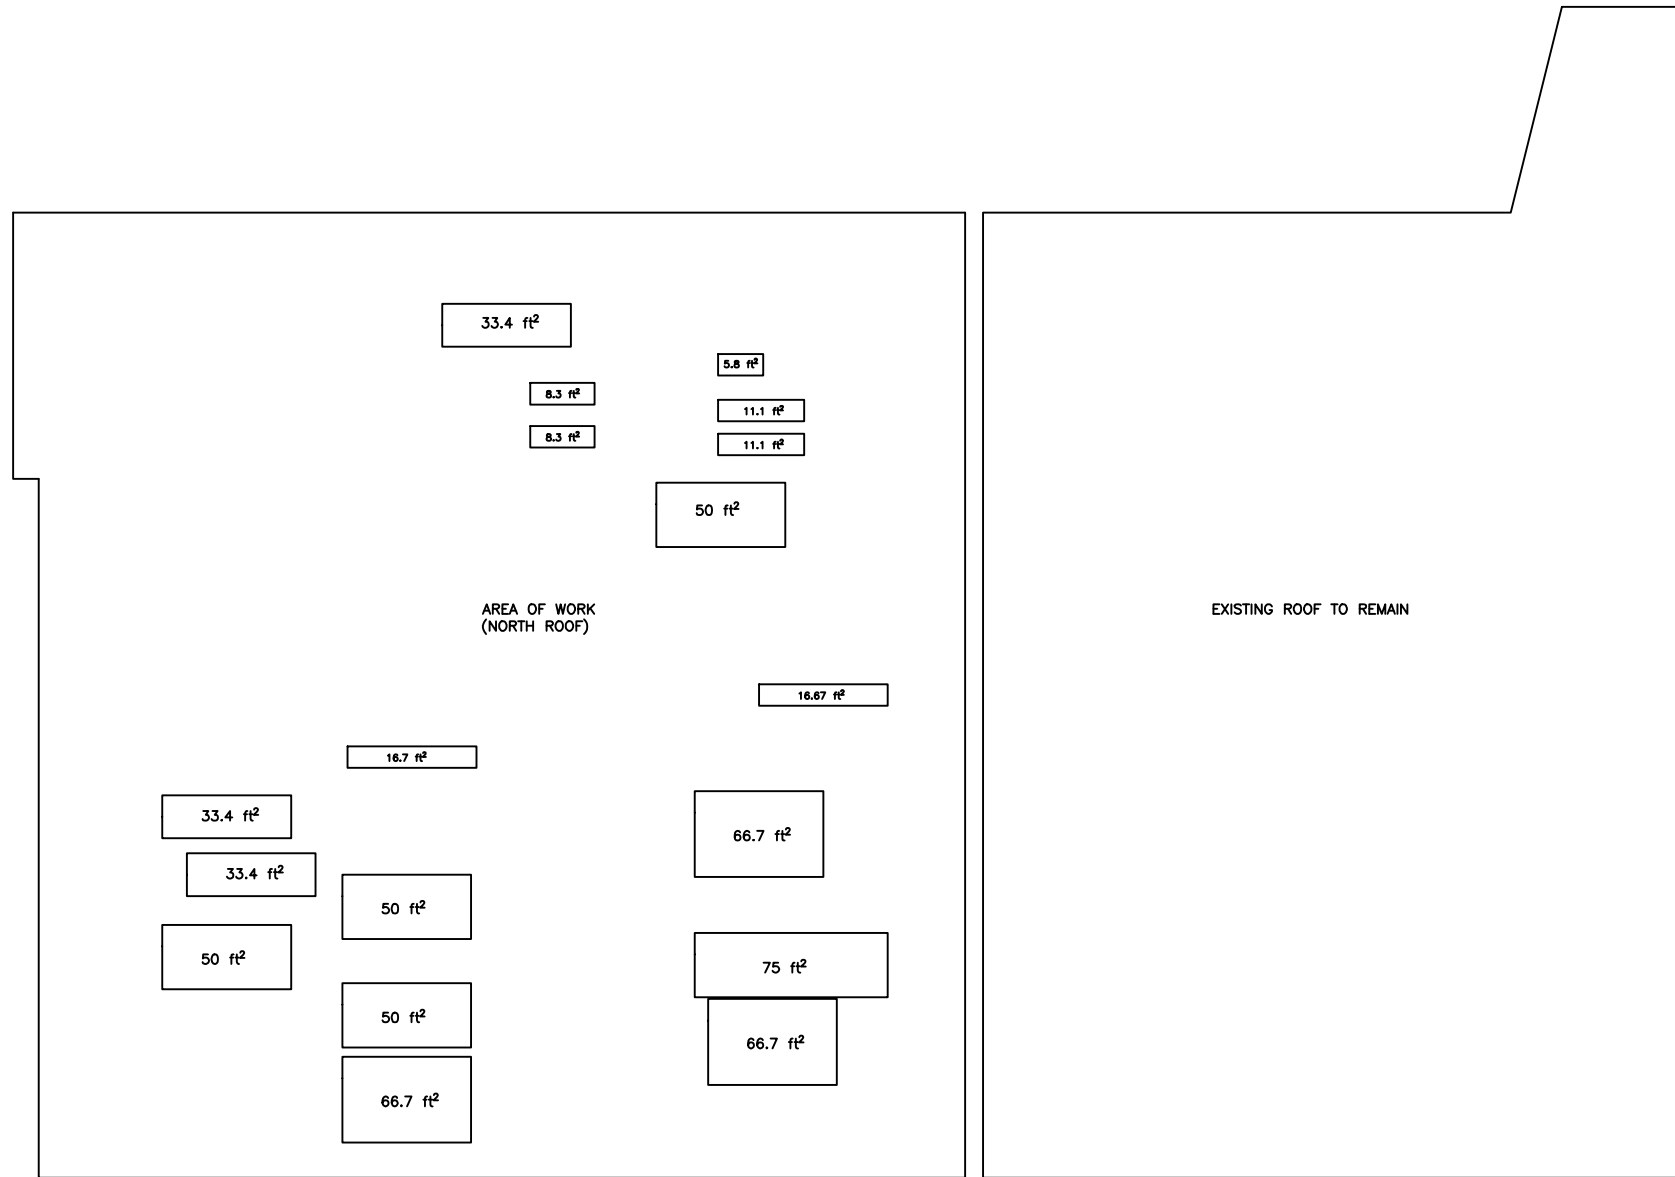
1 AS-BUILT DECK REPAIR DIAGRAM
 S-AB SCALE: 1/8" = 1'-0"

KEY
 AREA (ft²) - SUPPLEMENTAL 24GA GALVANIZED PANELS, FASTENED WITH #10 SCREWS 6" O.C. AROUND PERIMETER OF EACH PANEL.
