Report of Roof System Condition Assessment

Incubator Building – North Roof Area Removal
6345 Grand Blvd.
New Port Richey, FL 34652

Issue Date:
June 12, 2017

BillerReinhart Project No. 16-502

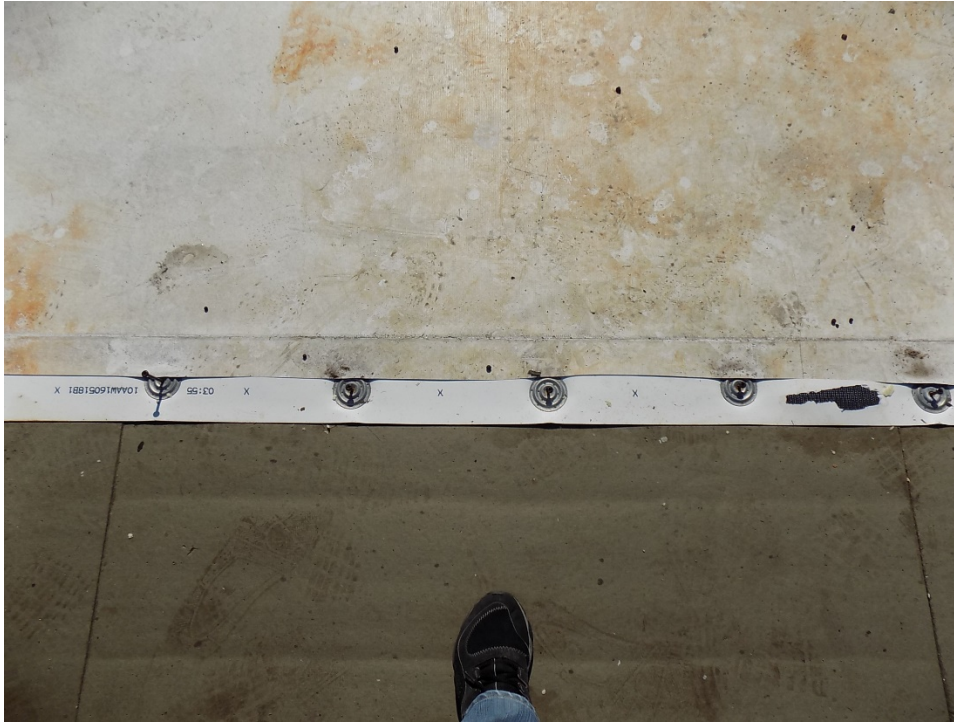
Figure A-1

1. Inadequate spacing of roof system fasteners along the building perimeter zones. Fastener markings were not utilized to space fasteners at 6 inches on center. Fasteners were spaced at approximately 12 inches on center (Figures A-1, A-2, A-3, and A-12).
2. Inadequate spacing of roof system fasteners within the field of the roof. Fastener markings were not utilized to space fasteners at 12 inches on center. Fastener spacing exceeded 12 inches on center (Figure A-13).
3. Lengthwise roof membrane seams were installed parallel to metal roof deck flutes. The membrane should have been installed perpendicular to the roof deck span to distribute wind forces over multiple roof deck panels (Figure A-4).

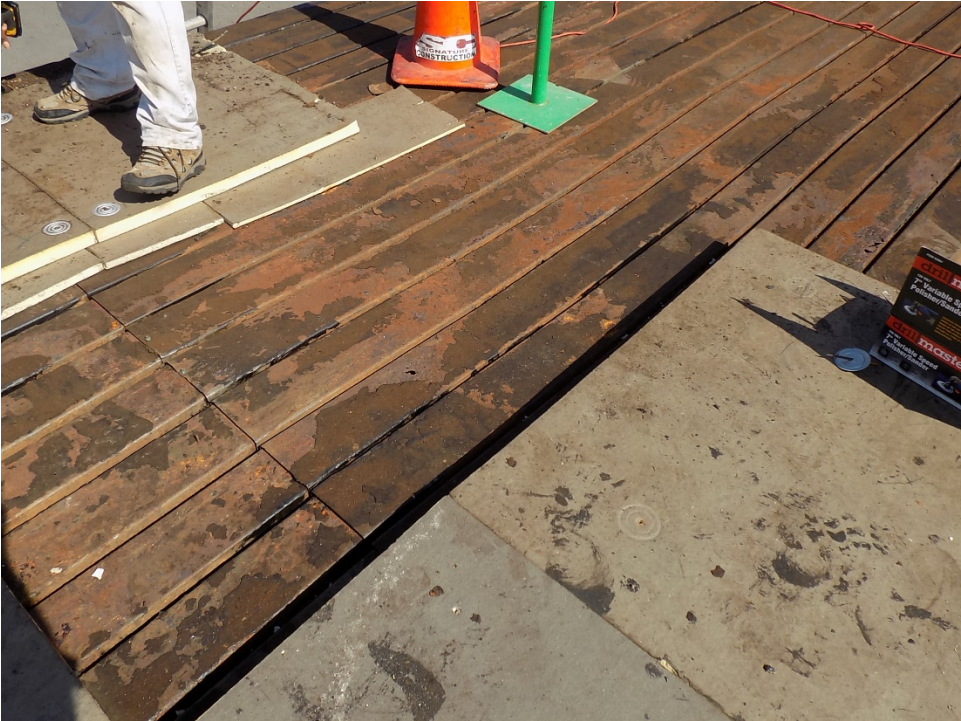
Figure A-5

4. The roof system was installed over deteriorated (corroded) metal roof deck. Portions of the roof deck exhibited full section loss. Refer to Figures A-5, A-6, and A-7.

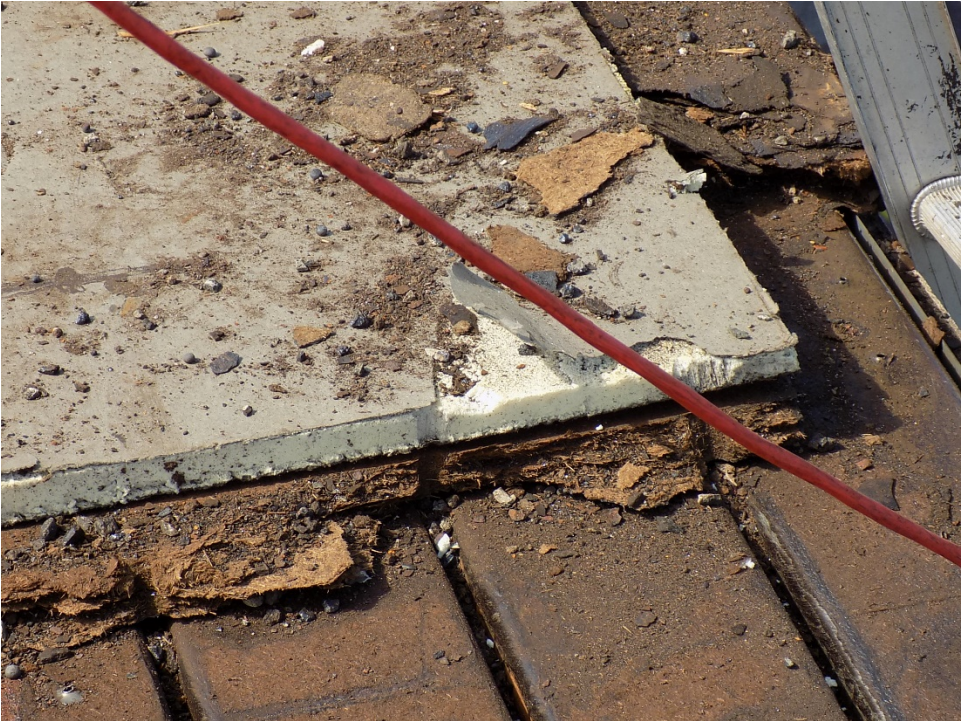
Figure A-8

5. The roof membrane was installed over the perimeter detailing from a prior roof system. The perimeter detailing consisted of ½” plywood over an older built-up roof system (Figures A-8, A-9, and A-14).

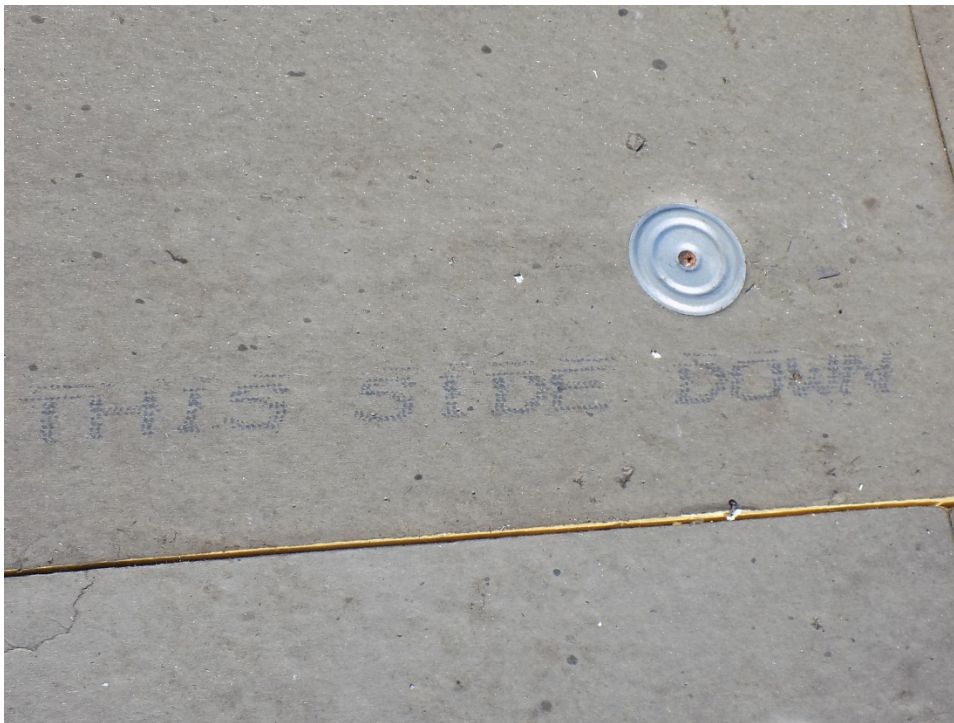
Figure A-10

6. Insulation panels were installed with their bottom sides facing upwards (Figure A-10).
7. Tapered insulation panels along the perimeter were installed with improper orientation. As a result, the roof sloped inward along the perimeter and ponding water resulted (Figure A-11).

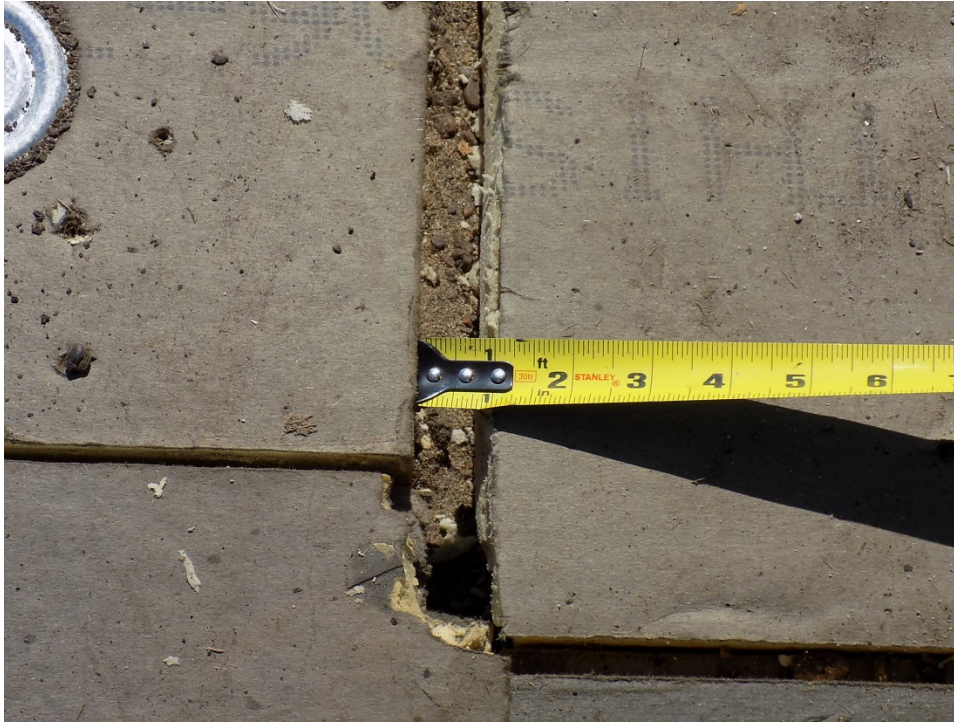
Figure A-15

8. Insulation was installed with large gaps (greater than ¼”) in between insulation panels (Figures A-15, A-16, and A-17).
9. Debris under the roof membrane resulted in surface irregularity (Figure A-18)

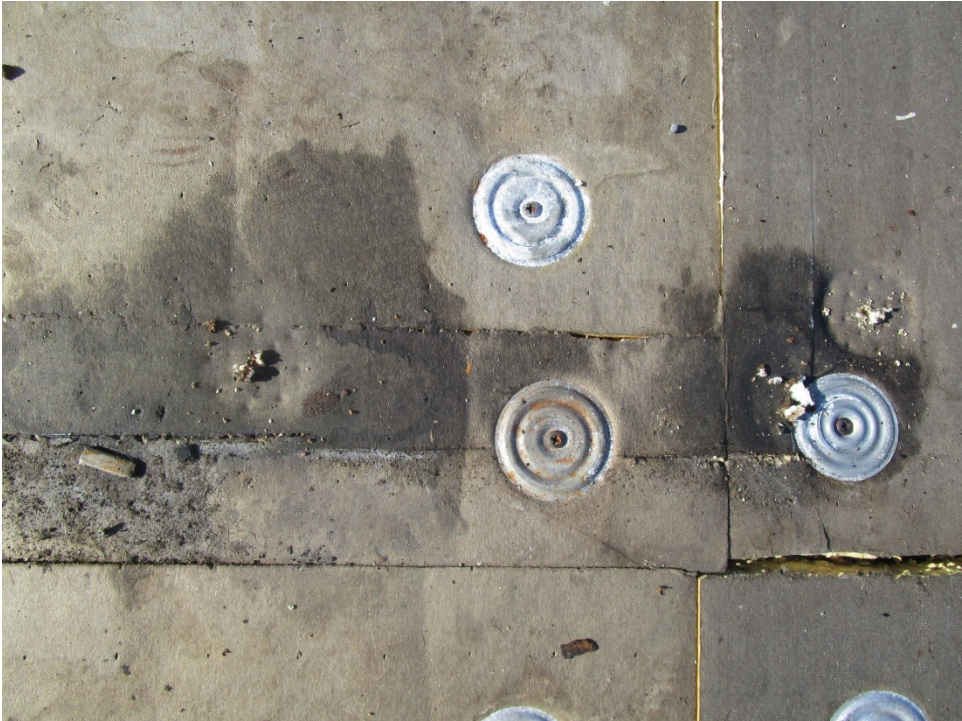
Figure A-18

10. Insulation panel fasteners were installed with inadequate panel edge distance (less than 12 inches) (Figures A-18 and A-19).
11. Insulation panel edges were not staggered (Figures A-20, A-21, and A-31).

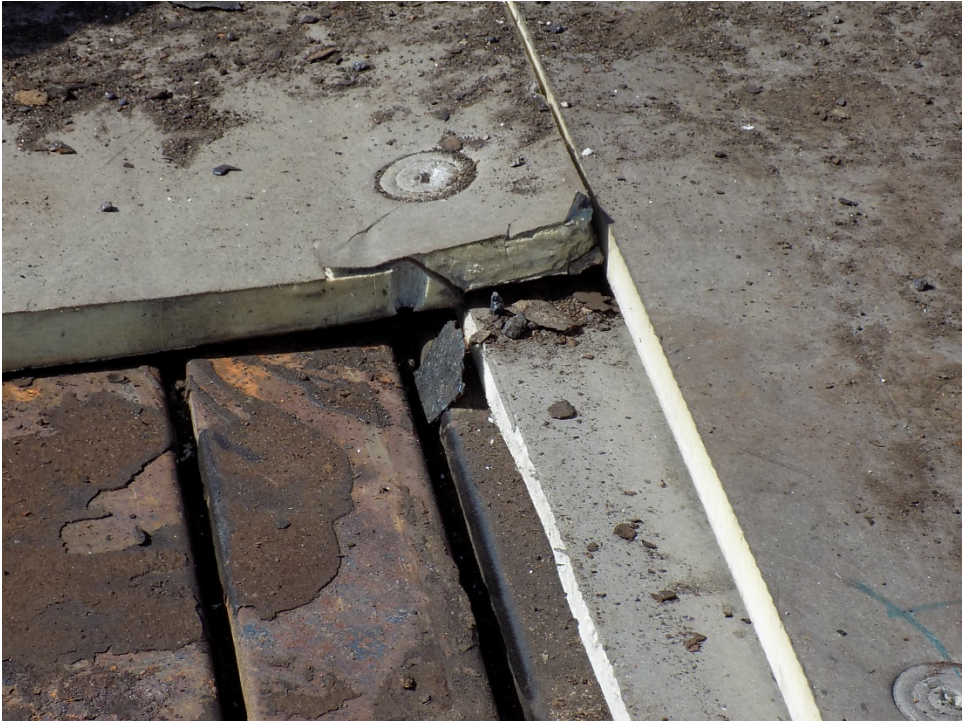
Figure A-22

12. Insulation panels spanned over open space between the metal roof deck and shim pieces – attempt to create a roof surface slope while accommodating for missing tapered panels (Figures A-22 and A-23).

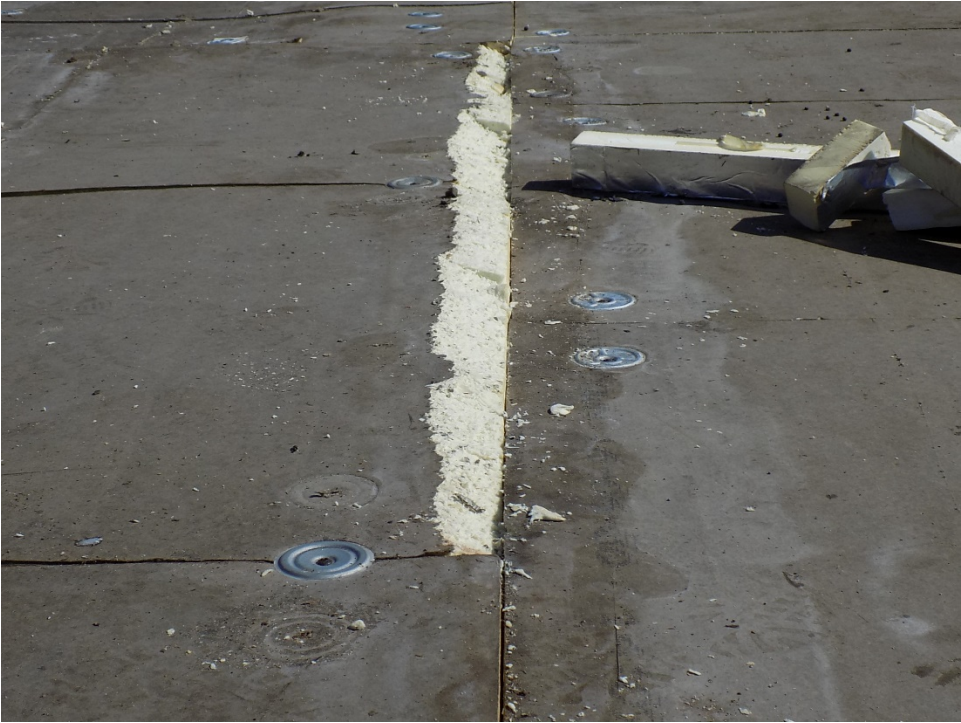
Figure A-24

13. Insulation panels installed with a bevel cut along panel edges – attempt to accommodate for missing tapered panels (Figure A-24).
14. Insulation panels installed with uneven edges resulted in roof surface elevation change between adjacent panels (Figures A-25 and A-26).

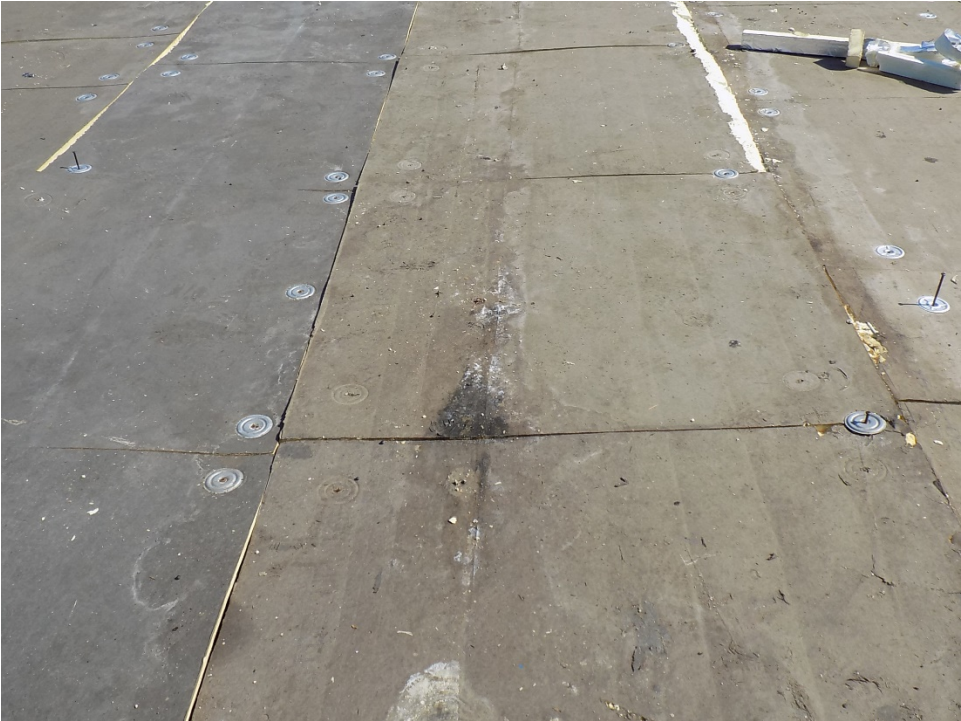
Figure A-27

15. Water staining on insulation panel surfaces indicative of moisture intrusion (Figures A-27 and A-31).
16. Excessive distance between roof perimeter and first row of roof system fasteners (Figures A-28 and A-29).

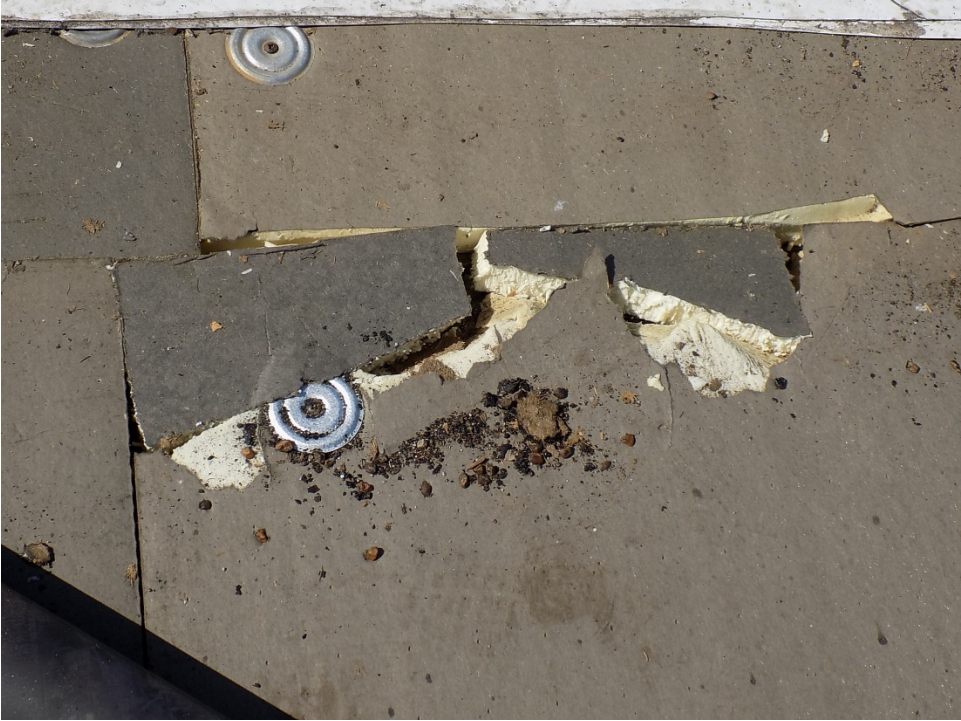
Figure A-30

17. Gaps between insulation panels filled with scrap pieces of roof insulation (Figure A-30).
18. Corrosion of insulation panel fasteners indicative of moisture intrusion (Figure A-31).

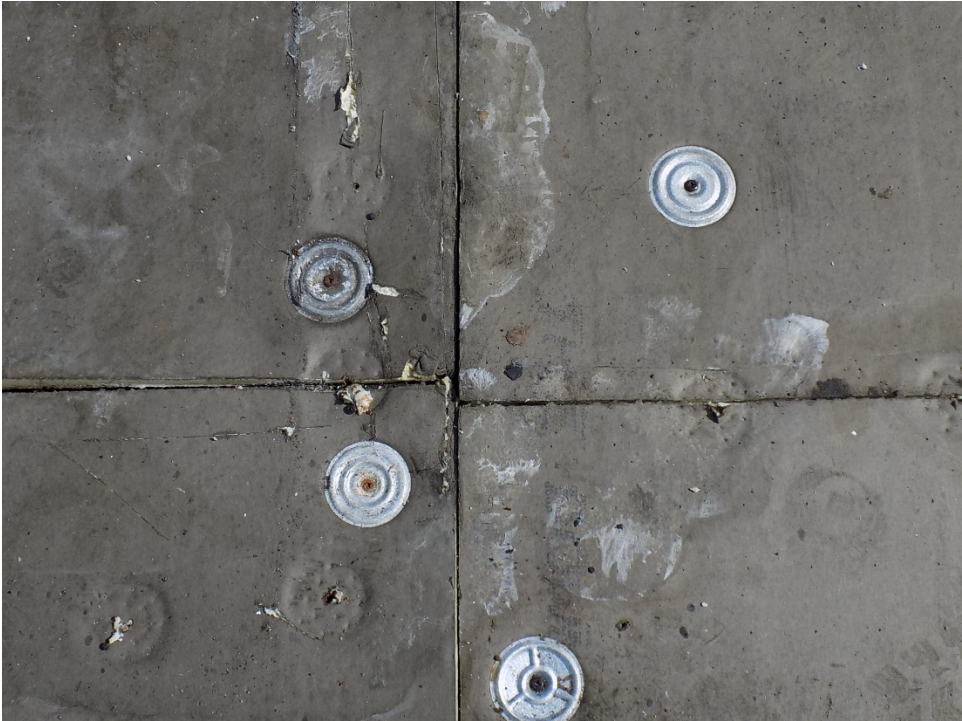
Figure A-31

19. Moisture related deterioration of insulation panels (indicative of moisture intrusion) (Figure A-31).
20. Board segments used as shims as an attempt to create a roof surface slope while accommodating for missing tapered panels (Figure A-32).

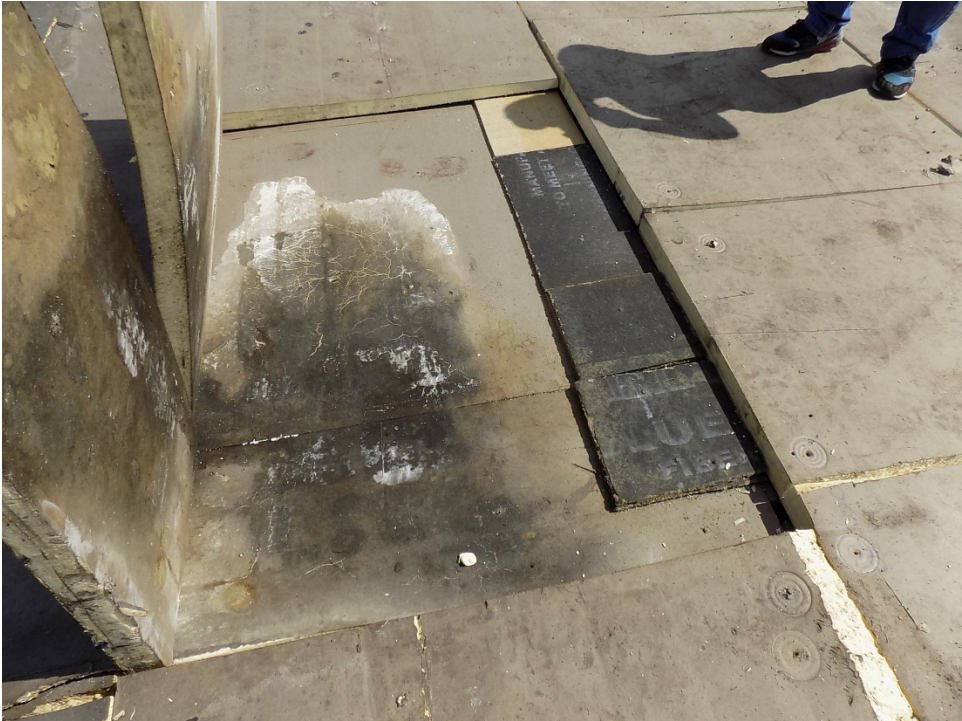
Figure A-32

21. Moisture related staining and deterioration of insulation panels under the top layer of insulation panels (indicative of moisture intrusion) (Figure A-32).

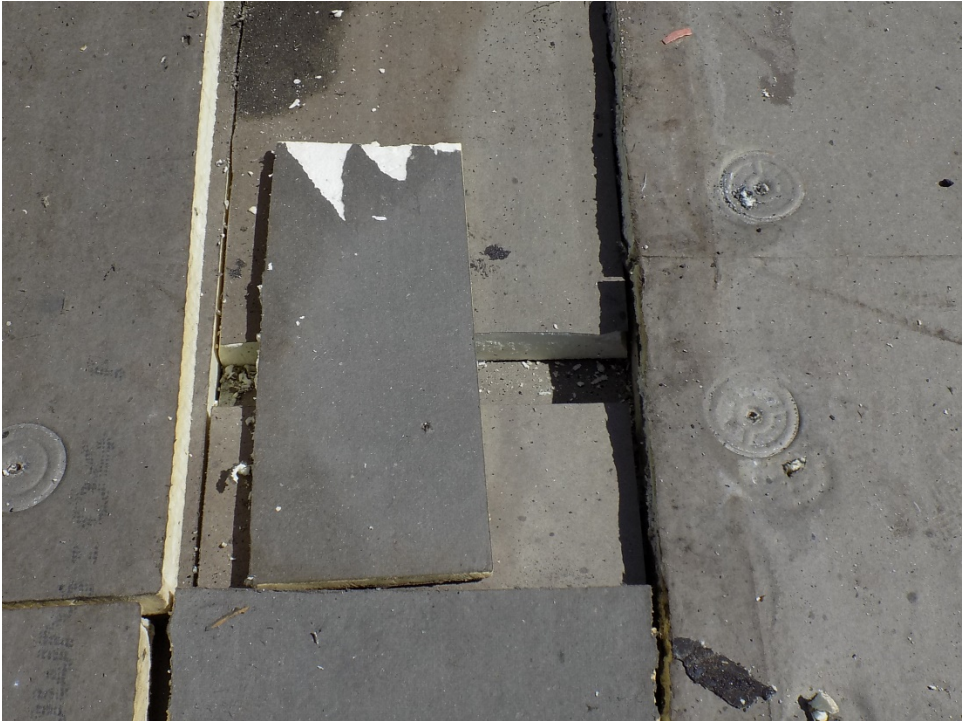
Figure A-33

22. Insulation panel segment used to bridge over large gap between underlying insulation panels (Figure A-33).

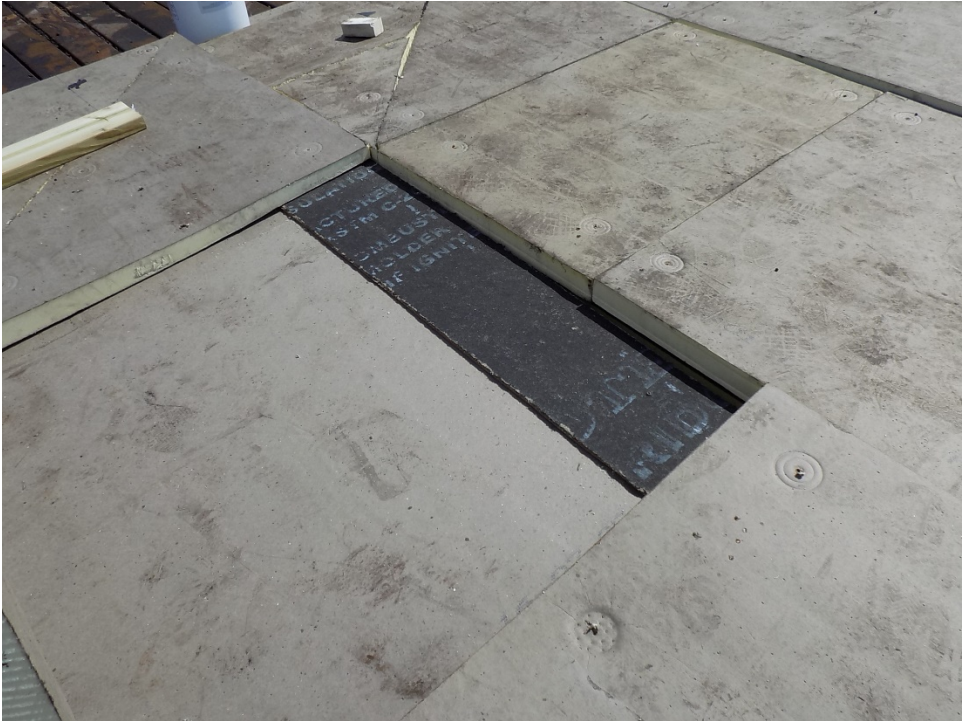
Figure A-34

23. Insulation panels spanned over open space between underlying insulation panels and shim pieces – attempt to create a roof surface slope while accommodating for missing tapered panels (Figure A-34).
24. Board and insulation panel shims along roof perimeter (Figures A-35 and A-36).
25. The existing expansion joint utilized tapered wood blocking over older flat wood blocking. Wood segments were utilized within the expansion joint space to fasten the tapered wood blocking, thus reducing the expansion joint's ability to contract during temperature changes (Figure A-37).
