CITY OF NEW PORT RICHEY

FINAL REPORT

WATER RECLAMATION FACILITY GRAVITY MAIN CONDITION ASSESSMENT

APRIL 2020

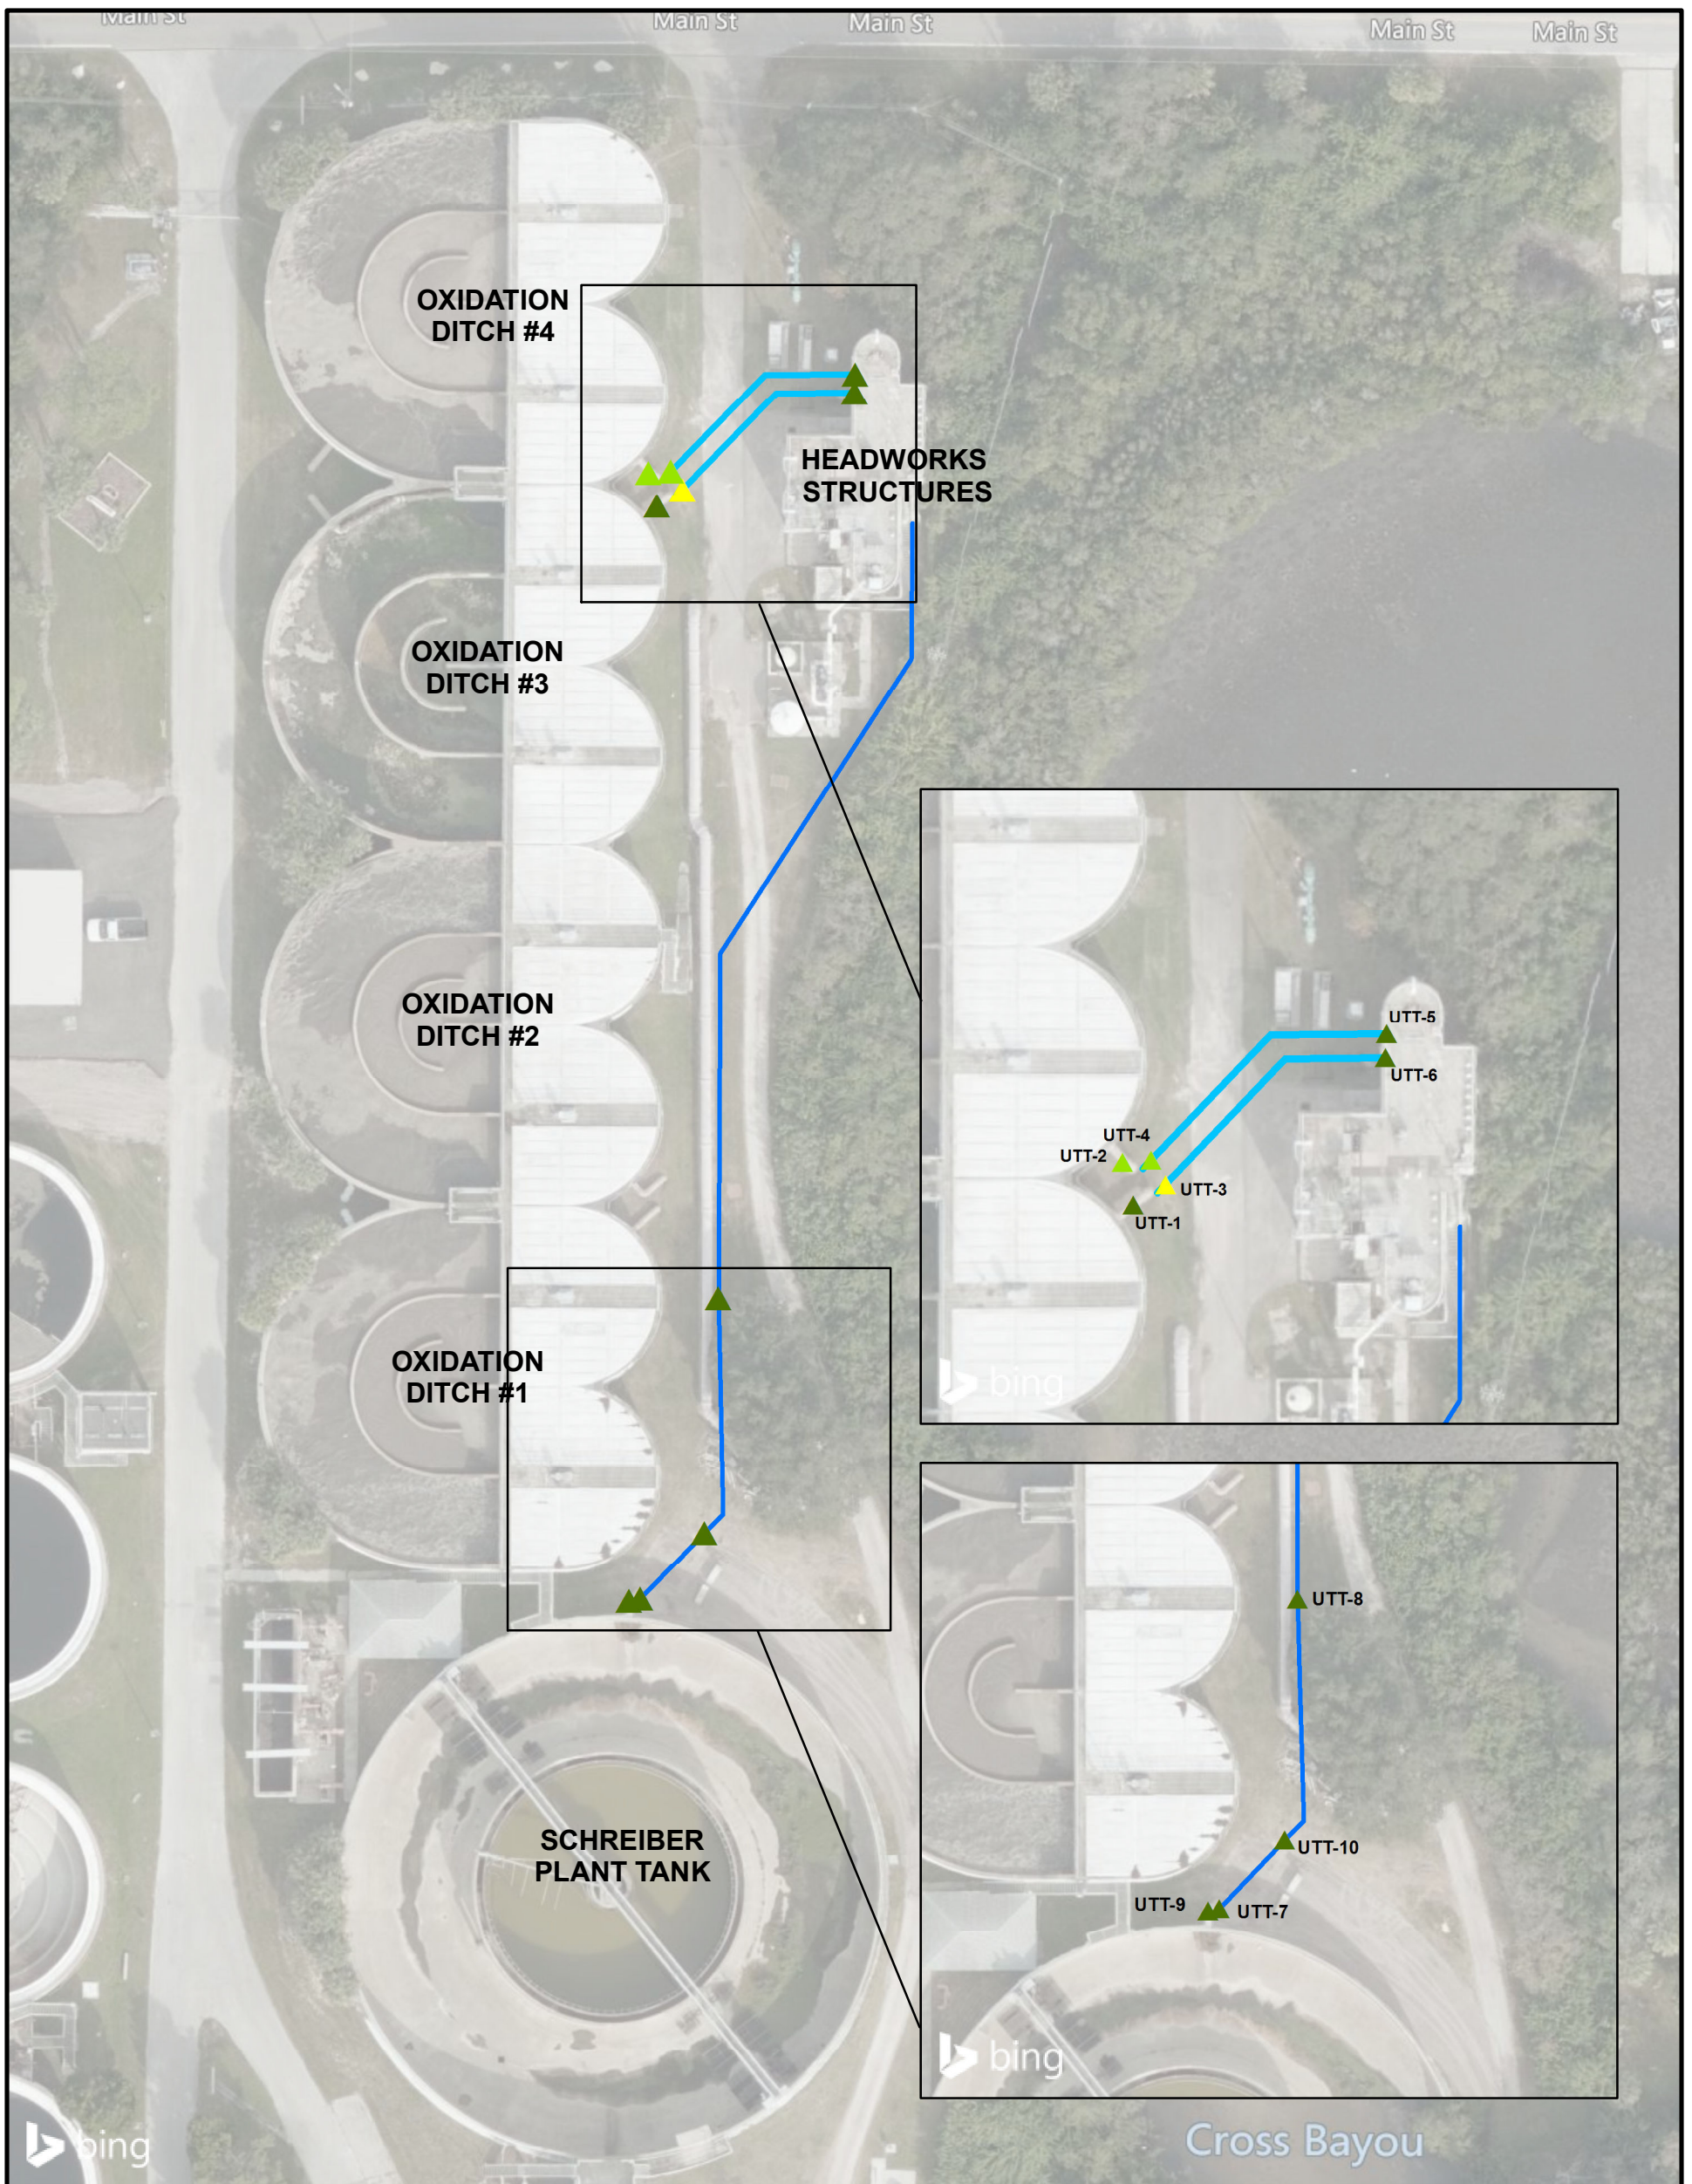
The results of the three (3) gravity main assessments are presented below. The results are also summarized and presented graphically on **Figure ES-1**.

1. The UTT data collected for DI pipe segments from the headworks structures to Oxidation Ditch #3, Oxidation Ditch #4, and the Schreiber Plant all indicate that current pipe wall thicknesses all meet or exceed a minimum pressure rating of 250 psi.

2. The UTT results at UTT-3 and UTT-4 for the below-grade pipe segments to Oxidation Ditch #3 and Oxidation Ditch #4, respectively, indicate a slight reduction in pipe wall thickness compared to the standard pipe wall thickness for a Class 51 DI pipe. No additional UTT were conducted for the below-grade pipe segments to Oxidation Ditch #3 or Oxidation Ditch #4; however, CCTV videos provided by the City adds additional evidence of some existing internal corrosion within these pipe segments.

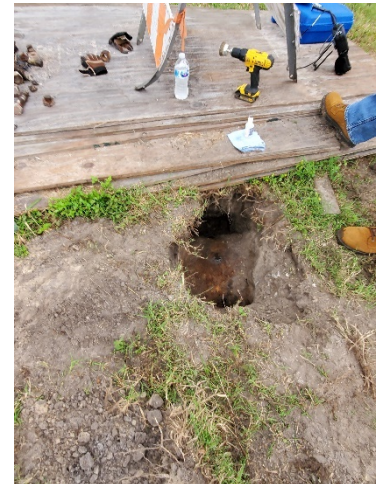
Figure 3-2: Exterior Pipe Corrosion.

6. Visual inspection during UTT showed signs of some exterior pipe corrosion (**See Figure 3-2**) at various locations for each gravity main pipe segment. It is unknown at this time whether this corrosion is due to contact between the pipe exterior and potentially corrosive soils, a high groundwater table, etc.
7. In summary, it was observed that below grade pipes were slightly corroded, whereas the above grade pipes did not show evidence of corrosion.

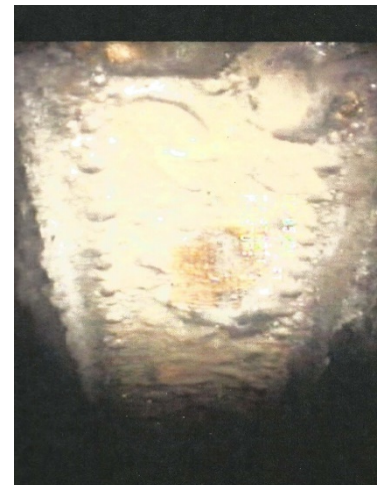
Figure 3-3: Interior Pipe Corrosion.

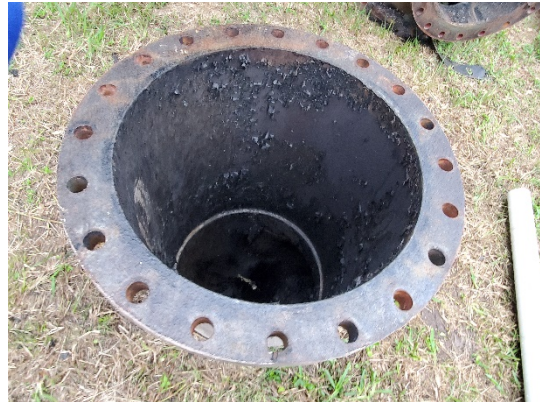
Figure 4-2: Interior Pipe Lining Deterioration.

- **Option 3 – Rehabilitation of two (2) 24-inch DI gravity main pipe segments via replacement of CIPP lining while maintaining active operation of at least one (1) 24-inch gravity main to either Oxidation Ditch #3 or Oxidation Ditch #4.** This option consists of replacement of the existing CIPP lining for the two (2) 24-inch DI gravity main pipe segments. One (1) constructability concern associated with this option includes installation of a CIPP lining in a gravity main with fittings, as this is atypical and can present risks of failure due to improper installation, though it has been discussed with and indicated by Layne, a CIPP lining company, that lining a main with fittings is possible and can be completed without an increased risk of failure. The two (2) pipe segments showed minor indications of pipe wall thickness reduction and some exterior corrosion and although these results are not indicative of an increased risk of failure, these pipes were installed in 1993 and the original lining has been worn and should be replaced.

- **Option 4 – Rehabilitation of one (1) 20-inch DI gravity main pipe segment from the headworks structures to the Schreiber Plant.** This option consists of replacement of the existing CIPP lining for the 20-inch DI gravity main pipe segment. Rehabilitation of the 20-inch gravity main would not require any interruptions to service, as this pipe is typically not active and is only used for wet-season overflows. This pipe segment did not show any indication of pipe wall thickness reduction; however, the pipe was installed in 1988 and the original liner has likely worn and is due for replacement.

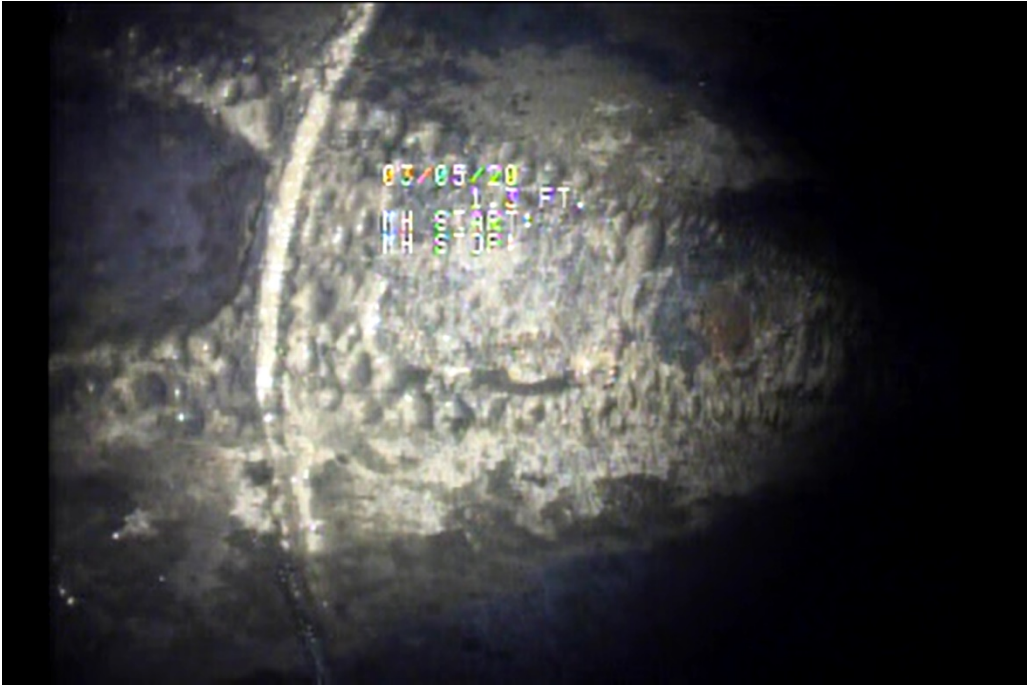
Figure B-2: Degradation of Interior Pipe Wall.

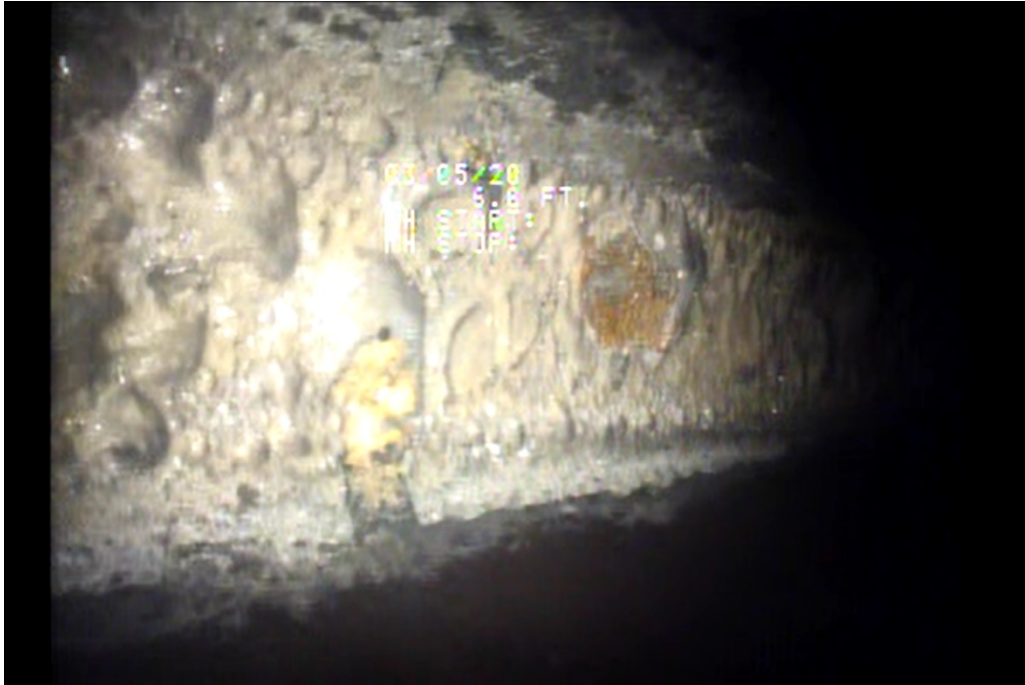
Figure B-3: Interior corrosion and 'caking' of solids.

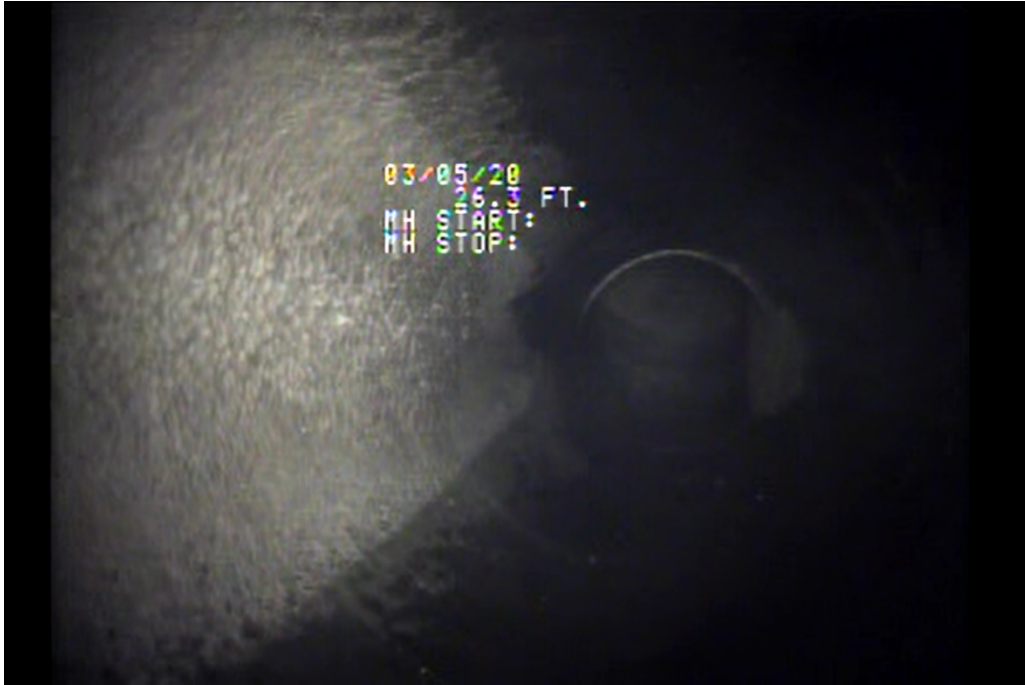
Figure B-5: White Film or 'Sheen' at Top of Pipe (left).

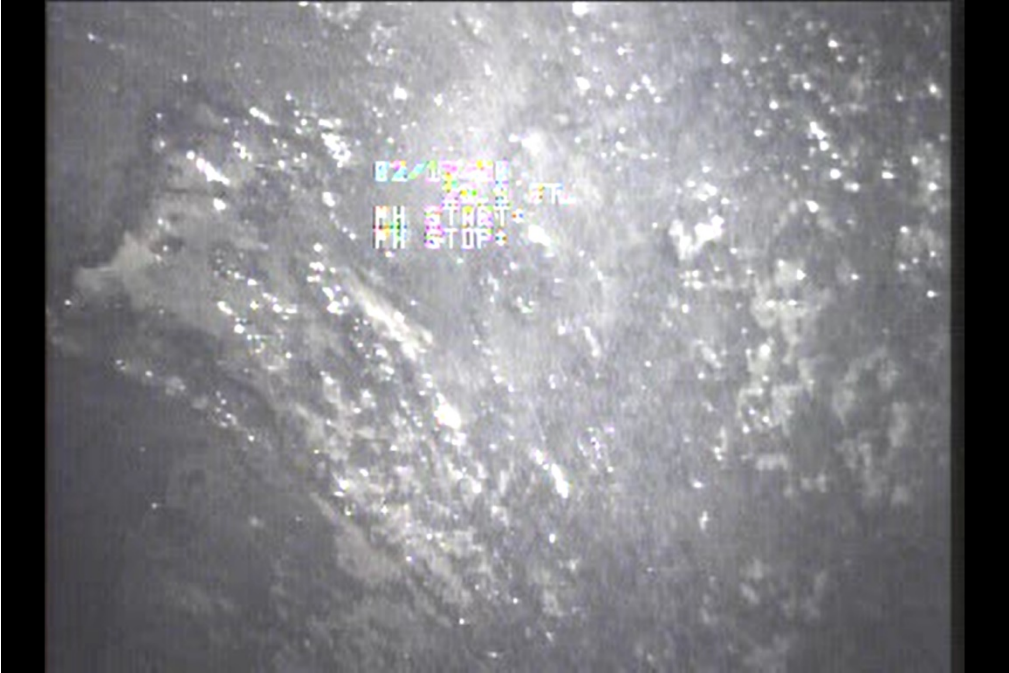
Figure B-7: Closeup on condition of 24-inch gravity main pipe interior.

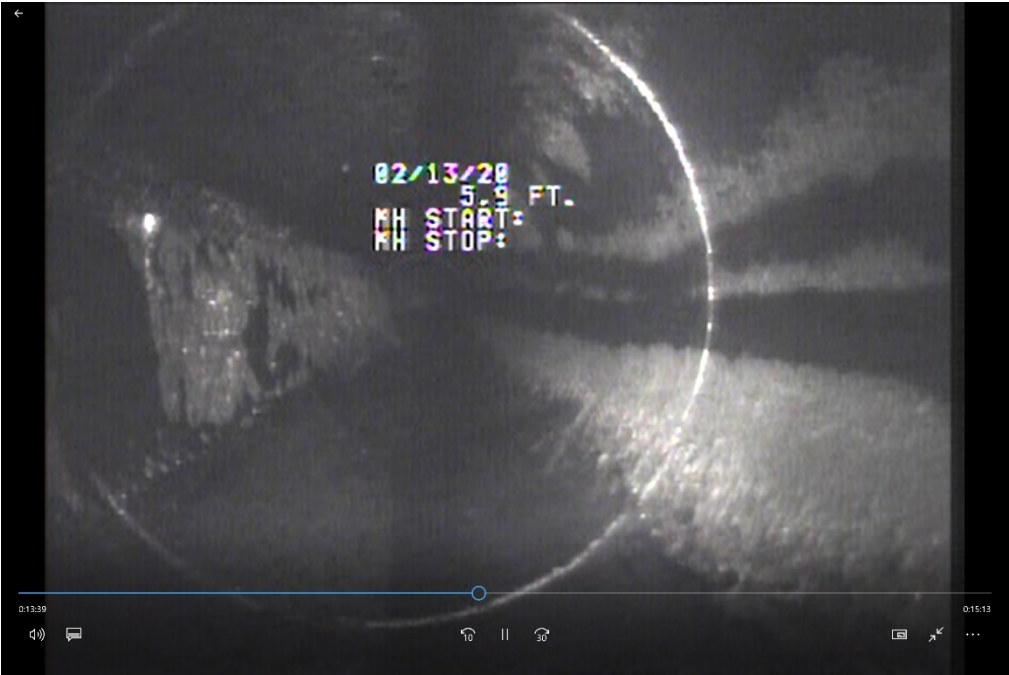
Figure B-8: White Film or 'Sheen' at Top and Bottom of Pipe (left and right).

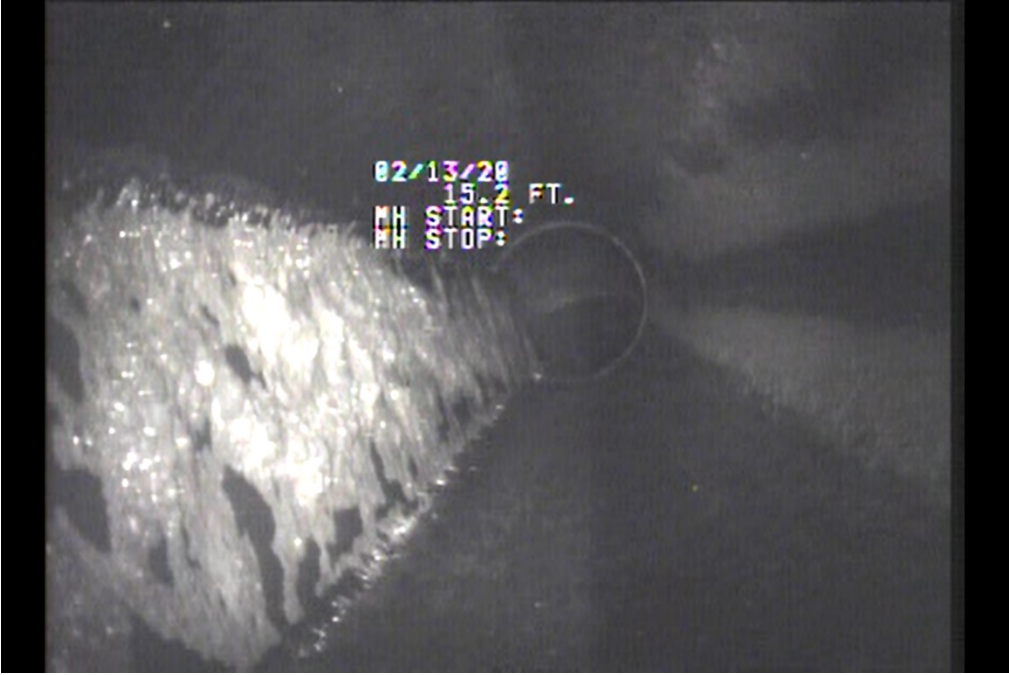
Figure B-9: Consistent White Film or 'Sheen' at Top and Bottom of Pipe (left and right).

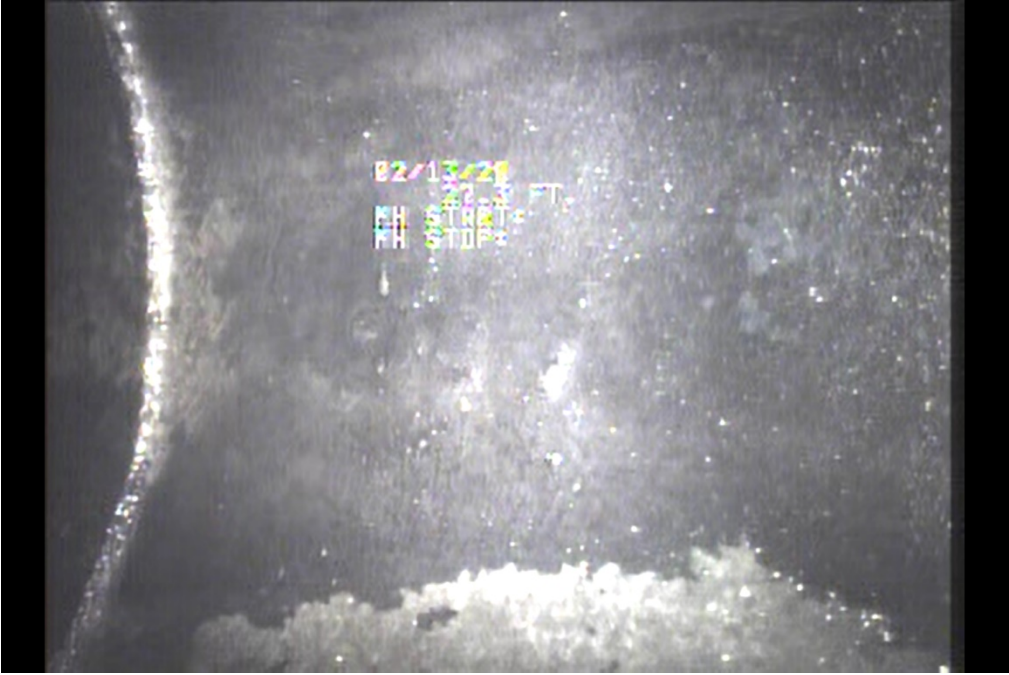
Figure B-10: Closeup of Impacts to Pipe Interior

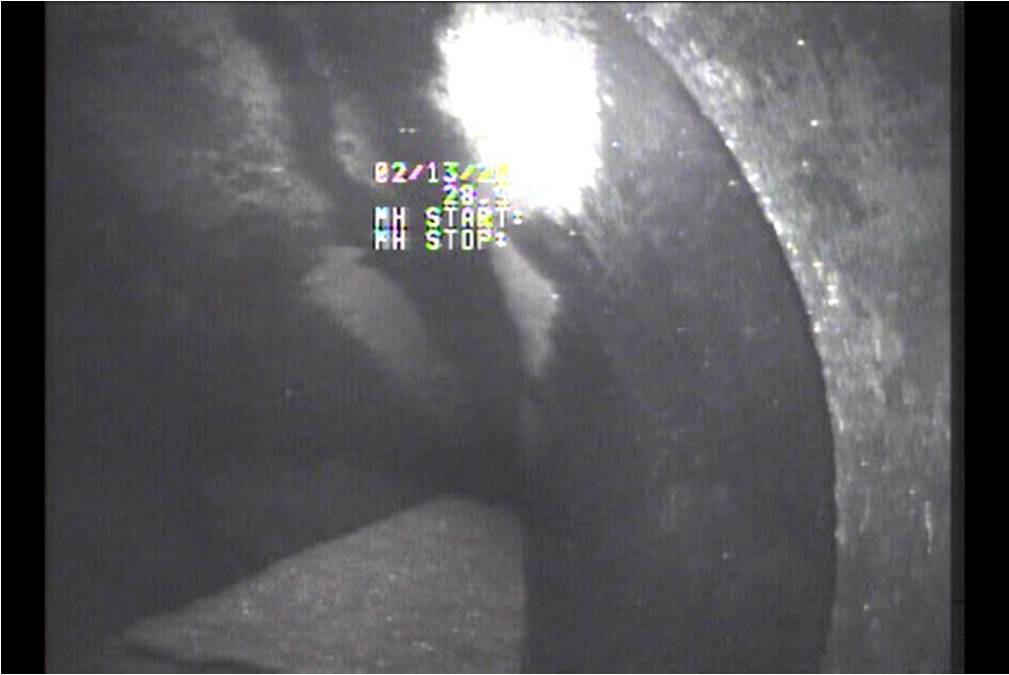
Figure B-11: Additional Pipe Wear Along Gravity Main.

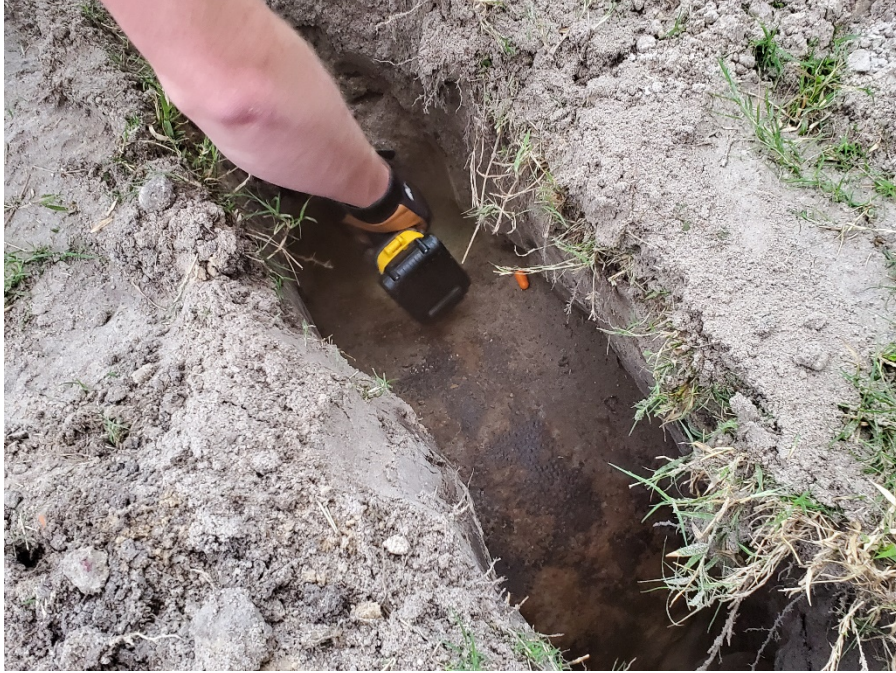
Figure C-3: Oxidation Ditch #3 Below-Grade Piping (UTT-3)

3. The UTT results at UTT-3 and UTT-4 for the below-grade pipe segments to Oxidation Ditch #3 and Oxidation Ditch #4, respectively, indicate a pipe wall thickness slightly lower than the standard pipe wall thickness for a Class 51 DI pipe. CCTV videos provided by the City adds additional evidence of some existing internal corrosion within these pipe segments (**See Appendix B**).

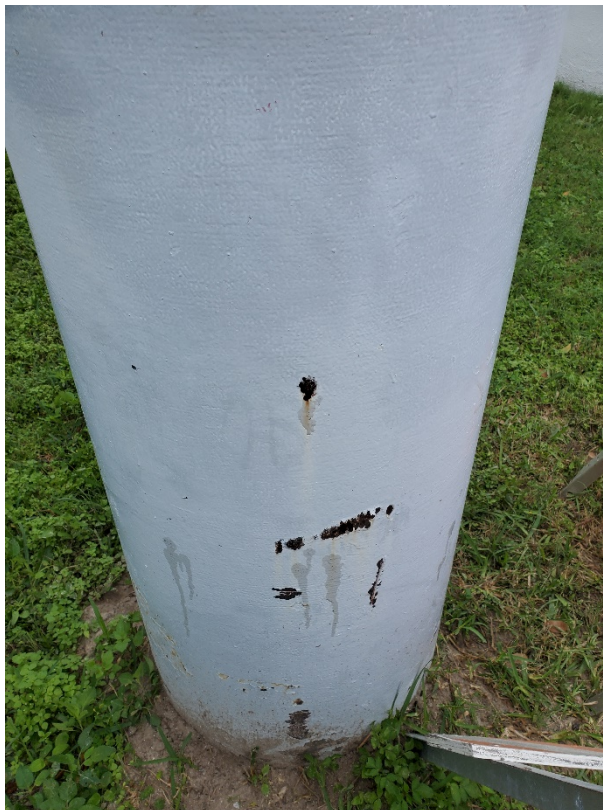
Figure C-8: Schreiber Plant Above-Grade Pipe Exterior Corrosion.
