Steel Potable Water Reservoir Inspection Report

Job Number: 55313b

Utility: New Port Richey WTP

Tank: Elevated

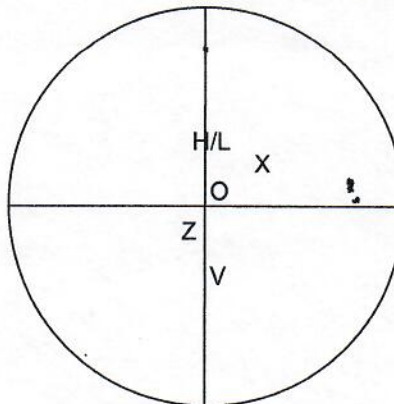
Sediment Depth Measurements

Avg. Depth 1/8" Cubic Yardage N/A Sediment Type Iron manganese
