CITY OF NEW PORT RICHEY CITY HALL HVAC ANALYSIS

NEW PORT RICHEY, FL

Prepared by:

March 23, 2022

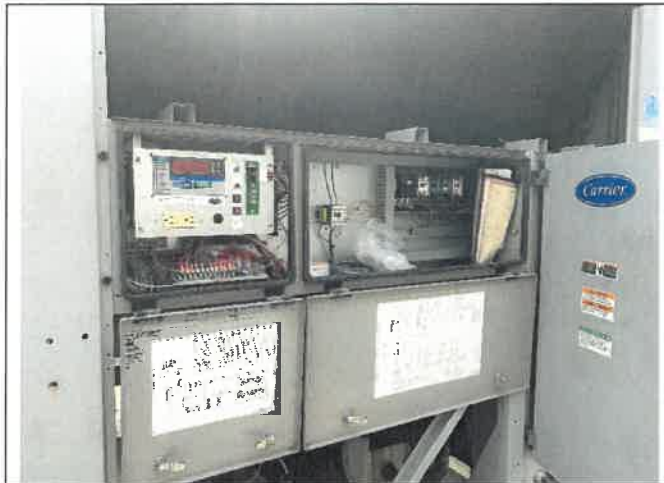
There are a variety of different controls manufacturers and types located throughout the facility. We would recommend that the control system be replaced and a new Direct Digital Control (DDC) control system be installed to operate the systems in an efficient manner. ABC controls is recommended to be installed in an effort to match the rest of the existing controls commonly installed in the city's facilities.

Photo 1 – Chiller Controls

Recommend Control System for replacement. Replacement to include a new Direct Digital Control (DDC) control system of the same manufacturer as currently found in other existing city facilities.
Construction Cost Estimate: \$100,000

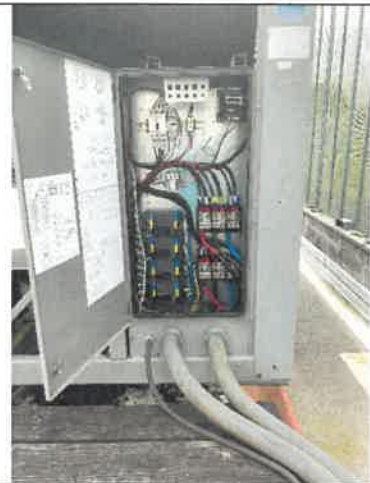
Photo 2 – Chiller Controls

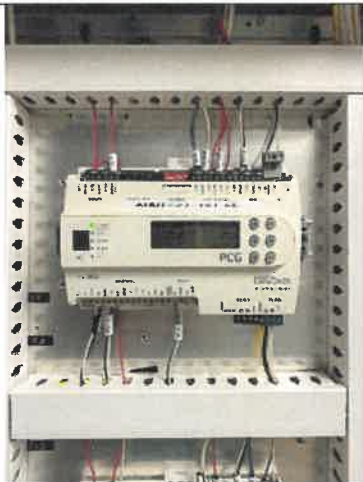
Photo 3 – AHU-1 Controls

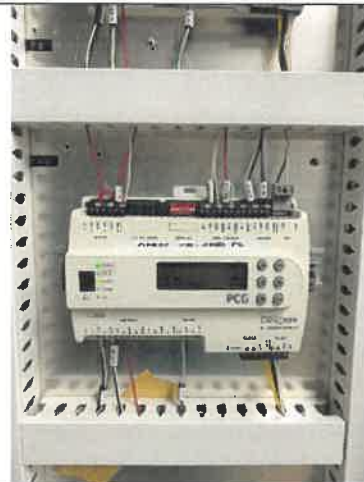
Photo 4 – AHU-2 Controls

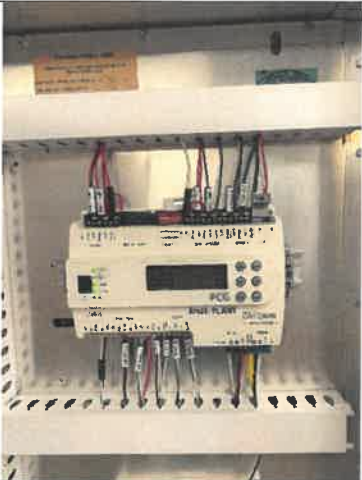
Photo 6 – AHU-3 Controls

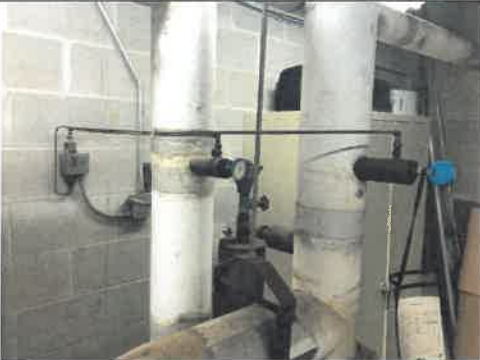
Photo 9 – Pneumatic Controls

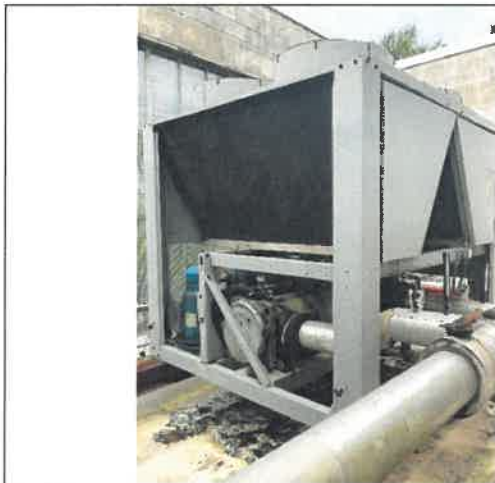
It appears that the original air-cooled chiller was replaced with a new 76-ton air-cooled chiller in 2007. This unit is now fourteen (14) years old and rapidly approaching the end of its anticipated life span. We do understand that two compressors were replaced in early 2019 which may allow the unit to last a little longer, but that additional added lifespan cannot be determined.

Photo 1 – Existing Chiller

Based on the limited life expectancy left with the system and the other issues detailed above we would recommend that the chiller be replaced. This includes all piping, valves, and support systems within the chiller enclosure.

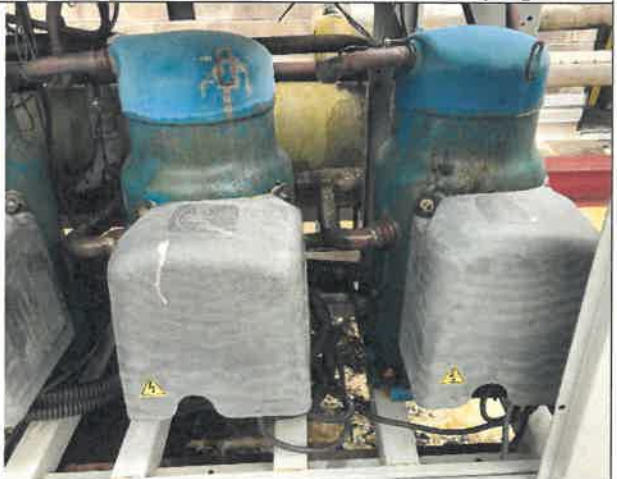
Photo 6 – Replaced Compressors

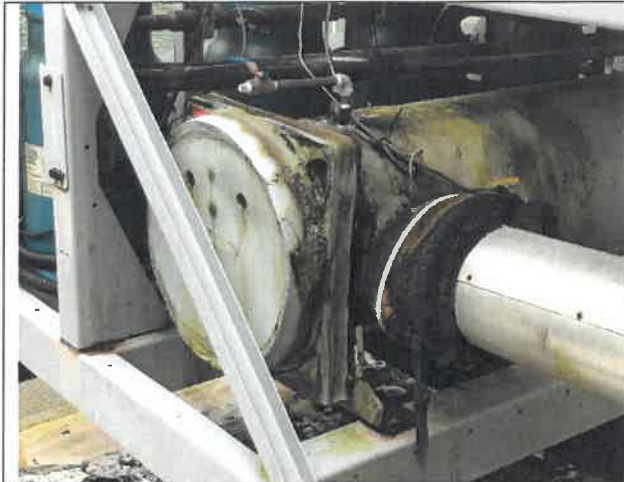
The existing insulation at the chiller is compromised. (Photos 9-11) This has an impact on the efficiency of the systems. In addition, this has led to condensation which has had an adverse impact on the chillers support system. (Photo 13). Existing valves at the chiller appear to be in poor condition and may not function properly (Photo 12). The coil fins are dirty and there is minor damage at the fins which can cause a degradation to the efficiency of the system (Photos 7-8). There is the ability to comb the fins and clean the coils to remedy these issues. These items are normal wear and tear and are expected. There is an existing annual maintenance period which focuses on coil cleaning. This annual maintenance period is due to happen shortly after the survey of the equipment.

Photo 9 – Existing Chiller Insulation

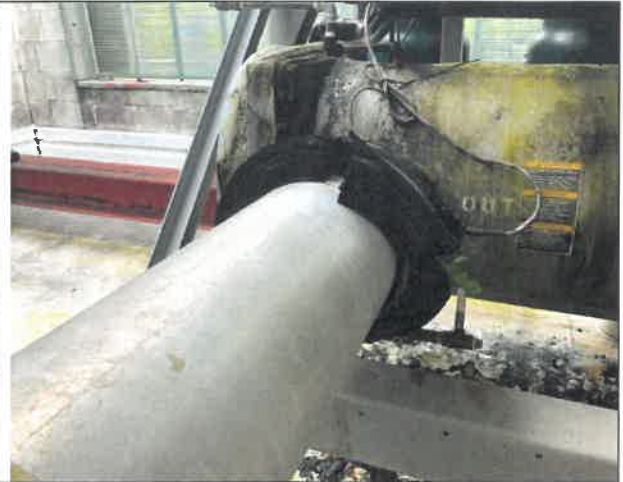
Photo 10 – Existing Chiller Insulation

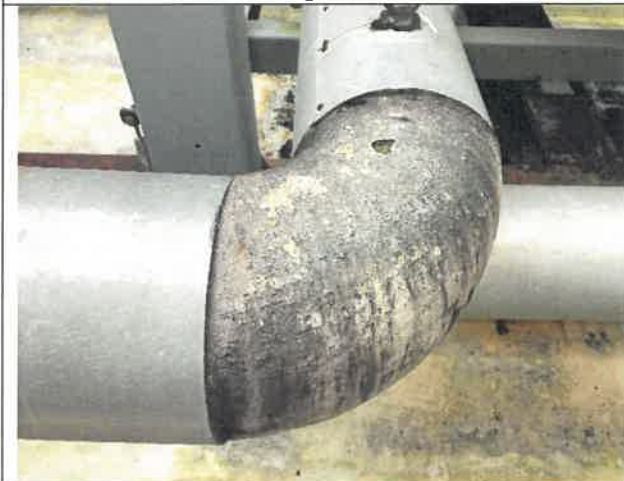
Photo 11 – Missing CHWP Jacketing

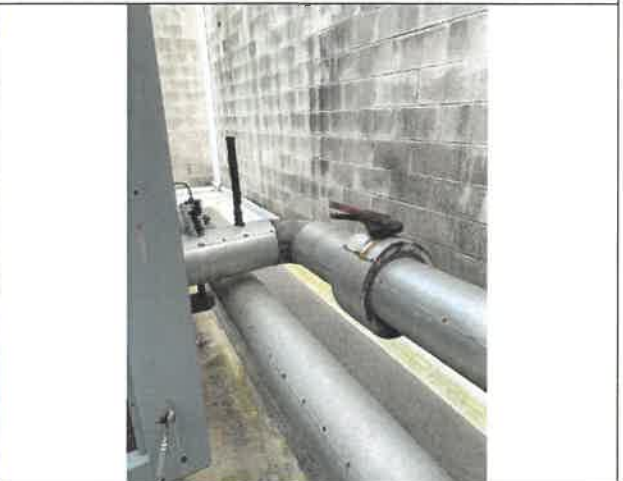
Photo 12 – Isolation Valve Condition

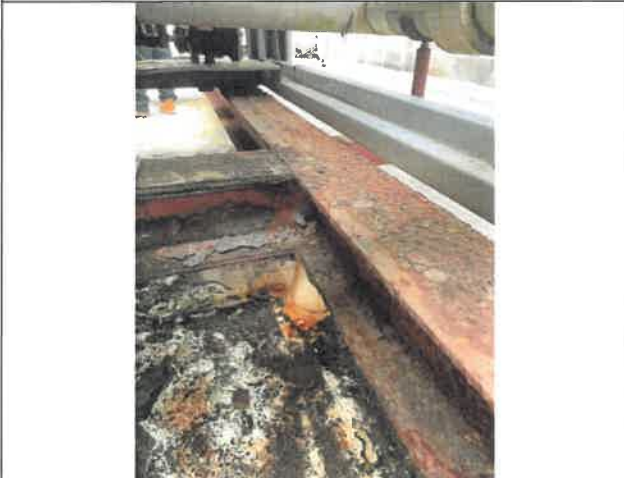
Photo 13 – Deteriorated Chiller Support

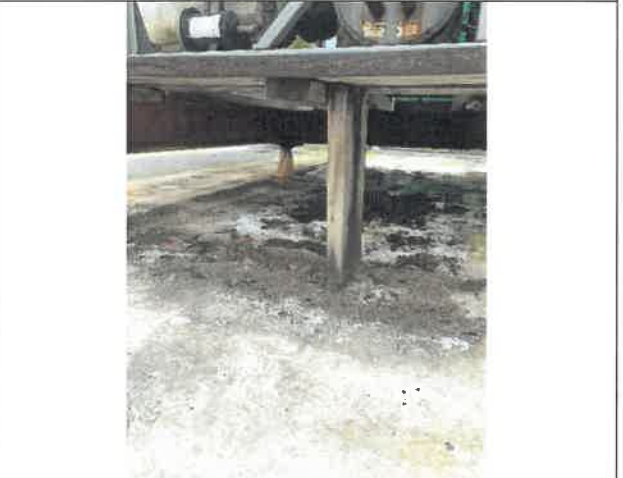
Photo 14 – Existing Roof Drain Condition

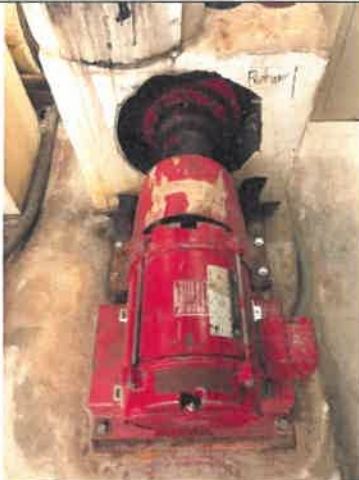
Some of the controls located at the pump are pneumatic and should be considered to be replaced. The motor on Pump 2 appears to be a newer motor than the motor on pump 1. There appears to be some rust that is forming on the unit but they are still operational.

Photo 1 – Existing Chilled Water Pump #1

Based on the limited life expectancy left with the system and the other issues detailed above we would recommend that the pumps be replaced. The pumps are also constant volume and not on a variable speed control. VFD's should be added to the new pumps.

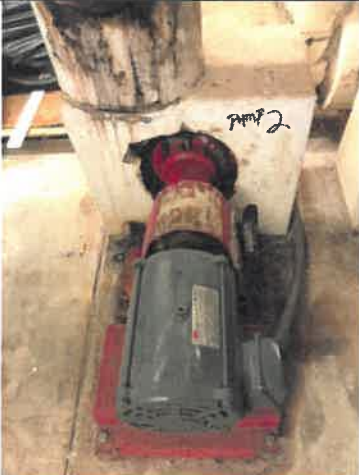
Photo 3 – Existing Chilled Water Pump #2

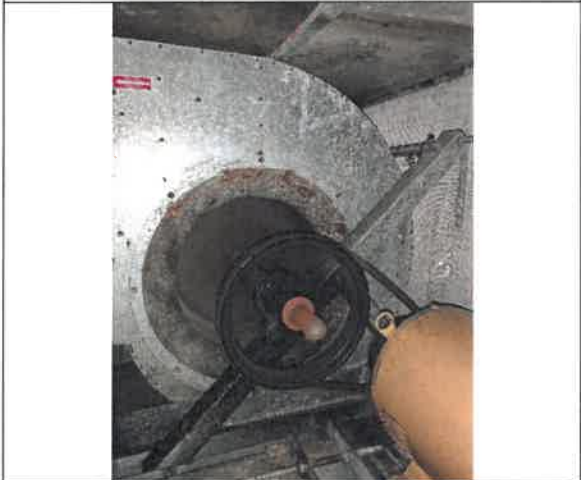
The existing chilled water coil located within the air handling appears to be in average condition, while the belt driven fan is beginning to show signs of rust and deterioration.

Photo 5 – Supply Fan

Based on our observations we would recommend that the unit and ductwork within the mechanical room be replaced.

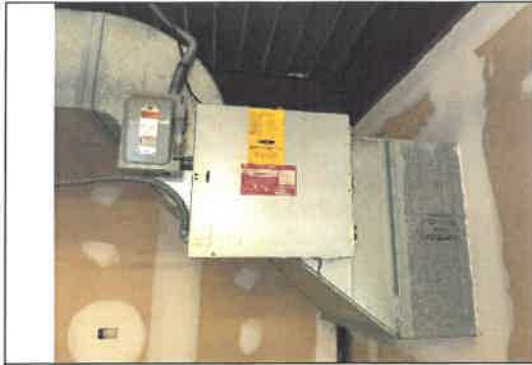
The electric duct heater located in the outside air ductwork is fed from an electrical disconnect that is located in the off position. This observation likely does not impact the building operations in a negative fashion. The facilities team has stated they are aware of this condition and regularly exercise the equipment during the winter season to maintain operation for emergency conditions.

Photo 9 – Electric Duct Heater

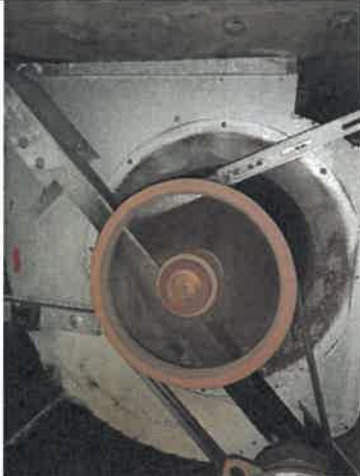
The existing chilled water coil located within the air handling appears to be in average condition but it is dirty and the belt driven fan is beginning to show signs of rust and deterioration. During the time of the site visit there was over an inch of standing water in the drain pan.

Photo 5 – Supply Fan Condition

Based on our observations we would recommend that the unit and ductwork within the mechanical room be replaced.

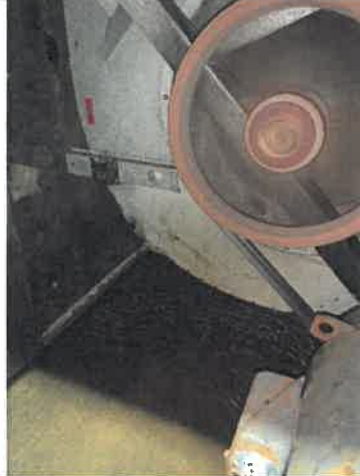
The supply and return air ductwork within the mechanical room is internally insulated and is showing some signs of age. Without testing it is impossible to know, but there appears to be microbial growth within the internal ductwork lining. This hazard level of the growth cannot be known until testing is conducted. It is recommended that testing be immediately performed to determine the exact nature of the growth. Turning vanes in the ductwork are limited to the supply air ductwork within the airside system that was observed. There is 12"x12" outside air ductwork connected to the system within the mechanical room.

Photo 6 – Insulation Condition

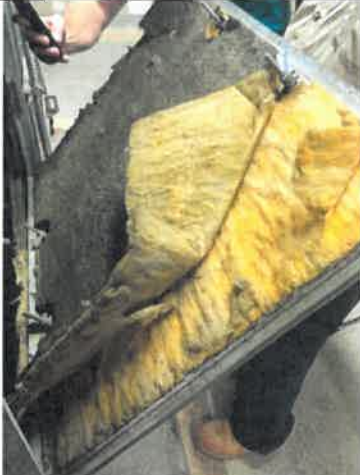
Photo 7 – Insulation Condition

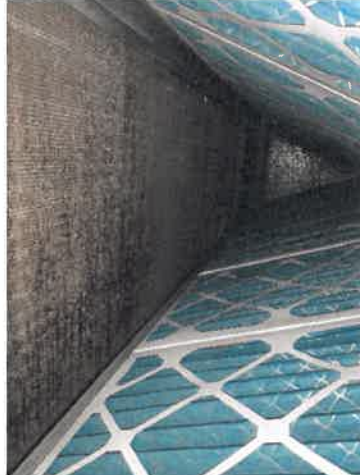
Photo 8 – Coil Condition

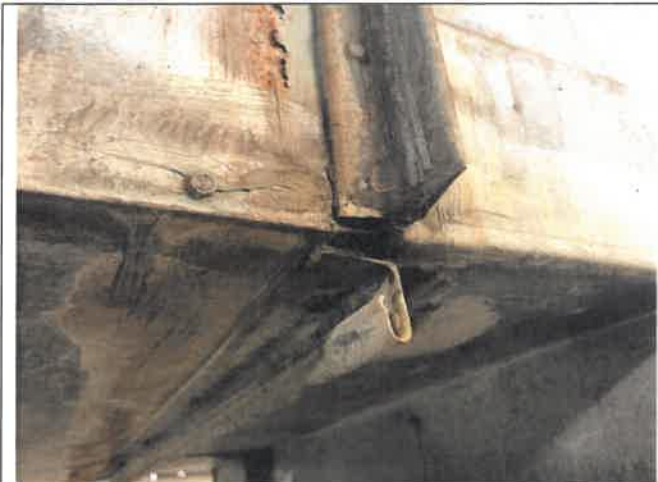
Photo 9 – Leaking Ductwork Seams

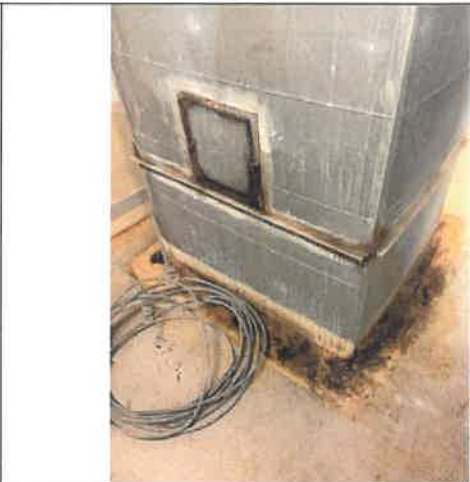
Photo 10 – Leaking Ductwork Seam

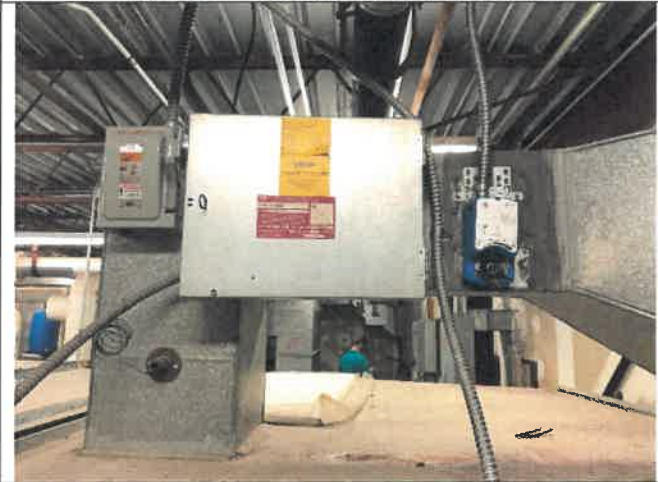
The electric duct heater located in the outside air ductwork is fed from an electrical disconnect that is located in the off position. This observation likely does not impact the building operations in a negative fashion. The facilities team has stated they are aware of this condition and regularly exercise the equipment during the winter season to maintain operation for emergency conditions.

Photo 11 – Electric Duct Heater

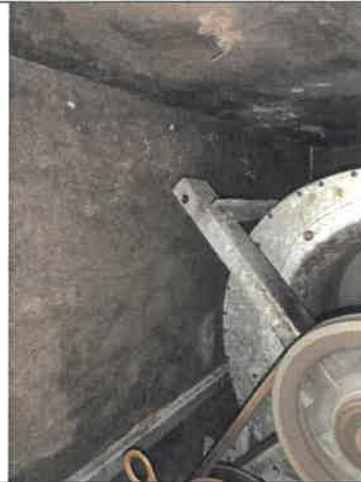
The supply and return air ductwork within the mechanical room is internally insulated and is showing signs of age. Without testing it is impossible to know, but there appears to be microbial growth within the internal ductwork lining. It is recommended that testing be immediately performed to determine the exact nature of the growth. Turning vanes in the ductwork is limited to the supply air ductwork within the airside system that was observed.

Photo 4 – Insulation Condition

Based on our observations we would recommend that the unit and ductwork within the mechanical room be replaced.

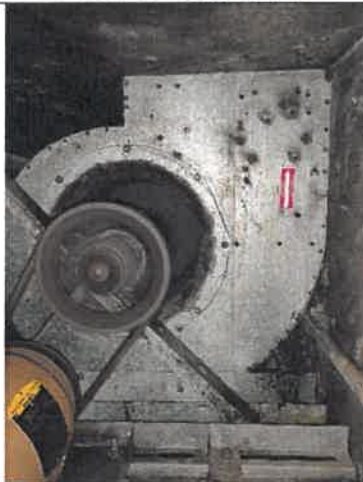
The existing chilled water coil located within the air handling appears to be in average condition and the belt driven fan is showing increased signs of rust and deterioration. There was some visible microbial growth within the unit, the exact substance was not tested to determine the specific type of growth. This hazard level of the growth cannot be known until testing is conducted. It is recommended that testing be immediately performed to determine the exact nature of the growth.

Photo 5 – Supply Fan Condition

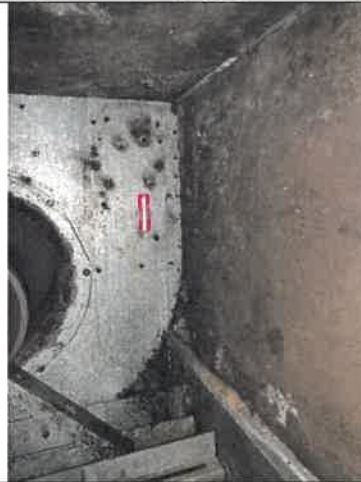
Photo 6 – Insulation Condition

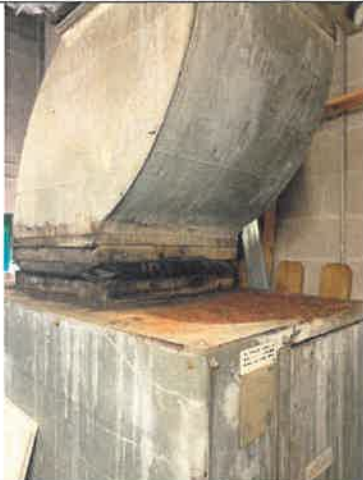
Photo 7 – Leaking Duct Seams

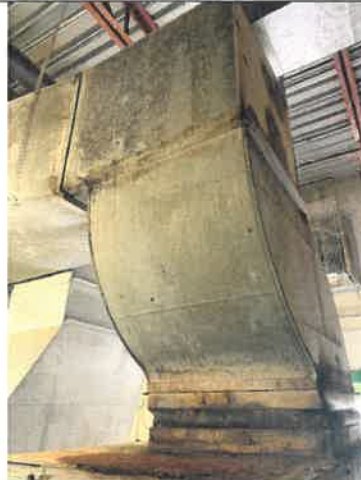
Photo 8 – Leaking Duct Seams

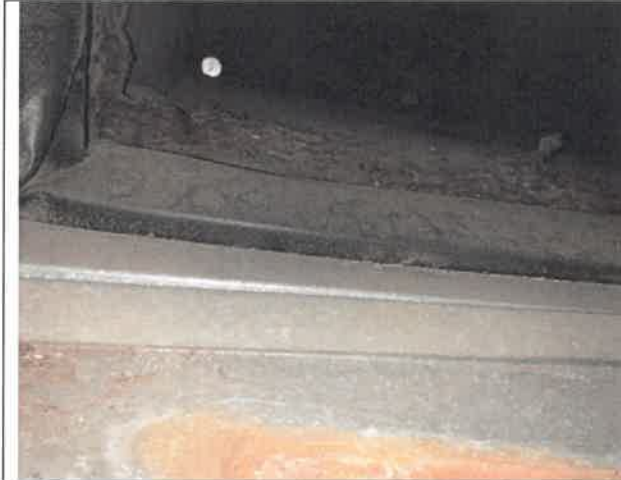
Photo 9 – Internal AHU-3

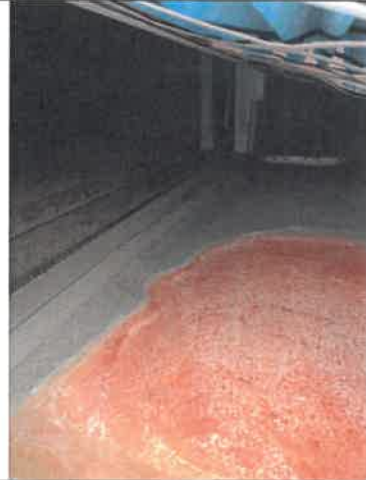
Photo 10 – Internal AHU-3

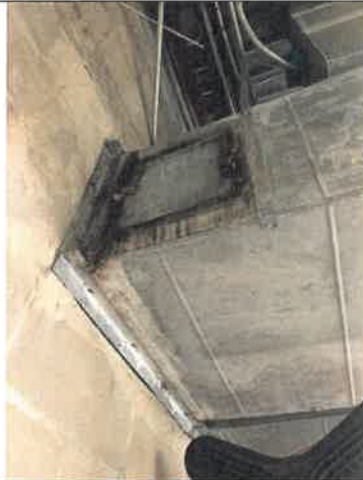
Photo 11 – Leaking Duct Seams

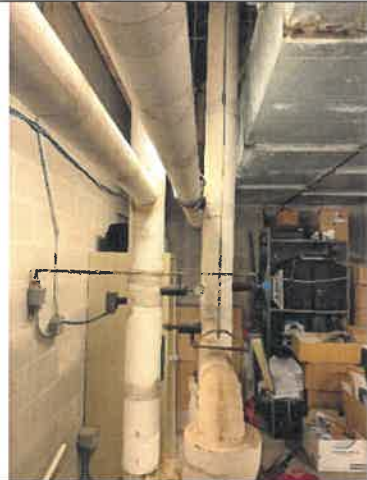
Photo 12 – Existing Pneumatic Controls

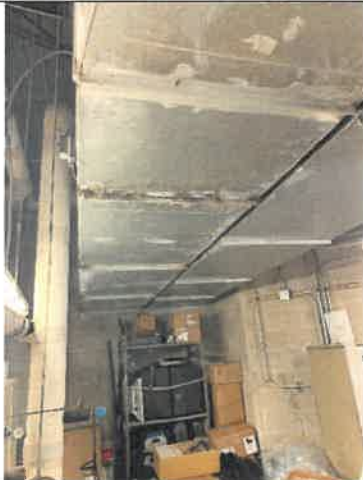
Photo 13 – Leaking Duct Seams

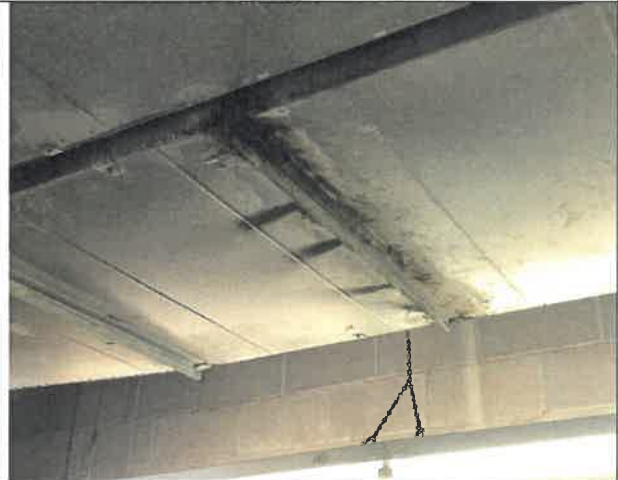
Photo 14 – Leaking Duct Seam

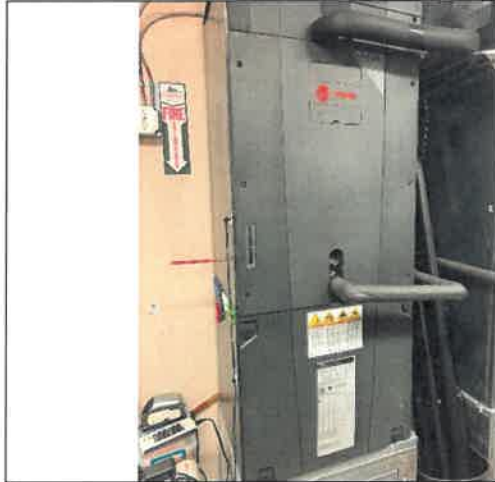
Based on the data provided these redundant direct expansion air handling units were installed in 2014 to serve Information and Technology spaces within the facility. It should be noted that these newly installed units are not integrated into the existing BMS. These units are in good condition and should remain in their current configuration.

Photo 1 – AHU-4

Do not recommend AHU-4 or AHU-5 for replacement. Integration of AHU-4 and AHU-5 into new BMS system would be recommended.

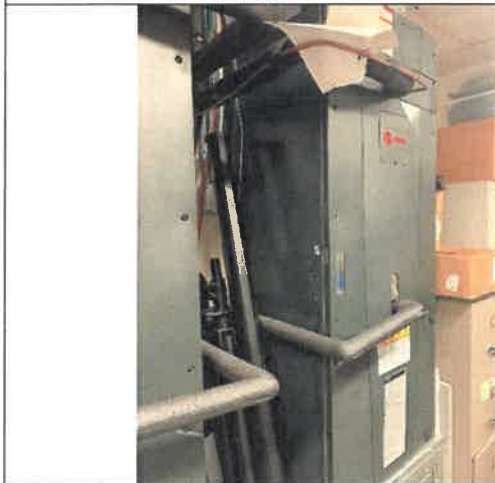
Photo 3 – AHU-5
