# CITY OF NEW PORT RICHEY PUBLIC WORKS AHU-2 HVAC ANALYSIS

NEW PORT RICHEY, FL

**VoltAir Consulting Engineers (VACE)** was requested to evaluate an existing HVAC DX Split system known as an air handling unit (AHU-2) located in Mechanical Room 127 at the City of New Port Richey (NPR) Public Works Building. This analysis involves a deficiency report based on the information gathered at the site visit conducted on Monday, June 26<sup>th</sup>, 2023.

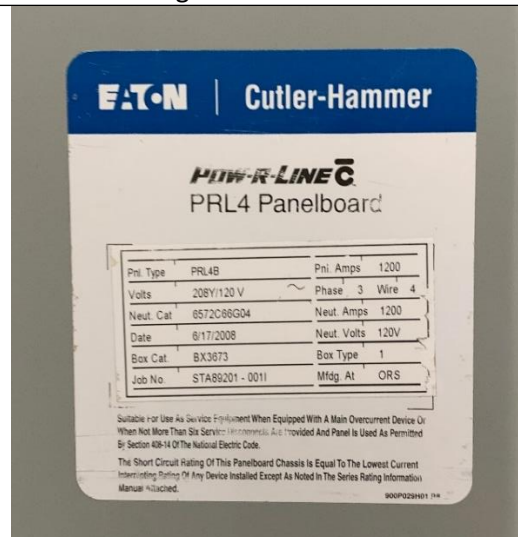
Figure 4 – Manufacturer's specification

The CU-2 (Breaker #12) and AHU-2 (Breaker #14) are receiving power from an Eaton PRL4B 208-volt 3 phase electrical panel (Shown in Figures 1-3). The manufacturing date shows as installed in 2008 when the building was originally constructed (Shown in Figure 4). It's located in Electrical Room 114 and it appears to be in good condition. At the time of the visit, there were no known signs of burning smell, flickering, nor frequent breaker trips.

It is recommended the breakers are replaced as required for the new equipment.

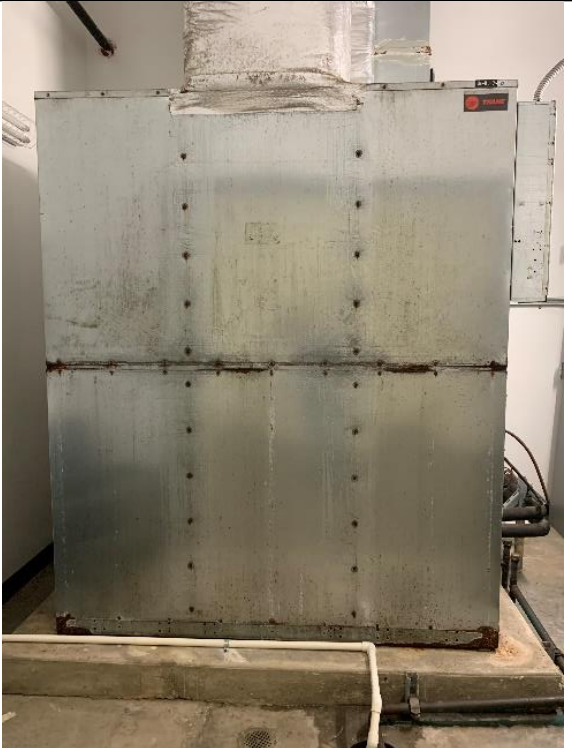
Figure 6 – AHU-2

AHU-2 and ductwork located in Mechanical Room 127 was installed during original construction in 2008. AHU-2 and the ductwork were found to be in poor condition during the site visit and is approaching the end of its useful life. Additionally, maintenance personnel informed history of service and replacements in the last 5 years including everything but actuators.

Based on observations VACE recommends AHU-2 and ductwork within the mechanical room be replaced. In addition, VACE recommends that the louver opened to the exterior be entirely sealed and the room be conditioned.
