# CITY OF NEW PORT RICHEY PARKS SEAWALL CONDITION ASSESSMENT REPORT

CITY OF NEW PORT RICHEY  
DEPARTMENT OF PUBLIC WORKS

STROUD ENGINEERING CONSULTANTS, INC.  
10503 Cyndee Lane  
Odessa, Florida 33556

June 2017

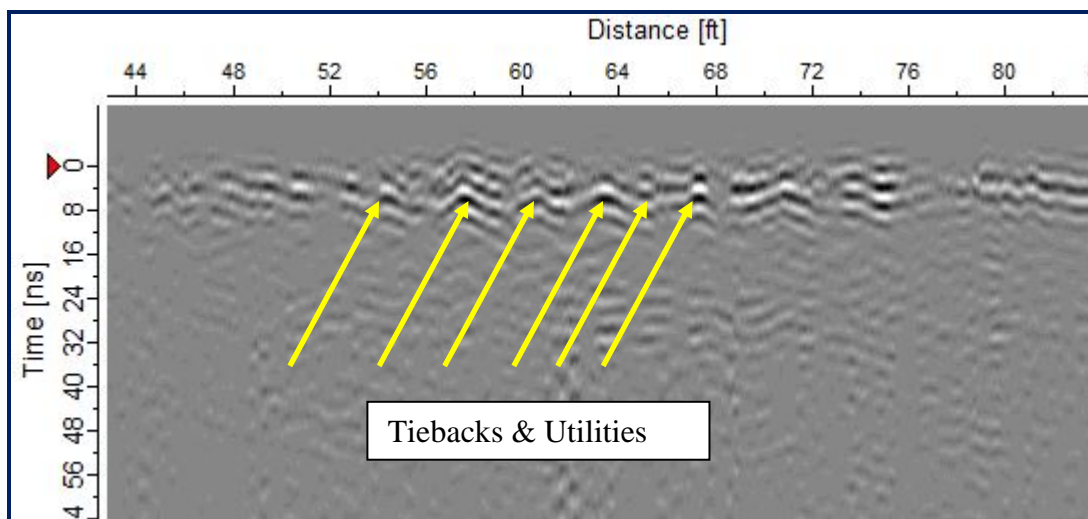
**Radargram 64 – Showing tiebacks and utilities on approximately three foot centers along the seawall at Jasmine Park.**
