CITY OF NEW PORT RICHEY CITY HALL HVAC ANALYSIS

NEW PORT RICHEY, FL

Prepared by:

March 23, 2022

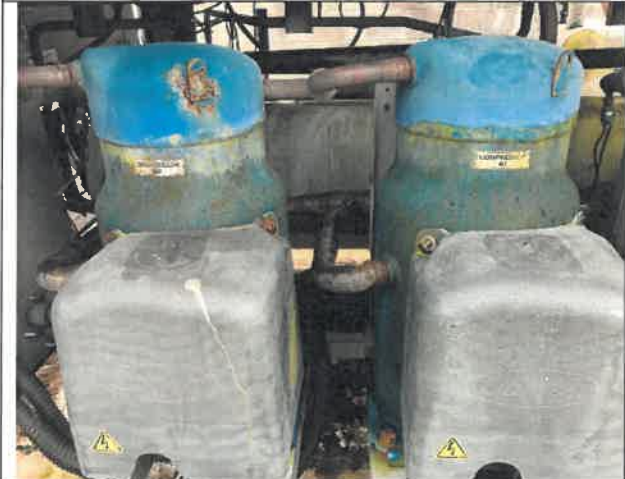
Photo 5 – Original Compressor A1 & A2

It appears that the original air-cooled chiller was replaced with a new 76-ton air-cooled chiller in 2007. This unit is now fourteen (14) years old and rapidly approaching the end of its anticipated life span. We do understand that two compressors were replaced in early 2019 which may allow the unit to last a little longer, but that additional added lifespan cannot be determined.

Based on the limited life expectancy left with the system and the other issues detailed above we would recommend that the chiller be replaced. This includes all piping, valves, and support systems within the chiller enclosure.

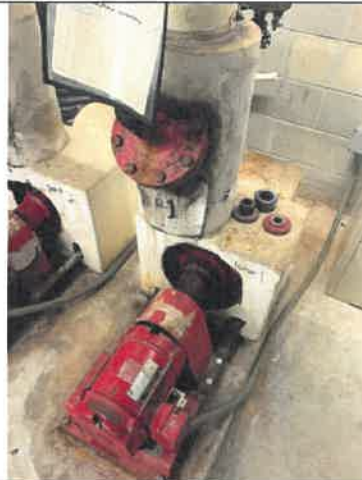
Photo 2 – Existing Chilled Water Pump #1

Some of the controls located at the pump are pneumatic and should be considered to be replaced. The motor on Pump 2 appears to be a newer motor than the motor on pump 1. There appears to be some rust that is forming on the unit but they are still operational.

Based on the limited life expectancy left with the system and the other issues detailed above we would recommend that the pumps be replaced. The pumps are also constant volume and not on a variable speed control. VFD's should be added to the new pumps.

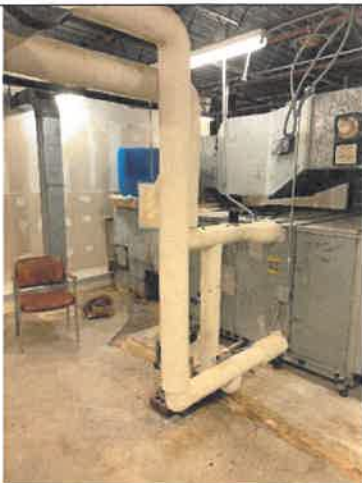
Photo 1 – Existing AHU-1

Based on the data that was able to be garnered from the unit these appear to have been installed during the original construction of the facility in 1989. This draw through chilled water air handling unit has a three-way valve at the chilled water piping and a newer variable frequency drive with an electric duct heater installed on the outside air intake of the unit. The exterior of the unit is in average condition for its age.

Based on our observations we would recommend that the unit and ductwork within the mechanical room be replaced.

Recommend AHU-1 for replacement. Replacement to include ductwork within the mechanical room.
Construction Cost Estimate: \$50,000
