## **THE PROBLEM:**

Water passes through seawall cracks or under seawalls, removing ground soil as it exits. This process creates a void that will eventually cause settlement of the land and structural problems.

## **THE SOLUTION:**

Polyurethane injection fills in the void and seals the cracks.

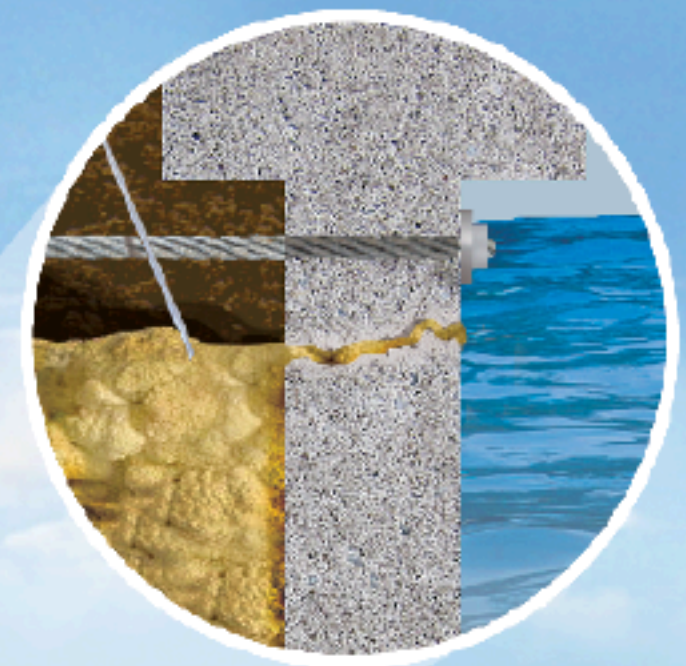
**Structure and land in danger of collapse**

**Deadman Tieback securing seawall.**  
As soils weaken, collapse is imminent.

**Hidden cavity growing under structure and along wall.**

**High Tide**

**Low Tide**

**Ground soil escaping from cracks, joints, and under wall.**
