**HISTORIC HACIENDA HOTEL**  
5621 MAIN STREET  
NEW PORT RICHEY FLORIDA, 34852

**Bender & Associates**  
**ARCHITECTS**  
p.a.

| DETAILS | |

### A8.3

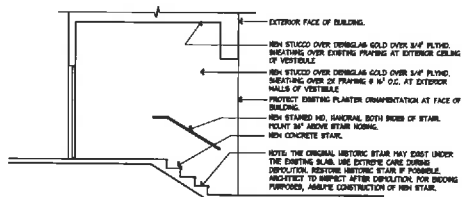
5 SECTION AT NEW MAIN EXTERIOR STAIR  
AB.3 SCALE: 1/4"=1'-0"

NEW WALL COLUMN PAINTED  
STUCCO / CONC. →
